July 12, 2023

Re: Site Inspection Report for July 7, 2023
Avon Crest Building Demolition Project
Avon Crest Facility – Stratford General Hospital
86 John Street South, Stratford, Ontario (Site)

2.0 RESULTS OF PROGRESS INSPECTION – JULY 7, 2023

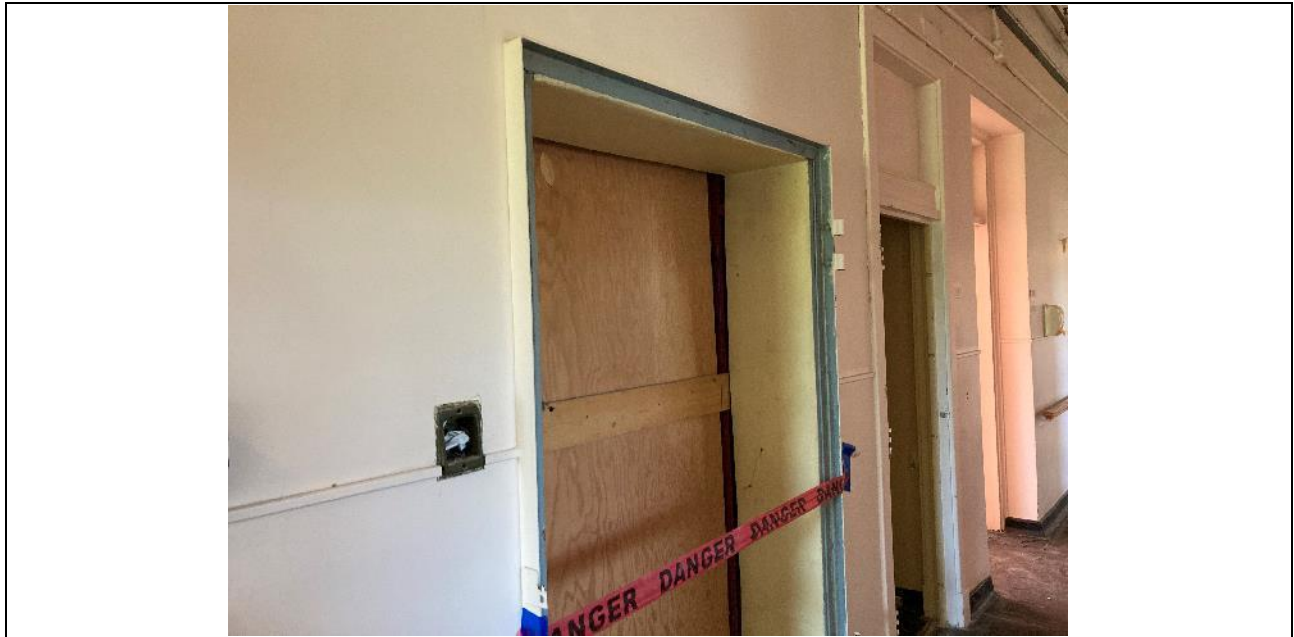
P1 – Second Floor Corridor

- Fire doors with asbestos-containing cores in the west corridor on the first, second and third floors were observed to have been removed (**P1**);
- Remaining asbestos-containing vinyl sheet flooring in the Accounting Supervisor Room on the first floor (Room 129A) was observed to have been removed (**P2**);

Fire doors containing asbestos-containing cores were removed from the west corridors on the first, second and third floors.

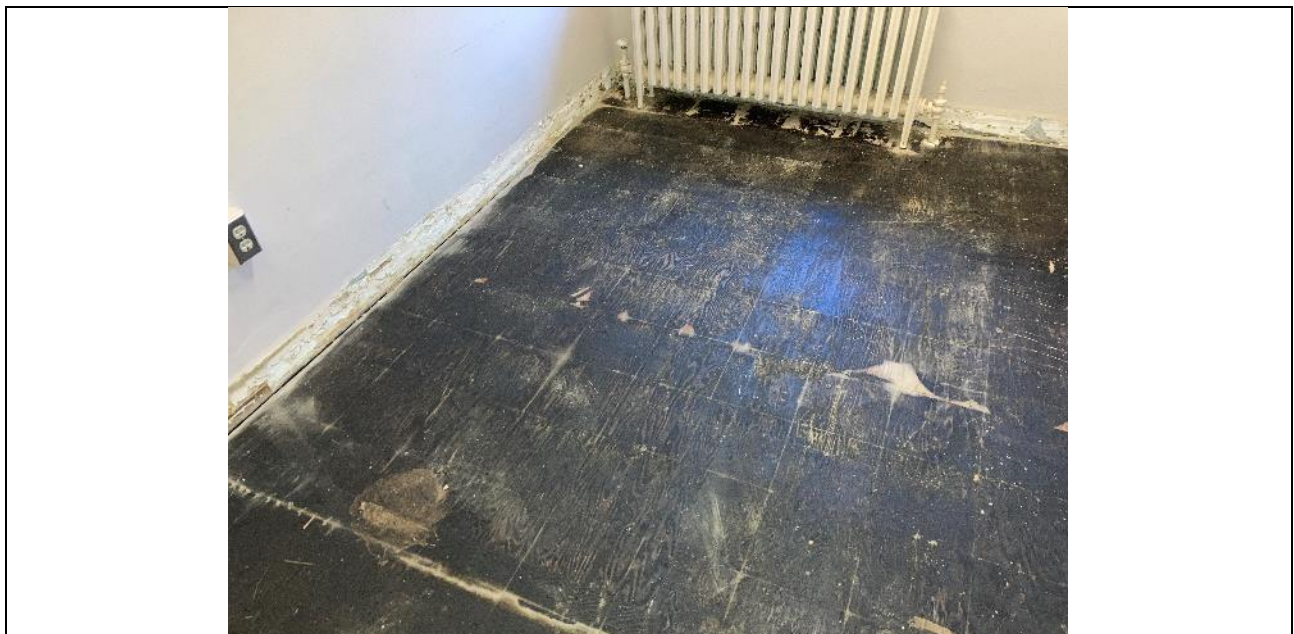
P2 – Room 129A

- Budget reportedly conducted removal of this material following Type 1 asbestos measures and procedures by removing the material with the subfloor, mostly intact. This is a variant on the Project Specifications (02 82 13.2);

Asbestos-containing vinyl sheet flooring was removed from remaining areas on the first floor.

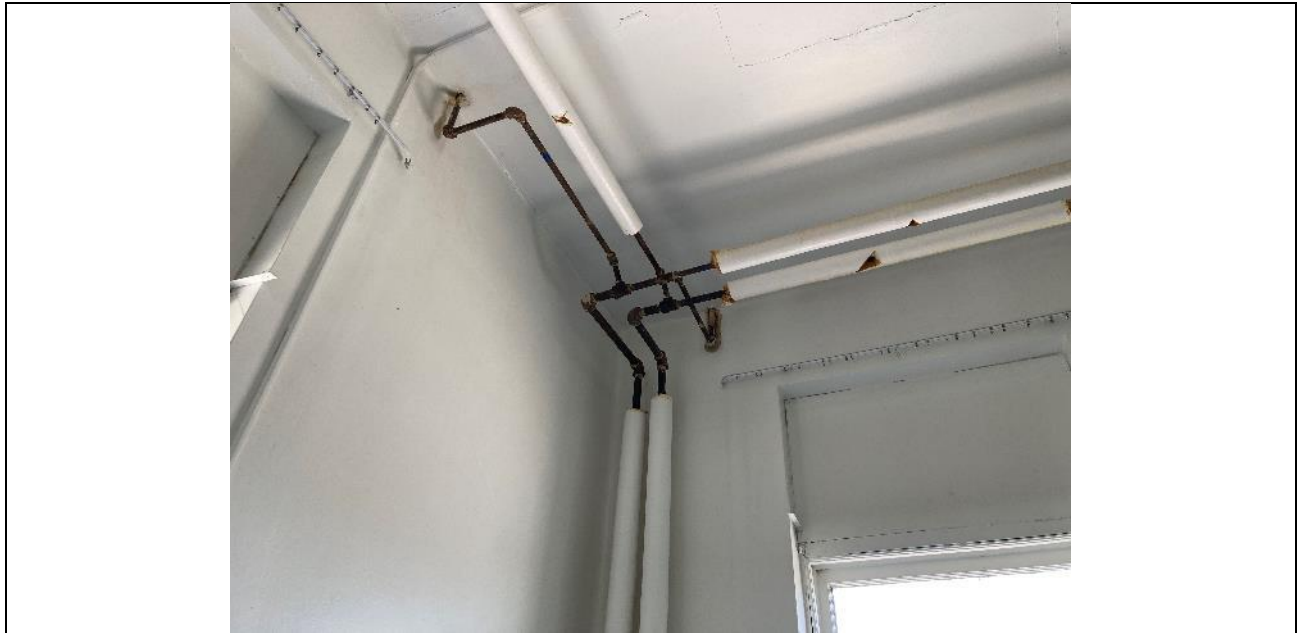
P3 – Room 234

- Remaining asbestos-containing parged cement pipe fitting insulation in the office on the second floor (Room 234) was observed to have been removed (**P3**);

Remaining asbestos-containing pipe fitting insulation was removed from remaining areas on the second floor.

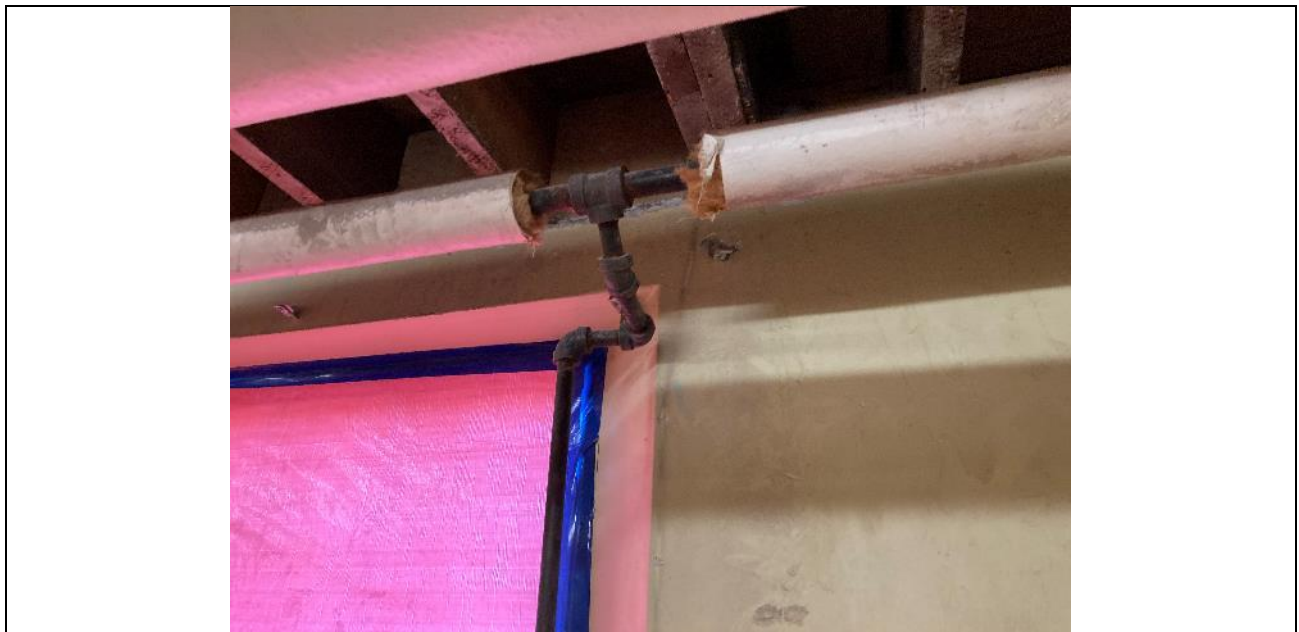
P4 – Pipe Insulation Removed

- Budget reportedly conducted removal of this material following Type 2 Glove Bag procedures as per the Project Specifications (02 82 13.4)
- Pipes were inspected for parging cement insulation remnants and were observed to be visually clean (**P4**);

Asbestos-containing pargead cement pipe fitting insulation was removed adequately throughout the majority of the basement.

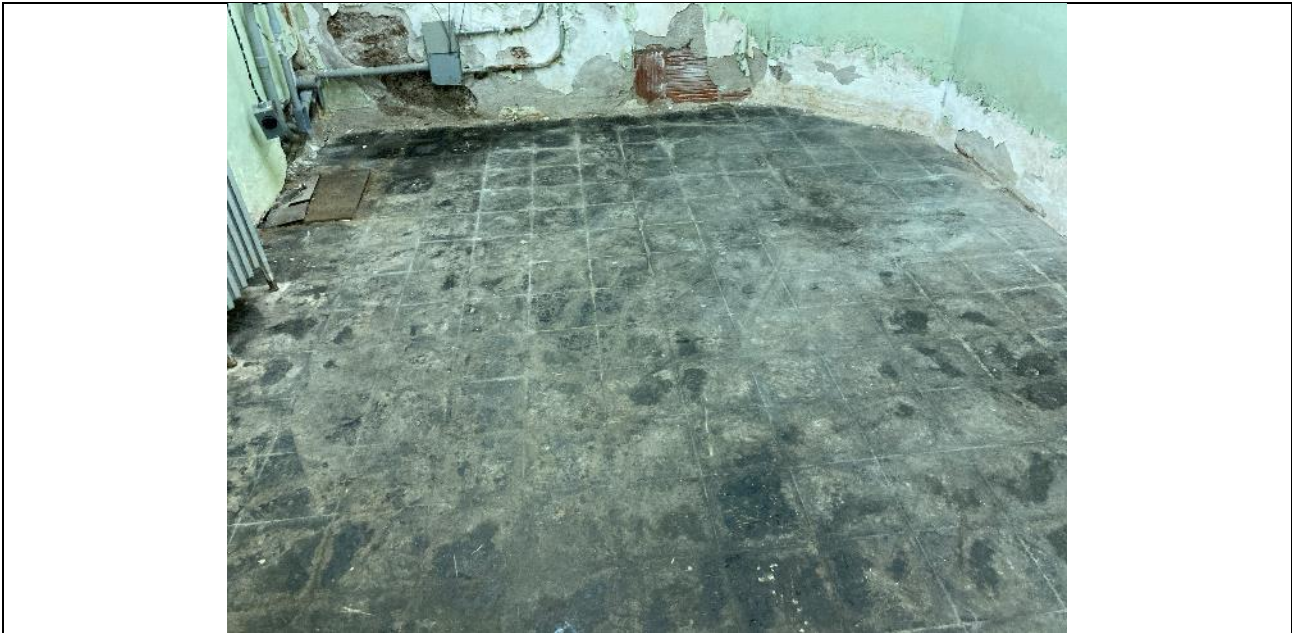
P5 – Room 026

- The work site appeared to be clean and tidy during the inspection (**P5**);
- A waste bin was observed on site. Waste within the bin was wrapped with polyethylene sheeting and sealed with tape (**P6**).

The work site, including all abatement areas, was clean and tidy during the inspection.

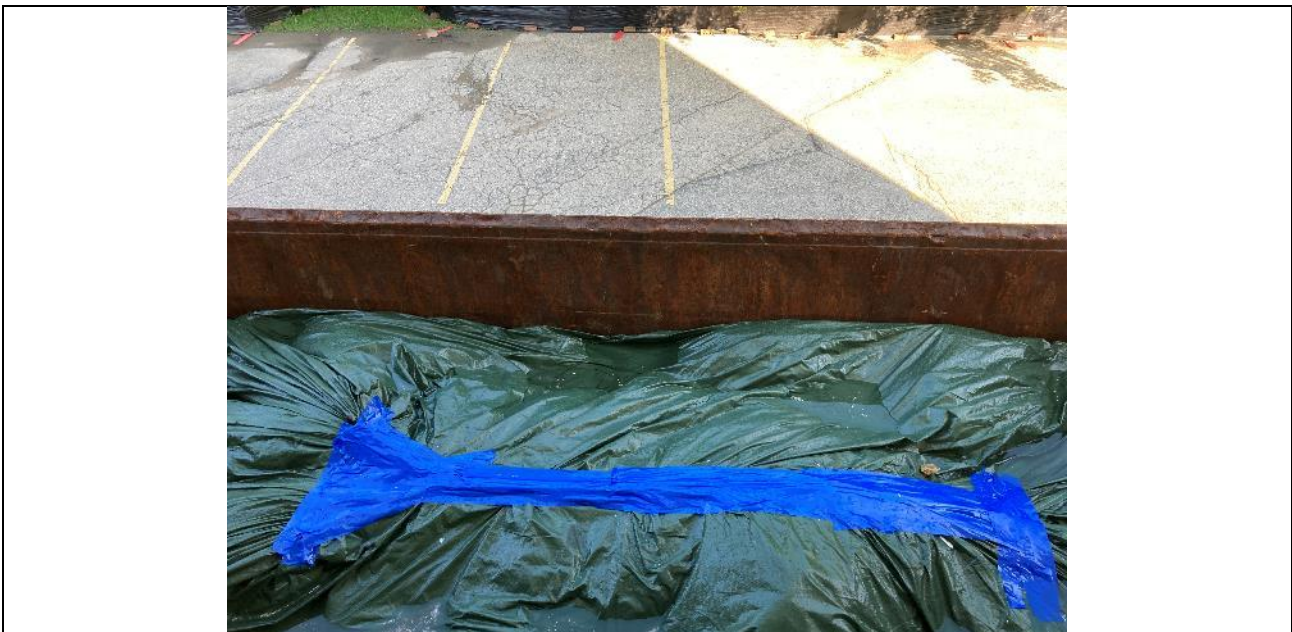
P6 – Asbestos Waste Bin

The asbestos waste bin was lined. The liner was closed and sealed.
