Re: Site Inspection Report for July 19, 2023
Avon Crest Building Demolition Project
Avon Crest Facility – Stratford General Hospital
86 John Street South, Stratford, Ontario (Site)

2.0 RESULTS OF PROGRESS INSPECTION – JULY 19, 2023

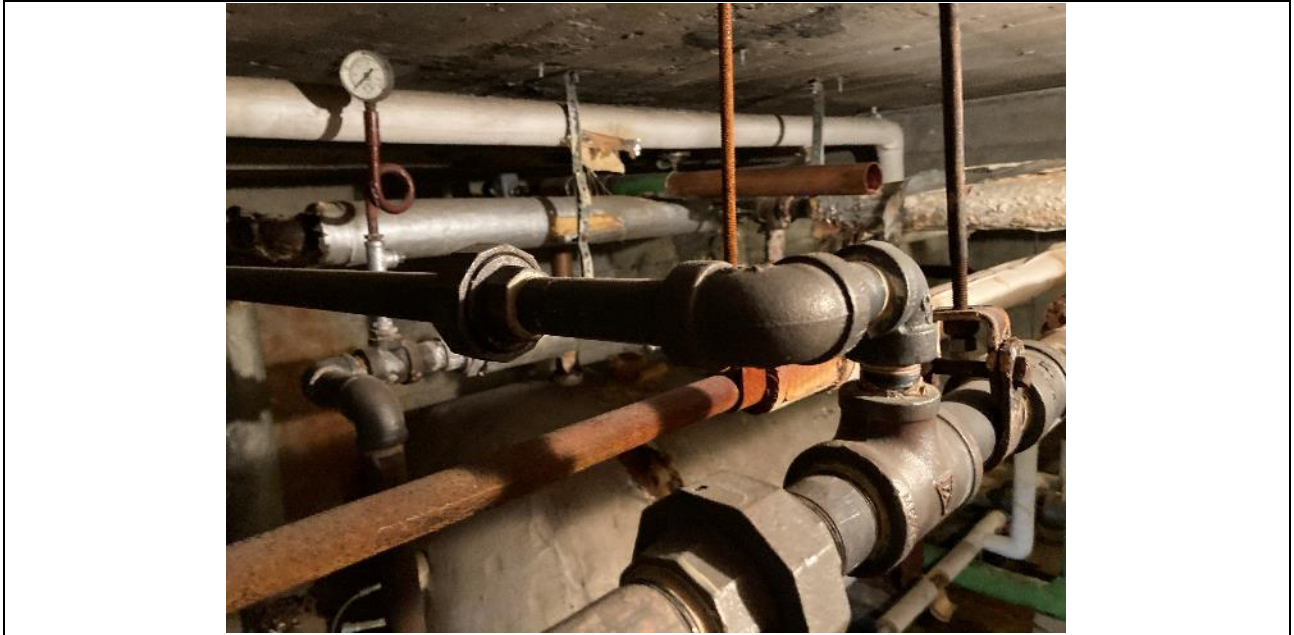
P1 – Laundry/Power Plant Crawlspace

- Parged cement pipe fitting insulation (**P1**);
 - Mechanical insulation on unit heaters (**P2**);
 - Boiler tank insulation (**P3**); and,
 - Boiler breeching insulation (**P4**);

Asbestos-containing parged cement pipe fitting insulation was removed from areas in the Laundry/Power Plant.

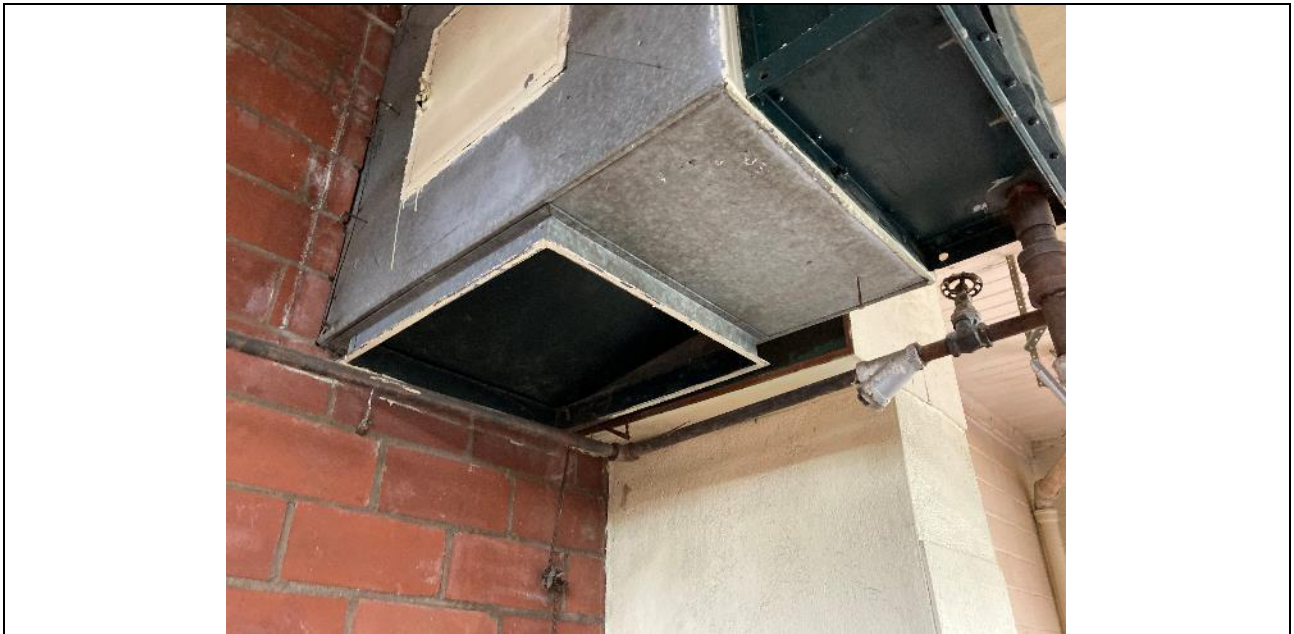
P2 – Laundry Room

Asbestos-containing mechanical insulation on unit heaters was successfully removed from the building.

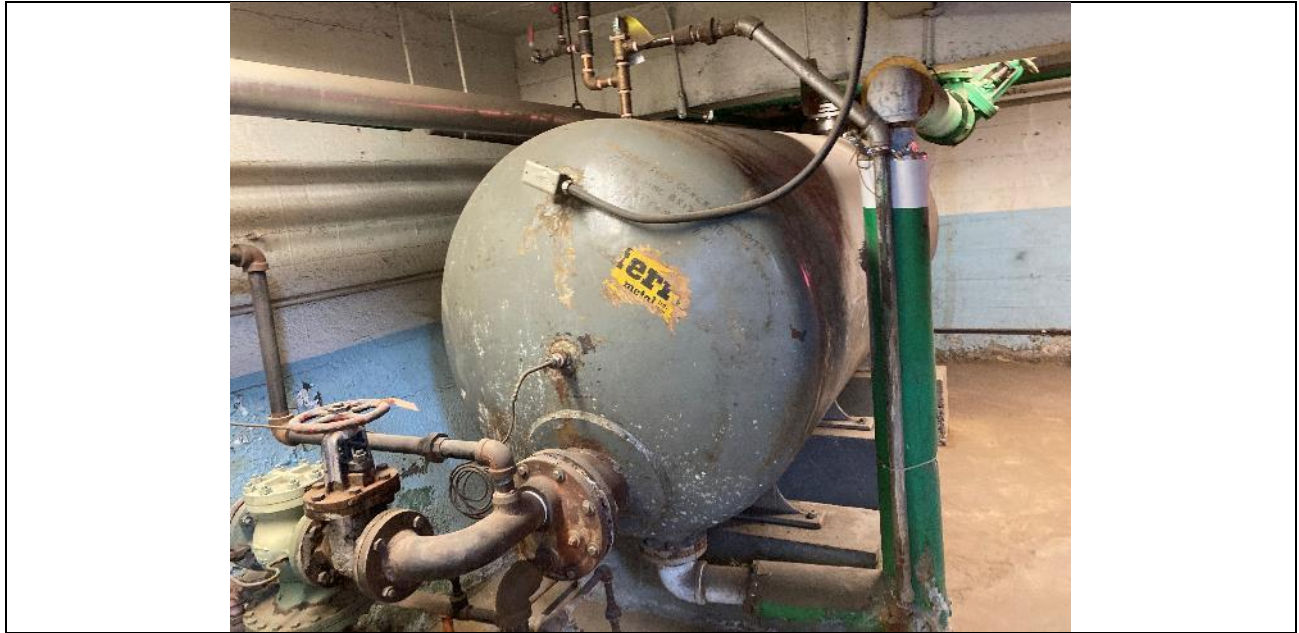
P3 – Power Plant

Asbestos-containing boiler insulation has been successfully removed from the building.

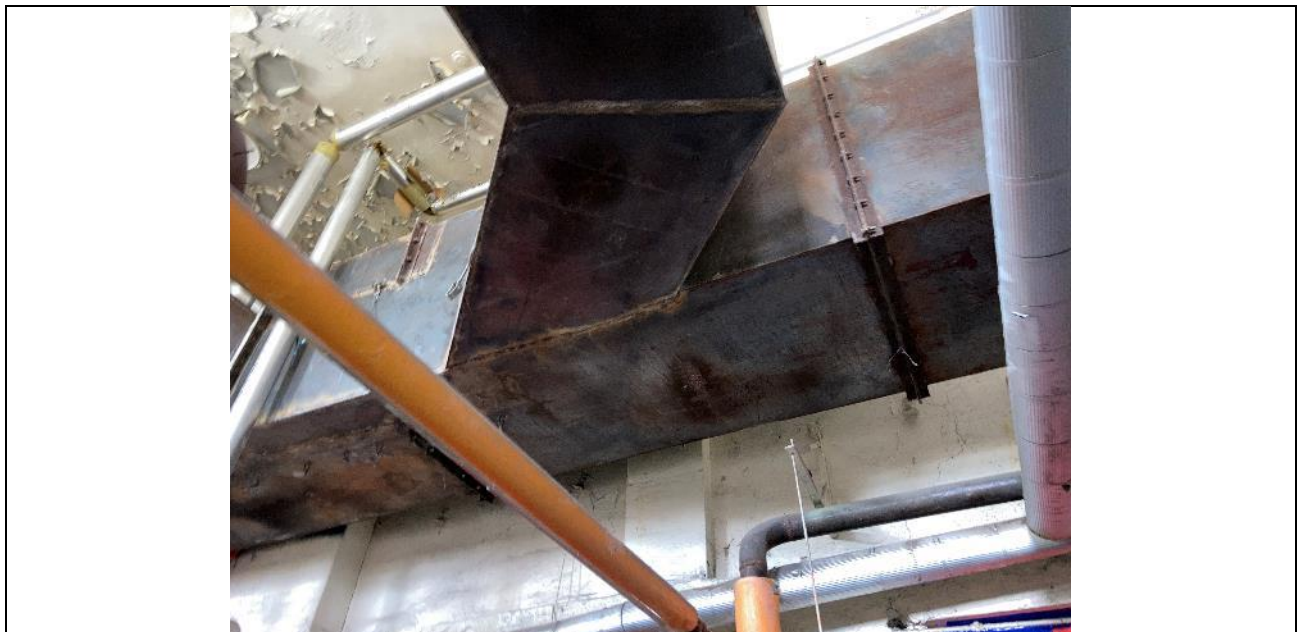
P4 – Power Plant

Asbestos-containing boiler breeching insulation has been successfully removed from the building.

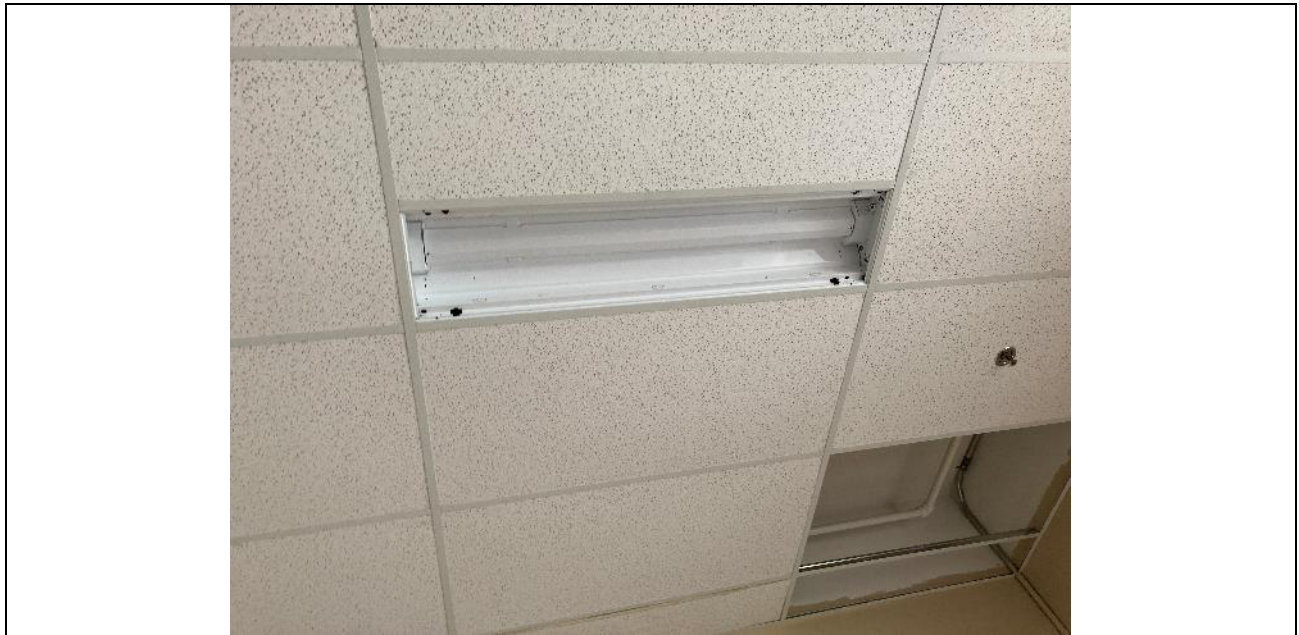
P5 – Room 111

- The majority of mercury-containing fluorescent light tubes have been removed from the Avon Crest Building and the Laundry/Power Plant (**P5, P6**). The following rooms/areas still contain fluorescent light tubes in order to provide sufficient lighting for workers:

Mercury-containing fluorescent light tubes have been removed from this area.

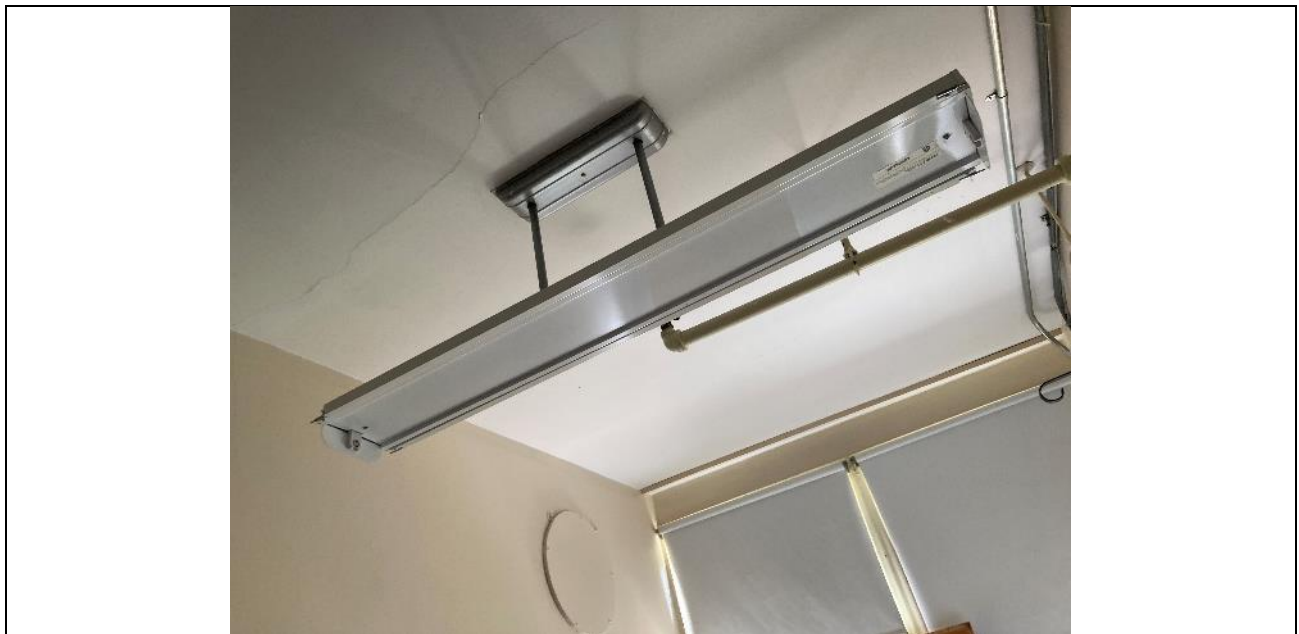
P6 – Room 338

Mercury-containing fluorescent light tubes have been removed from this area.
