Re: Site Inspection Report for July 11, 2023
Type 3 Pre-Contamination Inspection – Laundry Room and Power Plant
Avon Crest Facility – Stratford General Hospital
86 John Street South, Stratford, Ontario (Site)

3.0 RESULTS OF PROGRESS INSPECTION – JULY 11, 2023

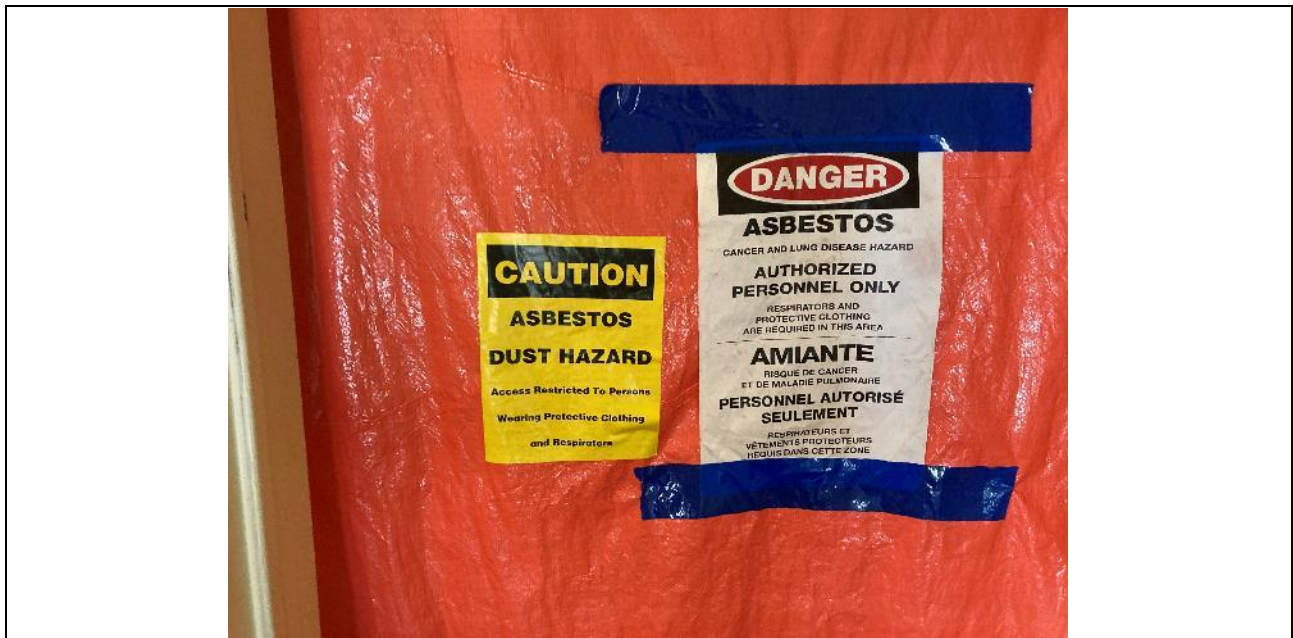
P1 – Outside Type 3 Work Area

- Access to the work area was secured with lockable doors.
 - Appropriate cautionary signage was posted at each door, warning of the hazards of asbestos exposure (**P1**).

Appropriate cautionary signage was posted to warn of the hazards of asbestos exposure.

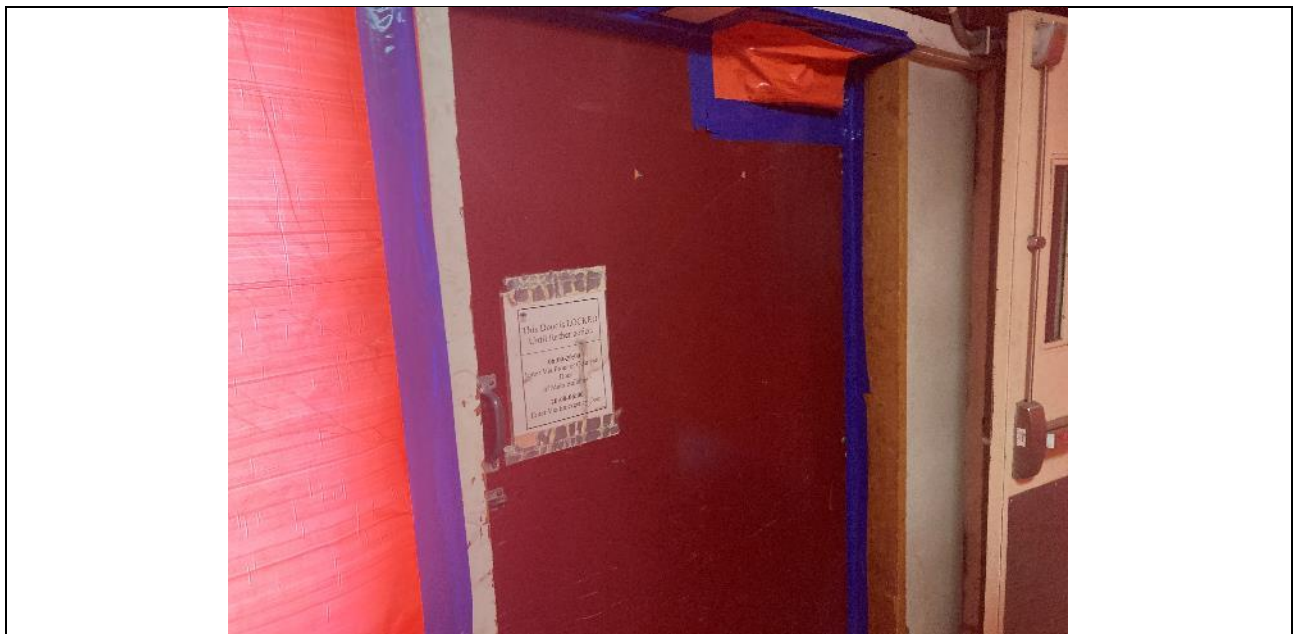
P2 – Type 3 Anteroom

- Entry and exit from the work area was limited to the doorway on the west side of the Avon Crest Basement Laundry Link (the Link).
- The entry points into the Link from the east (from the exterior) and the north (from the Avon Crest Facility) were sealed off using a combination of polyethylene sheeting and tape (**P2**).

All entrances/exits within the anteroom not designated as part of the path for workers were sealed with polyethylene sheeting and tape.

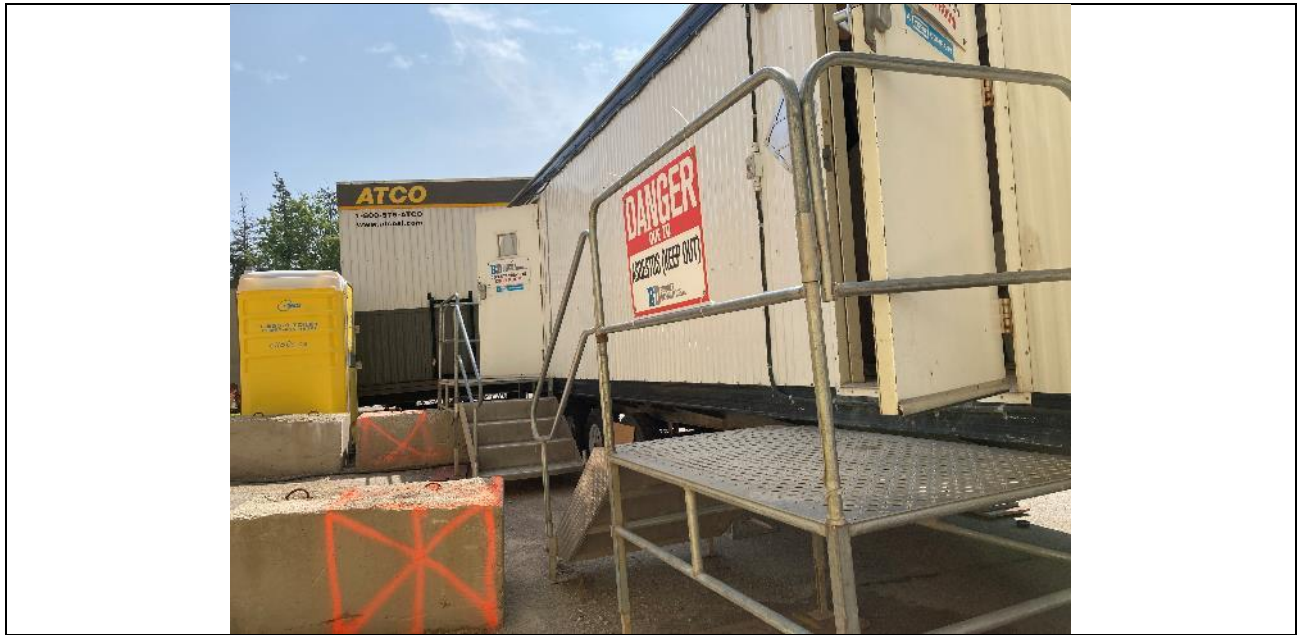
P3 – Exterior

- The decontamination trailer contains a dirty room, shower and clean room with signage posted to direct the workers appropriately (**P3**).
- The Link is to be used as an anteroom for the Type 3 work area and contained appropriate personal protective equipment and a HEPA vacuum (**P4**).

Decontamination trailer with signs to the dirty room and clean room in order to direct workers.

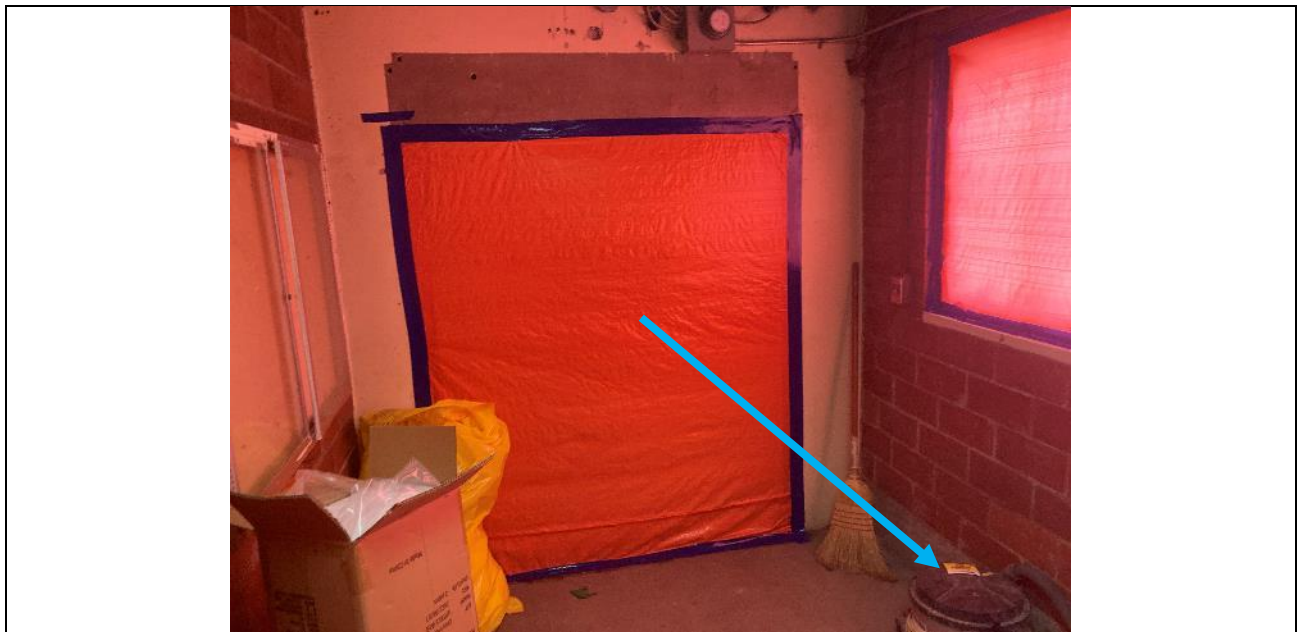
P4 – Type 3 Anteroom

- All workers are to decontaminate using the HEPA vacuum prior to exiting the anteroom directly to outdoors and then proceed directly to the decontamination facility.

Workers shall use the HEPA vacuum (blue arrow) prior to leaving for the decontamination trailer.

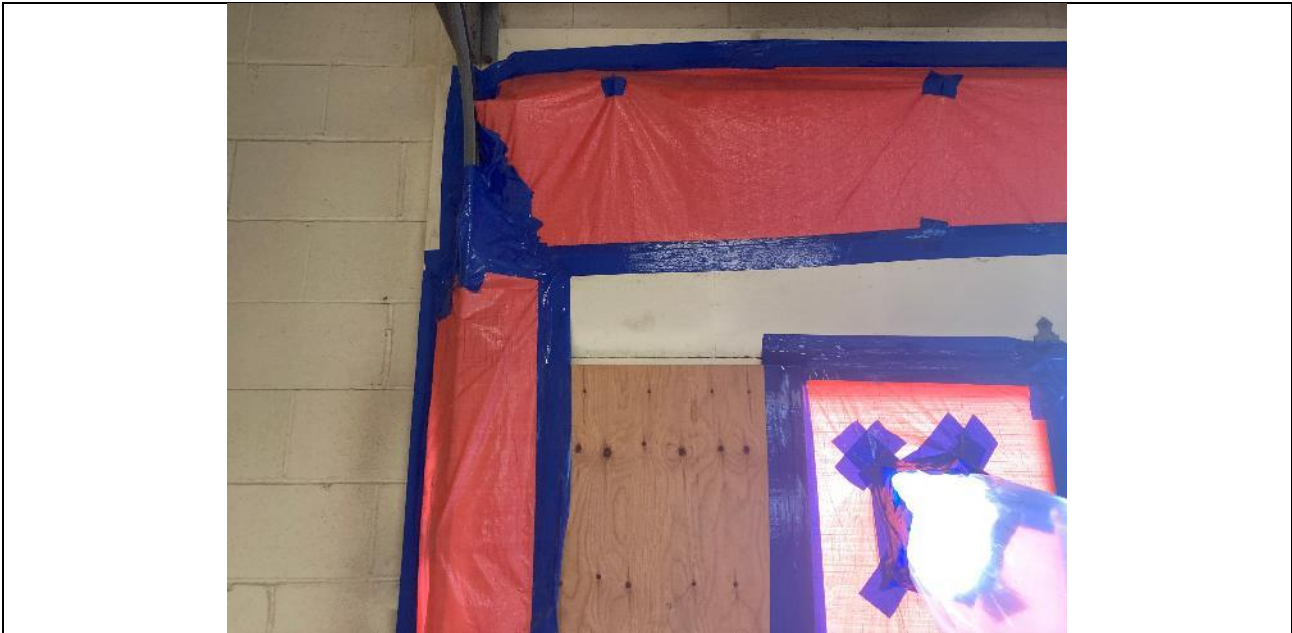
P5 – Type 3 Work Area

- At the time of inspection, workers were finishing sealing all gaps in site isolation barriers along exterior walls and air plenum supply diffusers and return intakes with a combination of polyethylene sheeting and tape (**P5**), as well as removing all movable contents from the work area.

Gaps in the exterior walls were sealed from the Type 3 work area with polyethylene sheeting and tape.

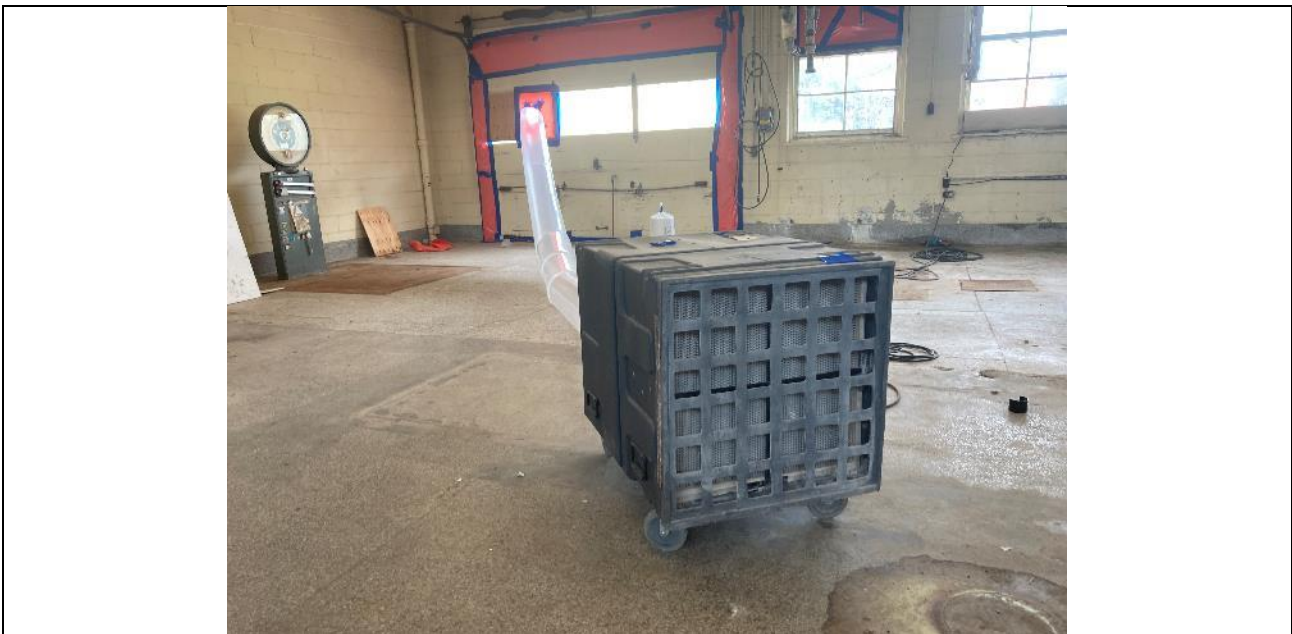
P6 – Type 3 Work Area

- Workers were observed to be pre-cleaning the work area.
- One (1) HEPA-filtered construction air handling unit (CAHU) was observed within the work area and was exhausting through an exterior window in the Laundry Room (**P6**).

HEPA-filtered construction air handling unit was observed present and exhausting to the exterior of the building.
