July 11, 2016
MTE File No.: C36672-101

**Revised Re: 2016 Asbestos Audit Update of
Stratford General Hospital
46 General Hospital Drive, Stratford, ON**

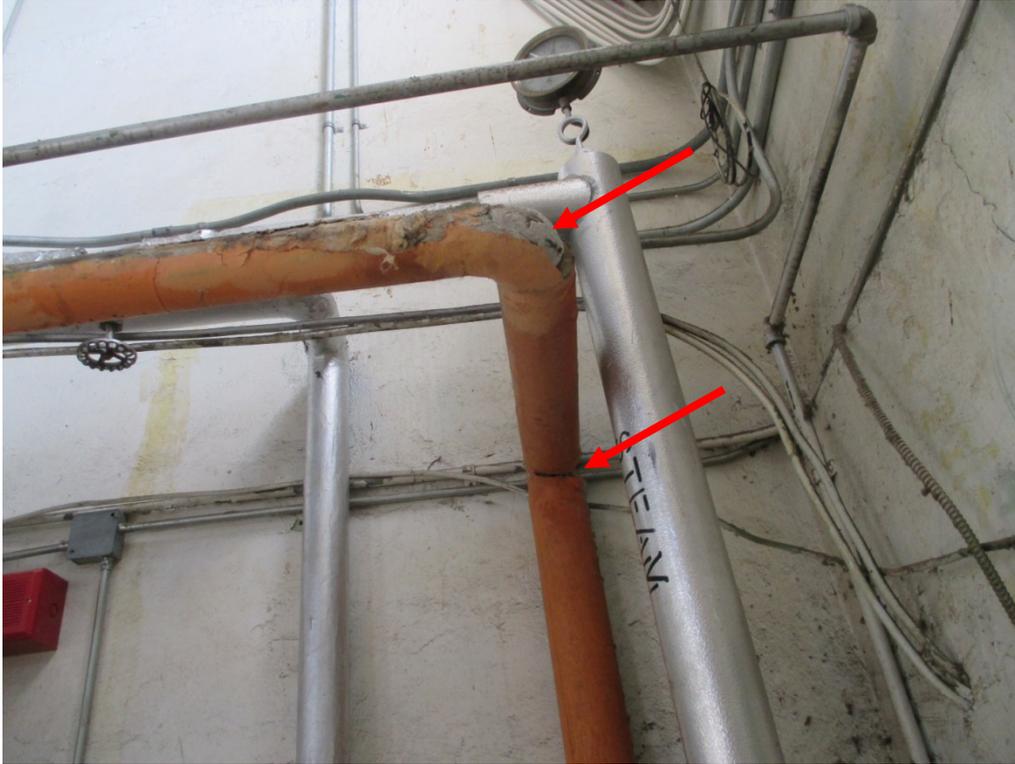
- Mechanical Insulations:
 - Parged pipe fittings on elbows/tees and valves located on pipe systems:
 - 5 pipe fittings were damaged at the time of inspection (Photographs 1-4).
 - Mag block insulation on hot water tanks and boilers:
 - Approximately 5 ft² damaged on ceiling mounted heaters at the time of inspection (Photographs 5-7); and
 - Approximately 10 ft² damaged on boilers at the time of inspection (Photographs 8-10).
 - Air Cell pipe insulation on pipe systems.

Photograph No. 1 – Avoncrest (Power Plant)
Two Damaged Pipe Fittings

In addition, damaged ACM was identified and requires removal or repair. All asbestos work must be conducted by contractors who are trained and experienced in the type of asbestos operations required, and should be overseen by a qualified third party Health, Safety and Environmental professional. In order to conduct Type 3 asbestos operations, contractors must be certified as Asbestos Abatement Workers AAW (Trade code 253W) and Asbestos Abatement Supervisors AAS (Trade code 253S) by The Ministry of Training, Colleges and Universities as prescribed by Section 20 of O. Reg. 278/05.

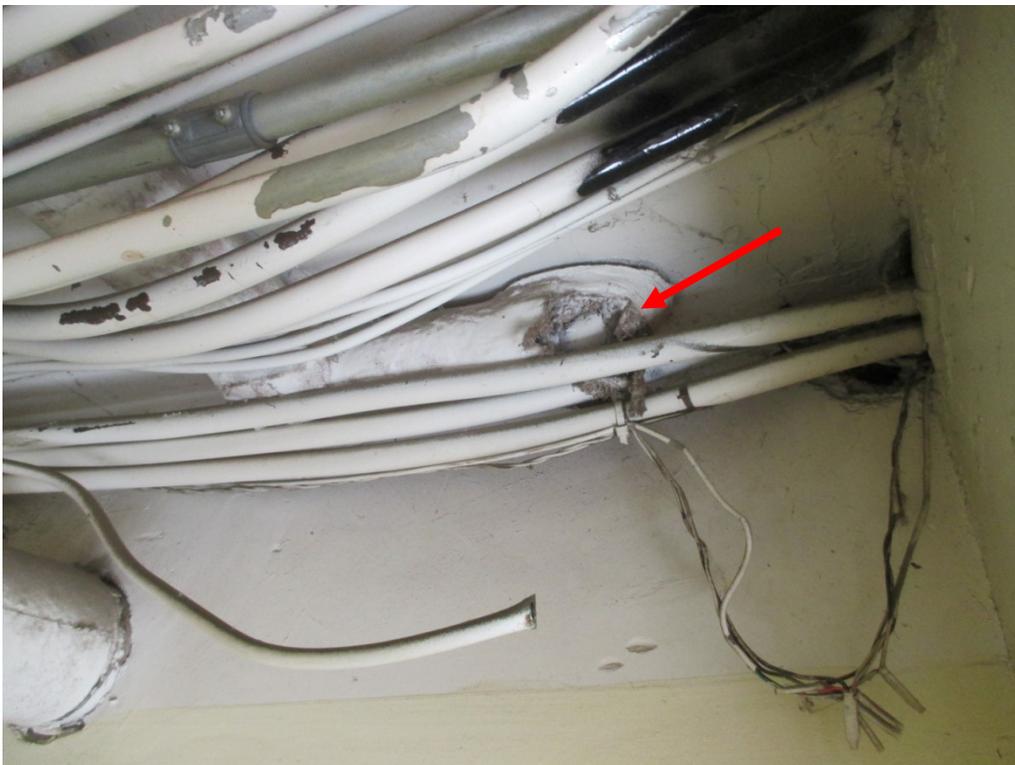
Photograph No. 2 – Avoncrest (Basement Corridor)
One Damaged Pipe Fitting

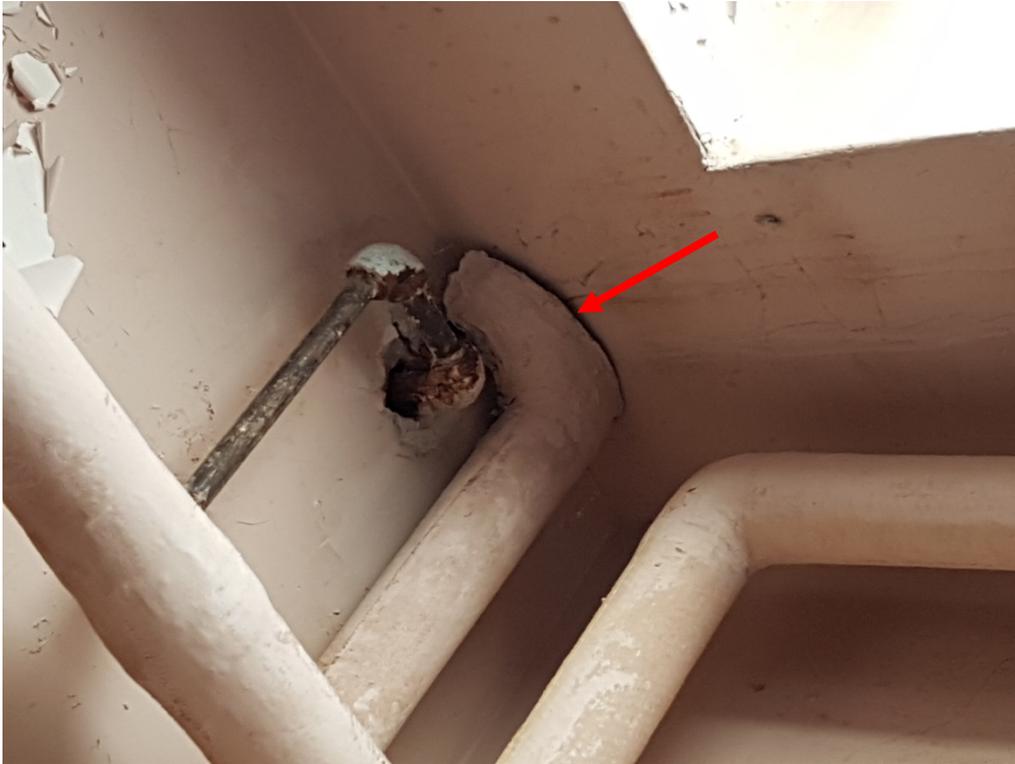
Photograph No. 3 – Avoncrest (Room 037B)
One Damaged Pipe Fitting

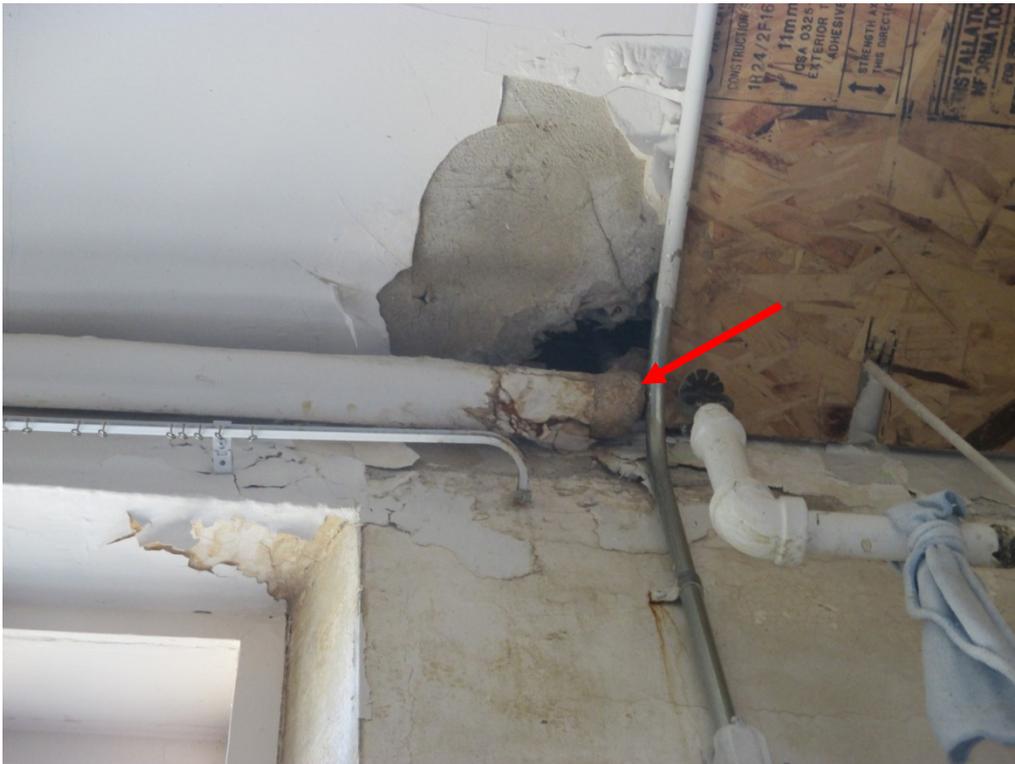
Photograph No. 4 – Avoncrest (Second Floor North Corridor)
One Damaged Pipe Fitting

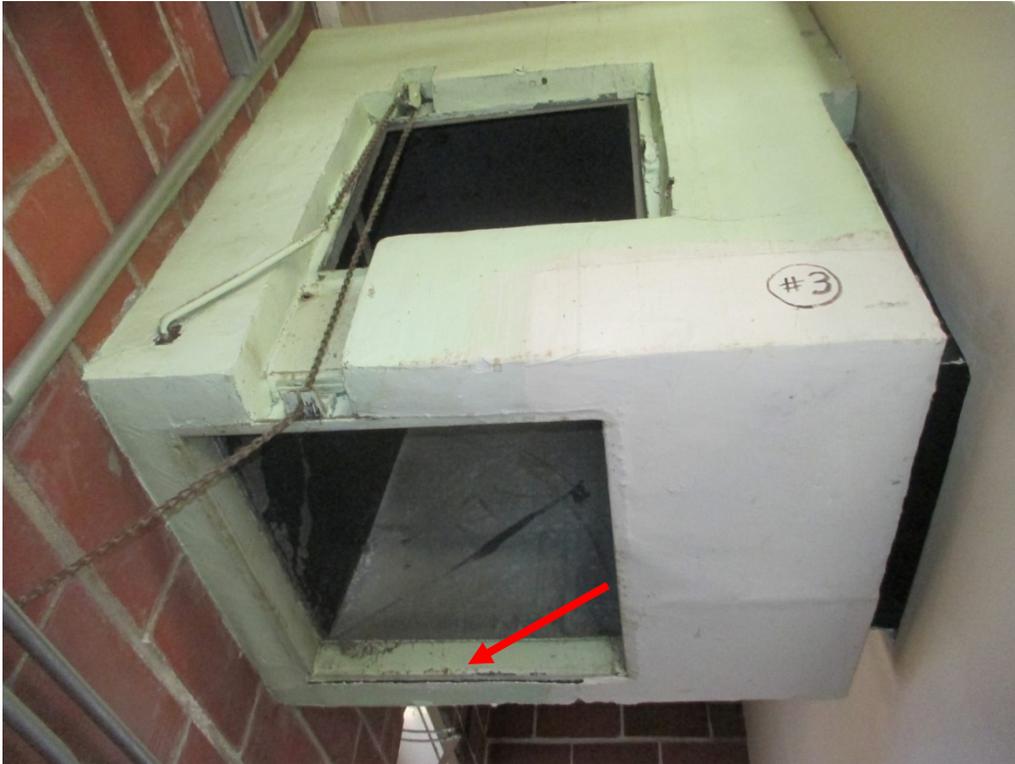
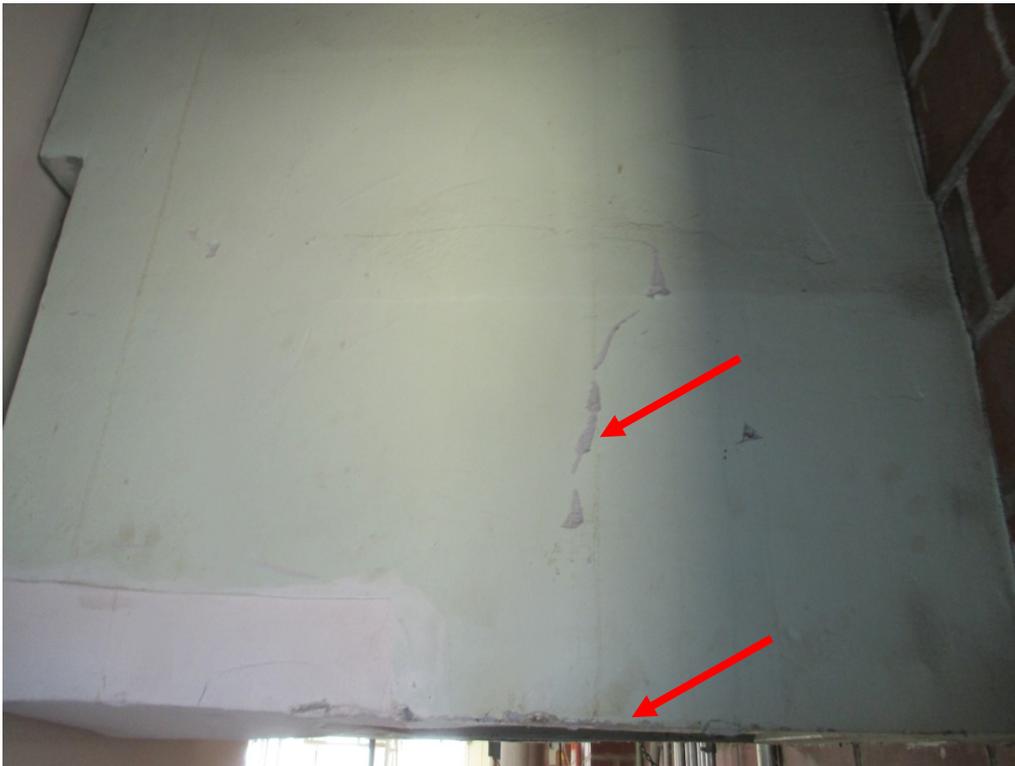
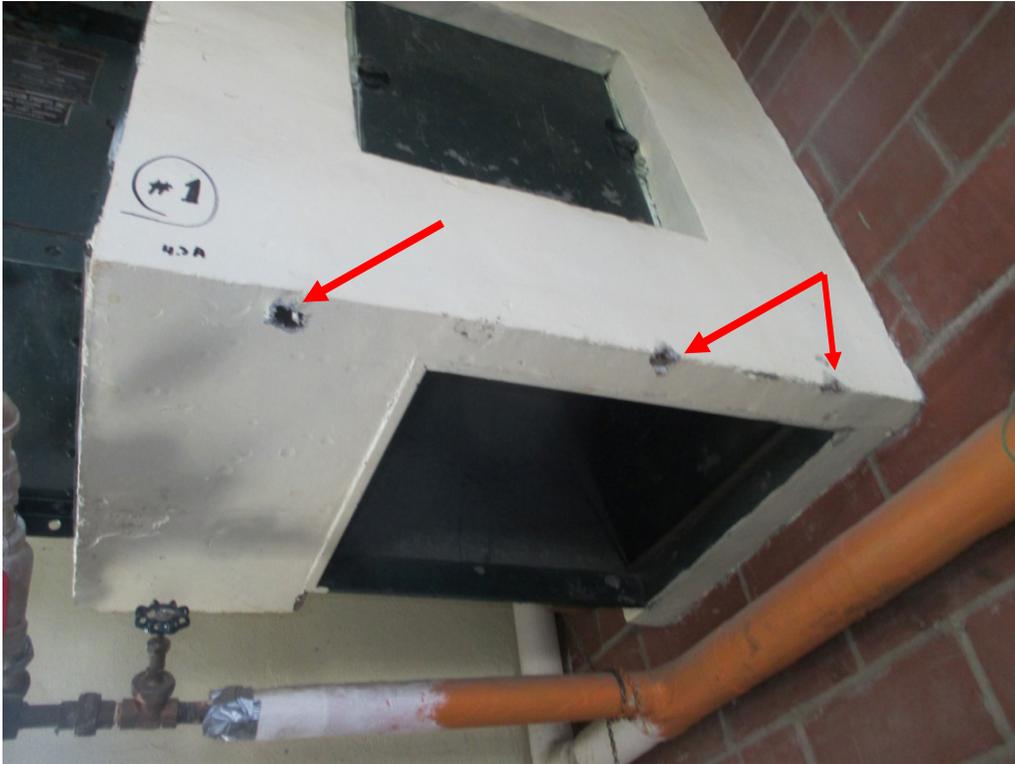
Photograph No. 5 – Avoncrest (Laundry)
Damaged Mag Block Insulation on Ceiling Mounted Heaters

Photograph No. 6 – Avoncrest (Laundry)
Damaged Mag Block Insulation on Ceiling Mounted Heaters

Photograph No. 7 – Avoncrest (Laundry)
Damaged Mag Block Insulation on Ceiling Mounted Heaters

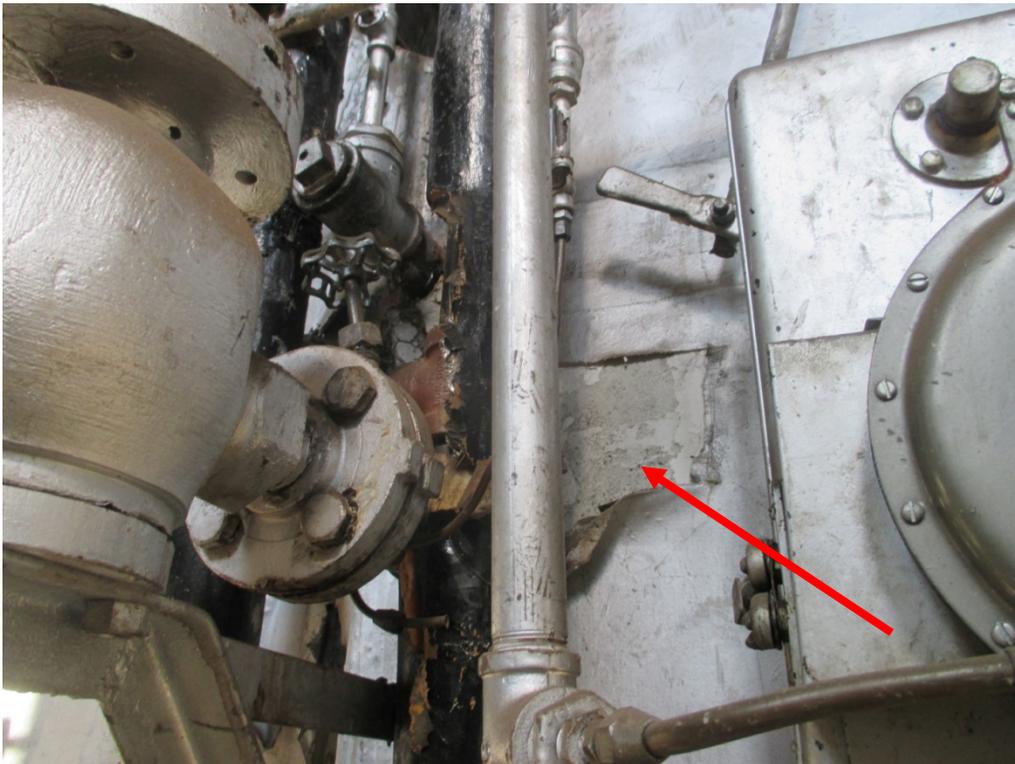
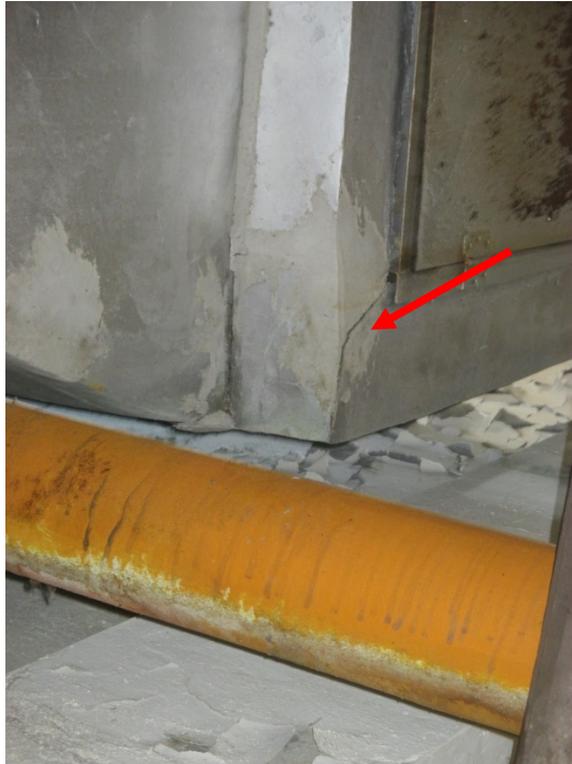
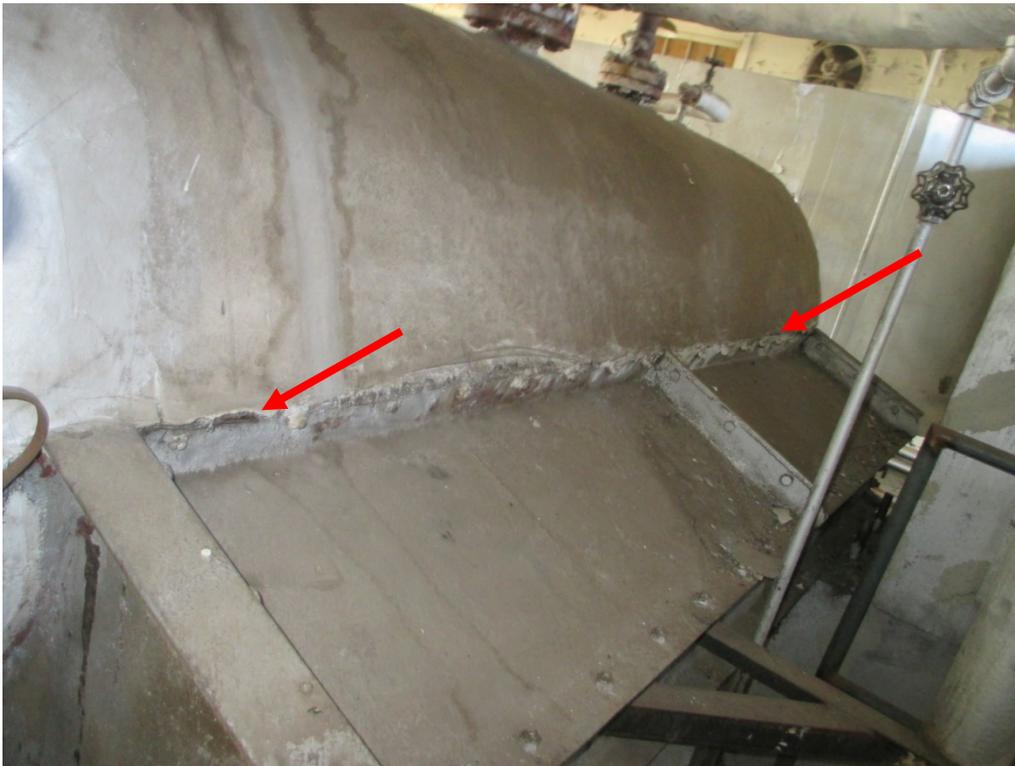
Photograph No. 8 – Avoncrest (Power Plant)
Damaged Mag Block Insulation on Boilers

Photograph No. 9 – Avoncrest (Power Plant)
Damaged Mag Block Insulation on Boiler

Photograph No. 10 – Avoncrest (Power Plant)
Damaged Mag Block Insulation on Boiler

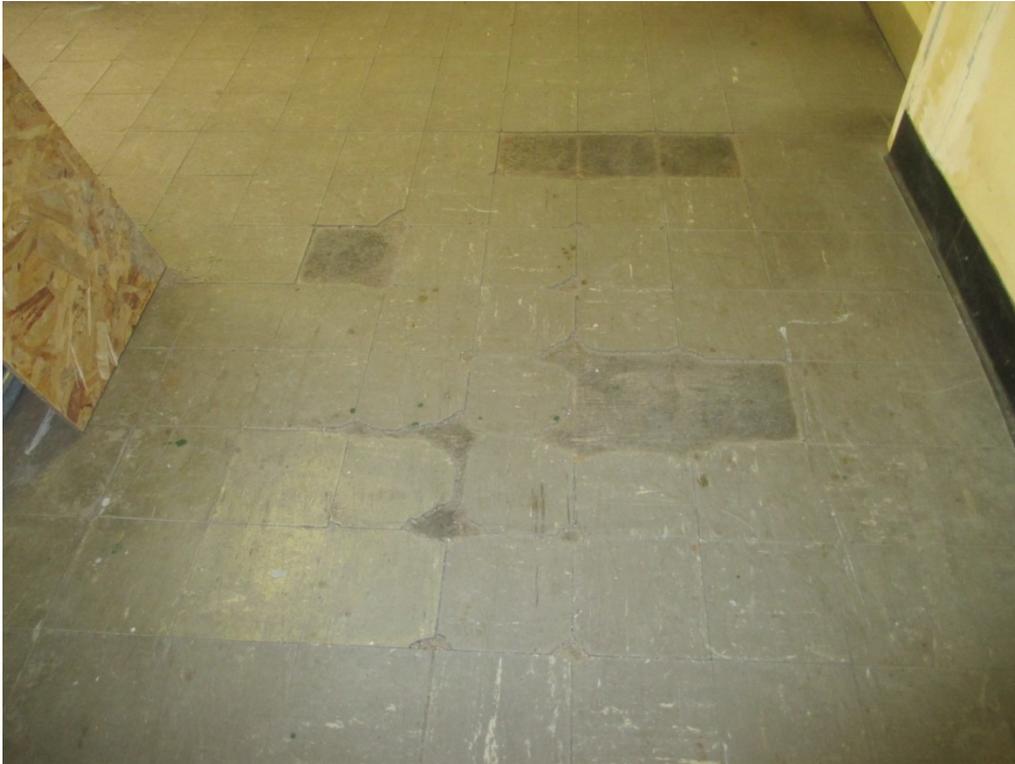
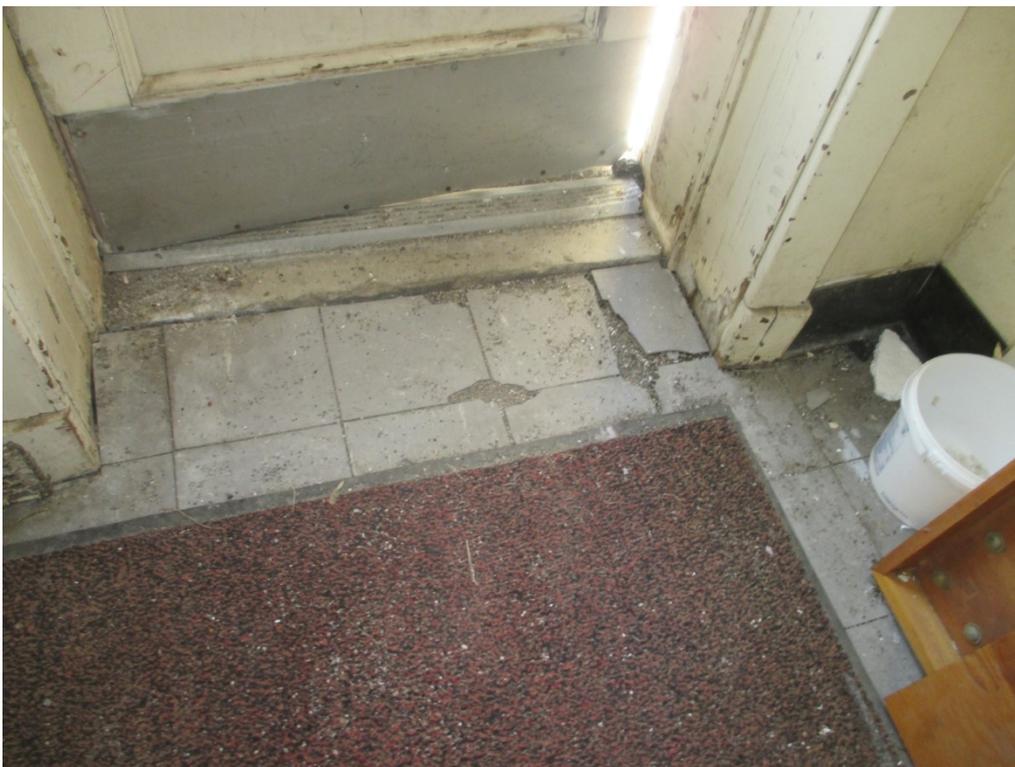
- 9"x9" beige with rust fleck vinyl floor tiles:
 - Associated mastic is non asbestos-containing.
- 9"x9" grey with white fleck vinyl floor tiles (Basement):
 - Approximately 20-30 tiles were damaged at the time of inspection (Photographs 11 & 12).
- 9"x9" dark grey with white/red streak vinyl floor tiles;
- 9"x9" blue with white streak vinyl floor tiles;
- 9"x9" red with white fleck vinyl floor tiles;
- 12"x12" white with green fleck vinyl floor tiles;
- 12"x12" green with white fleck vinyl floor tiles;
- 12"x12" green vinyl floor tiles;
- 12"x12" white multi-colour fleck vinyl floor tiles;
- Beige pebble vinyl sheet flooring;
- Brown pebble vinyl sheet flooring;
- Red pebble vinyl sheet flooring; and
- Hard texture coat on ceilings and walls.

Photograph No. 11 – Avoncrest (Basement Corridor)
Damaged 9" x 9" Grey with White Fleck Vinyl Floor Tiles

Photograph No. 12 – Avoncrest (Basement Corridor)
Damaged 9" x 9" Grey with White Fleck Vinyl Floor Tiles

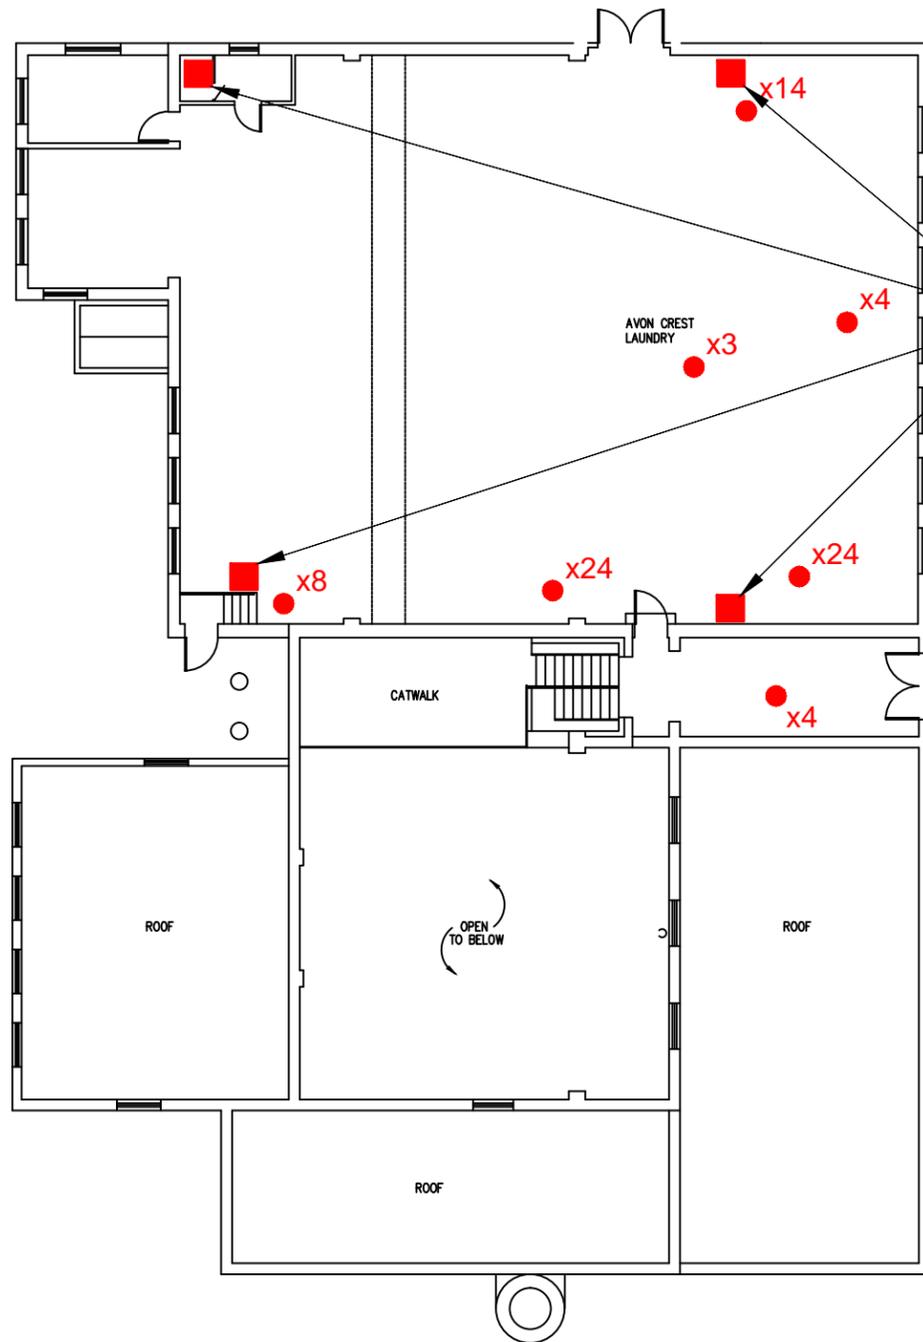
LAUNDRY AND POWER PLANT - LEVEL ONE

SUSPECT MAG BLOCK INSULATION ON CEILING MOUNTED HEATERS

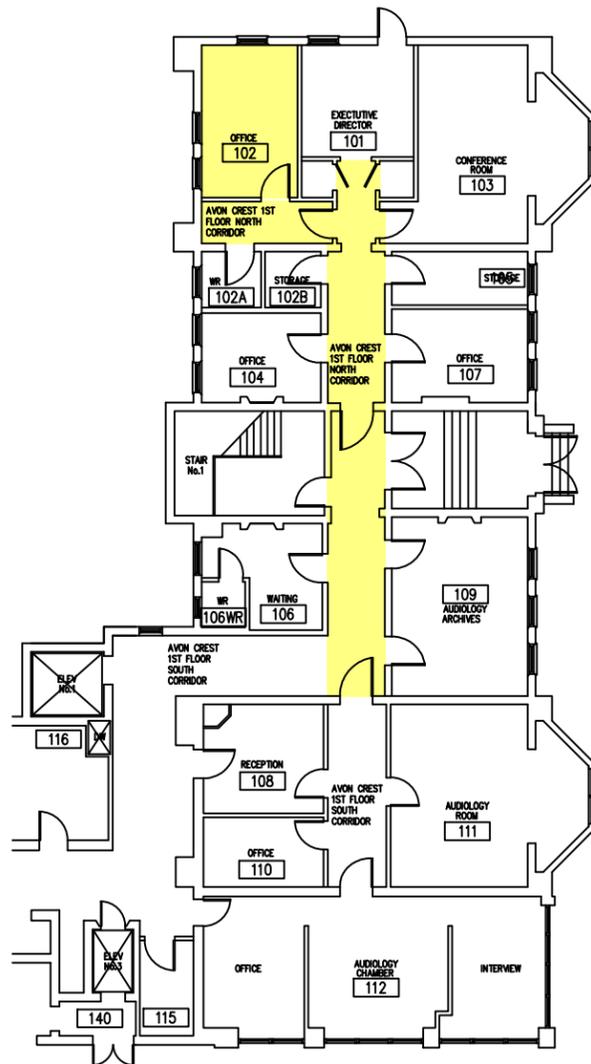
NORTH WING

MAG BLOCK AND AIRCELL INSULATION SUSPECTED ON PIPE LINES THROUGHOUT

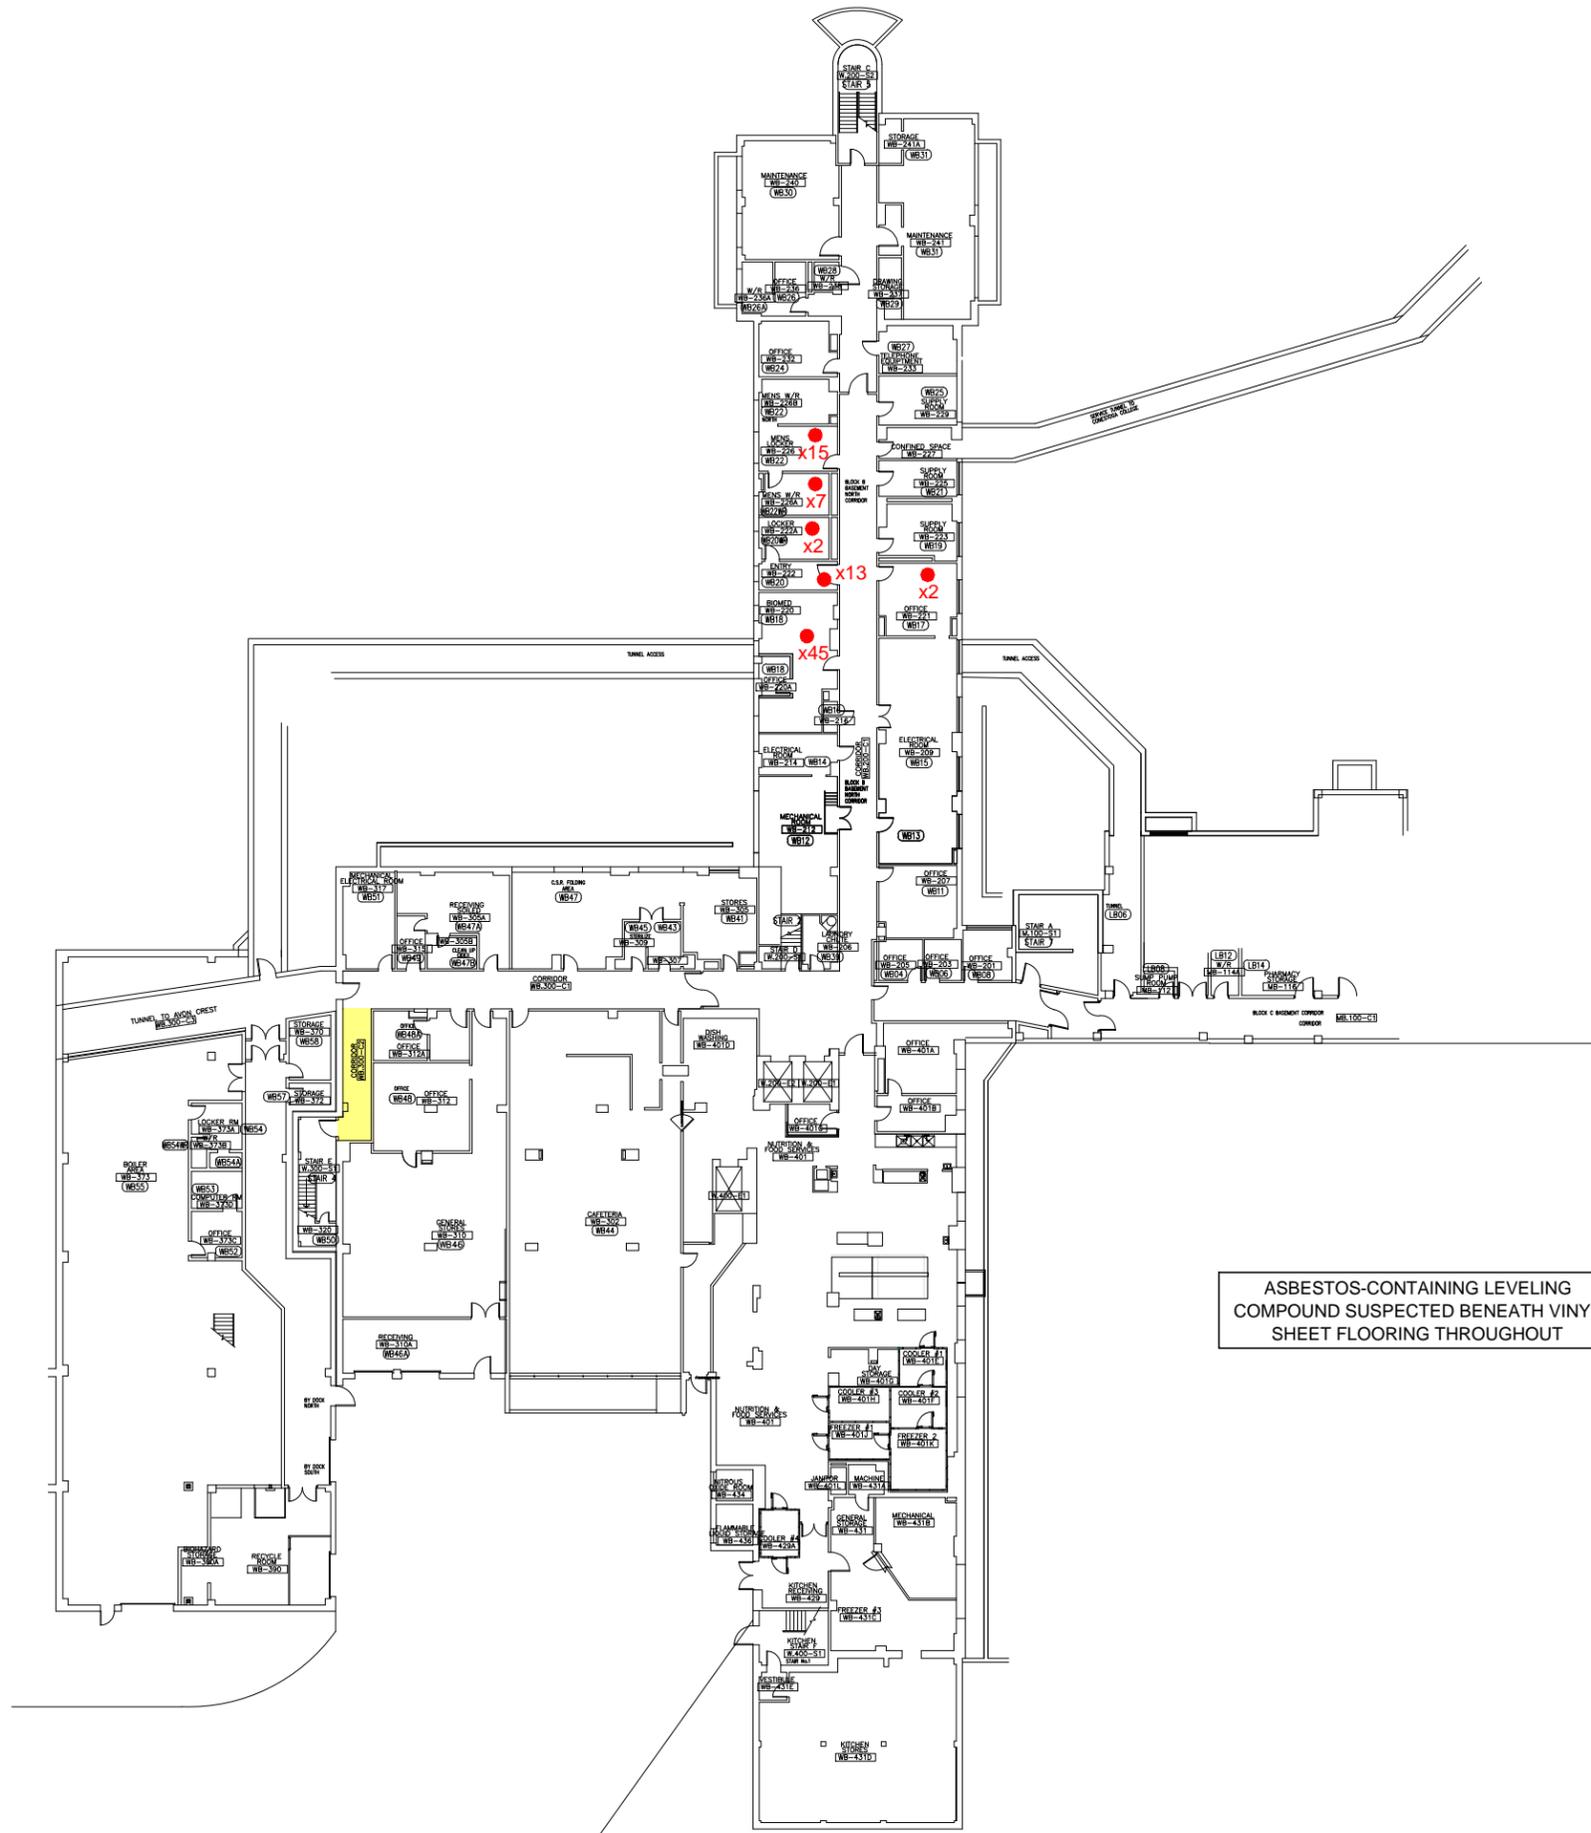
ASBESTOS-CONTAINING LEVELING COMPOUND SUSPECTED BENEATH VINYL SHEET FLOORING THROUGHOUT

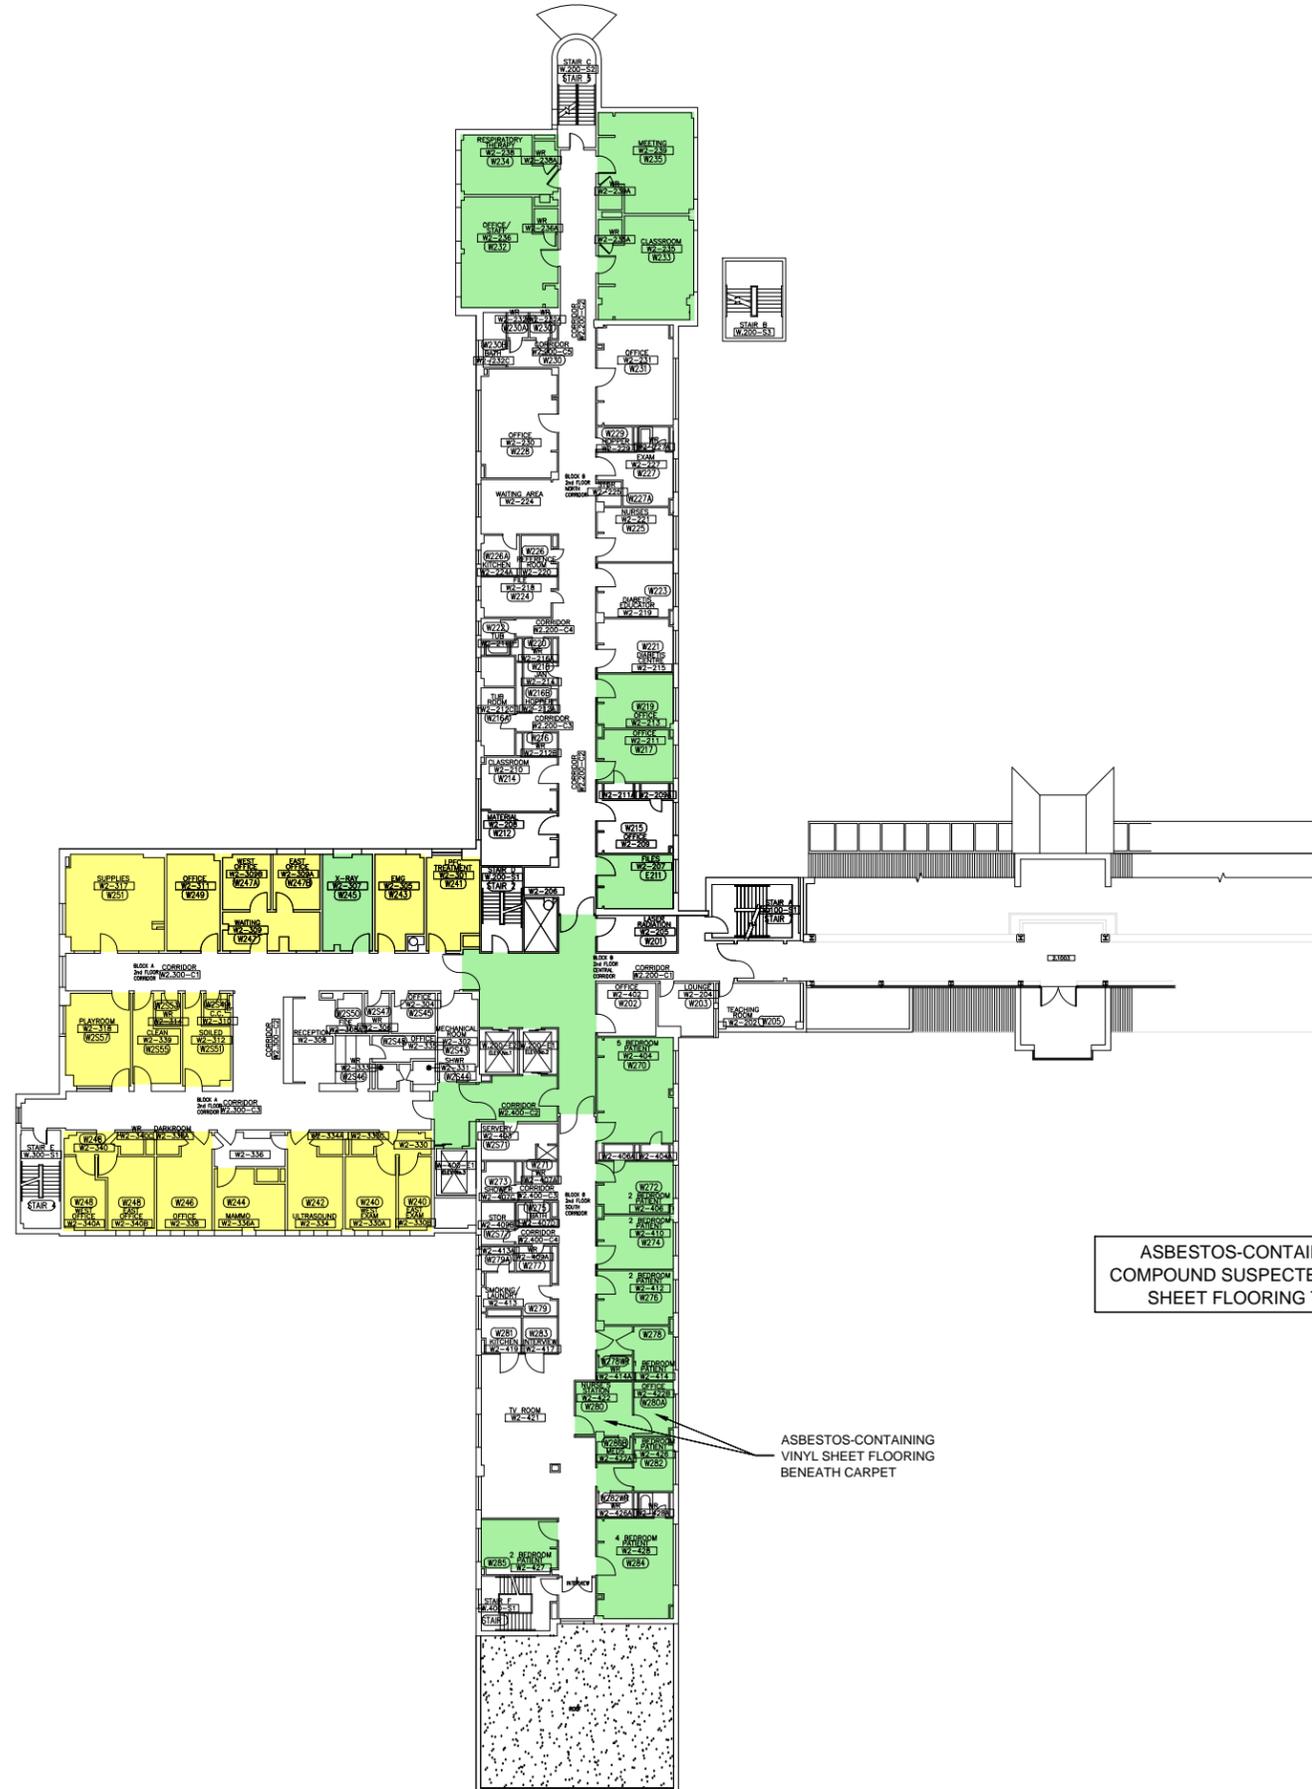
ASBESTOS-CONTAINING LEVELING COMPOUND SUSPECTED BENEATH VINYL SHEET FLOORING THROUGHOUT

ASBESTOS-CONTAINING VINYL SHEET FLOORING BENEATH CARPET

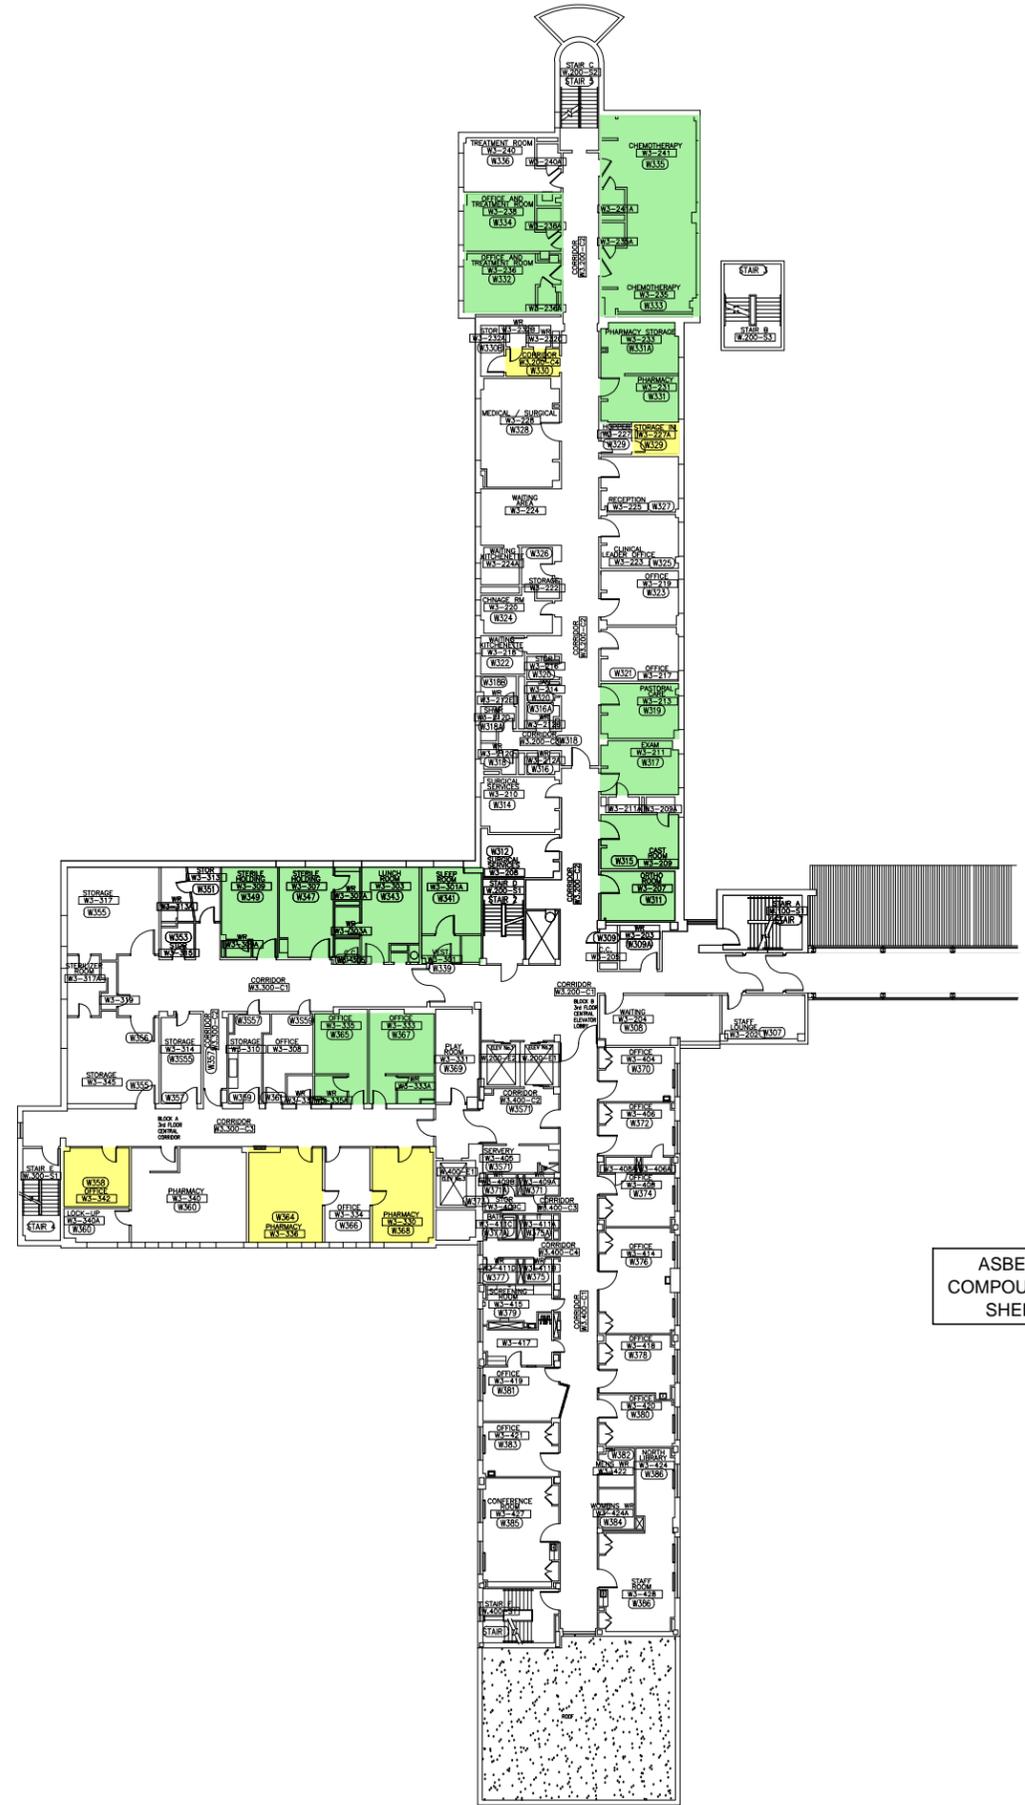
ASBESTOS-CONTAINING LEVELING COMPOUND SUSPECTED BENEATH VINYL SHEET FLOORING THROUGHOUT

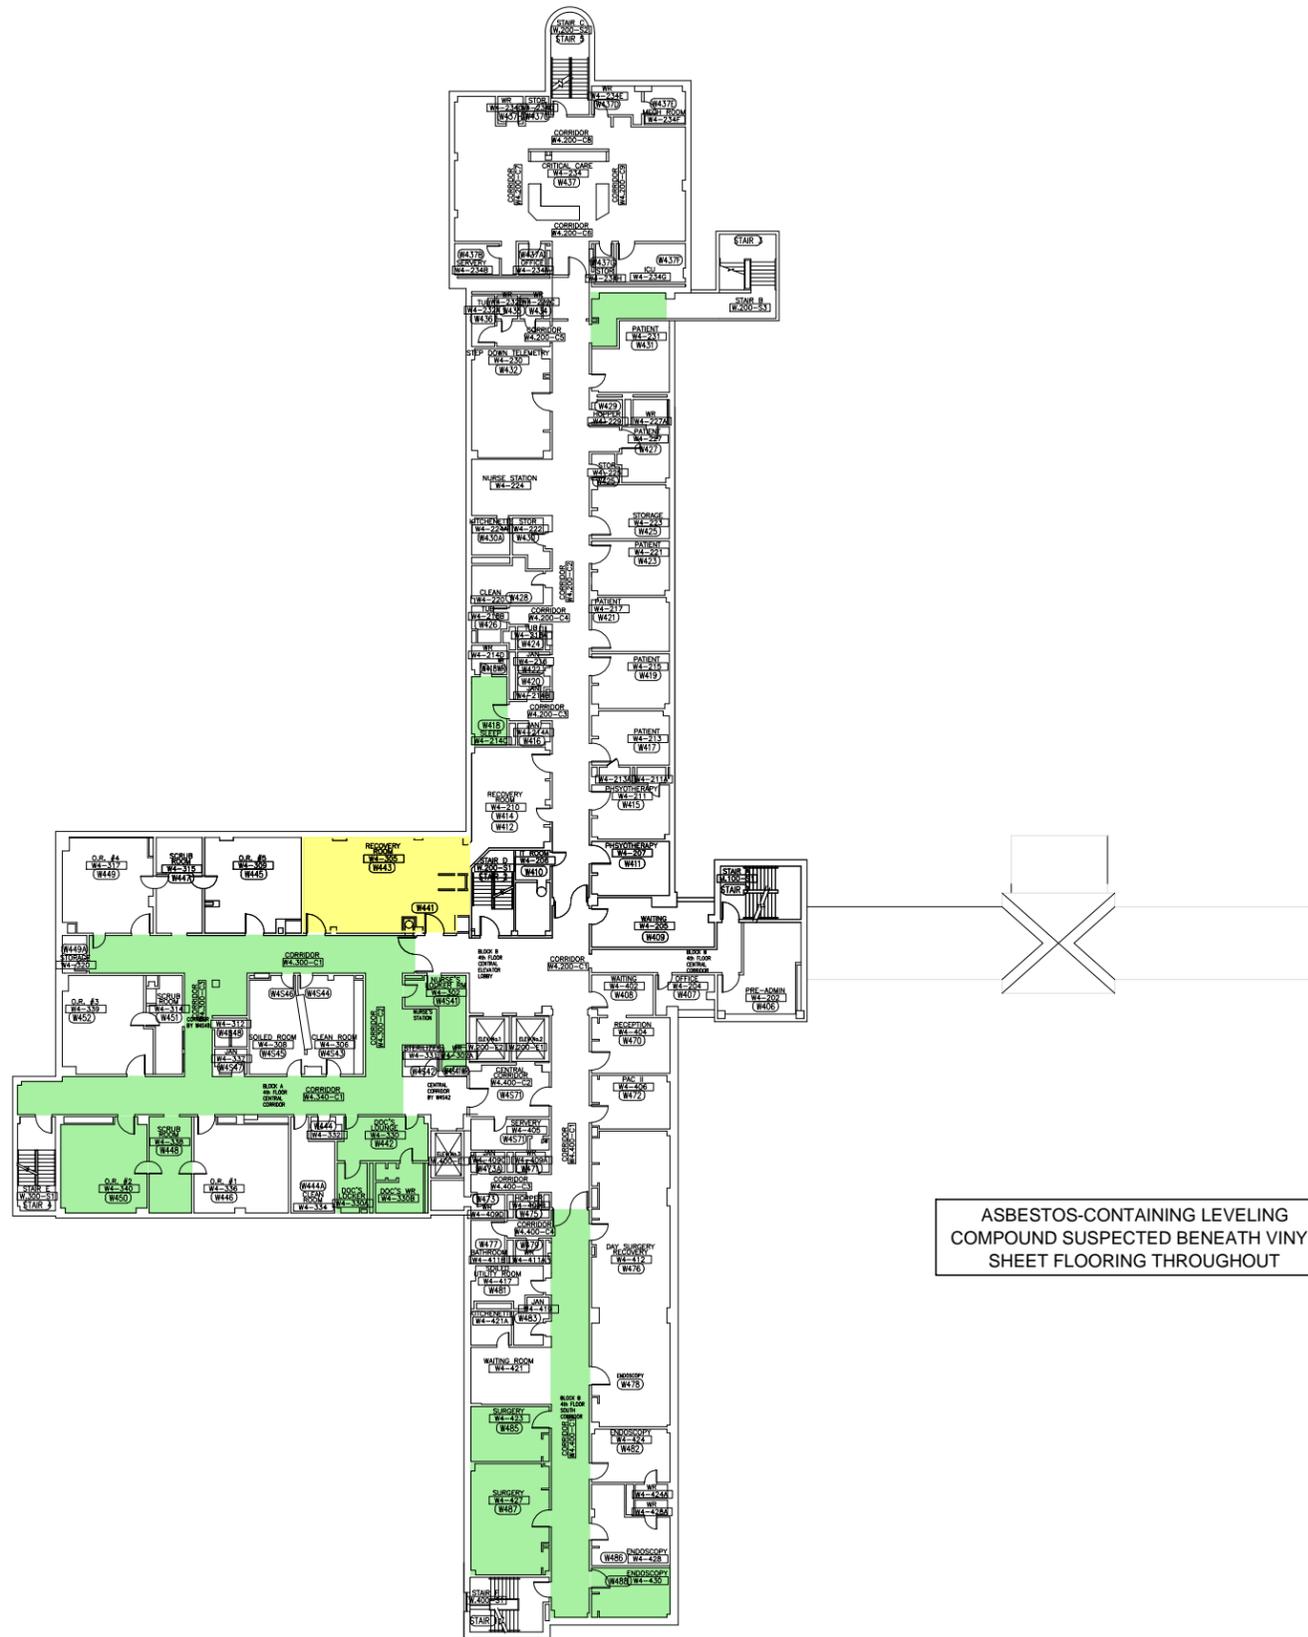
ASBESTOS-CONTAINING LEVELING COMPOUND SUSPECTED BENEATH VINYL SHEET FLOORING THROUGHOUT

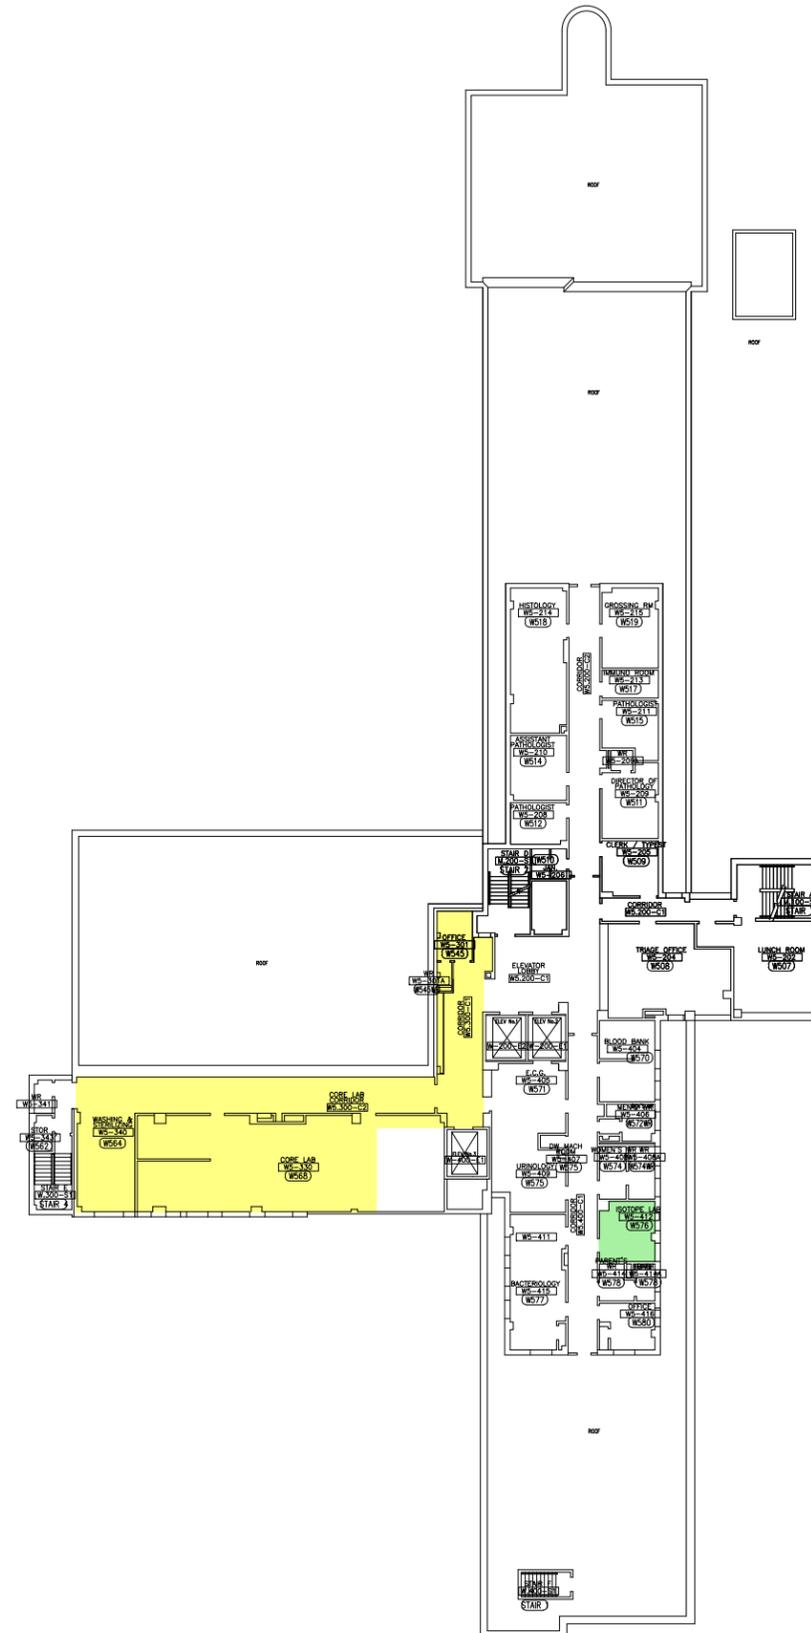
ASBESTOS-CONTAINING LEVELING
COMPOUND SUSPECTED BENEATH VINYL
SHEET FLOORING THROUGHOUT
