# AVONCREST

## Designated Substance Audit Report

11 Avoncrest Drive  
Sratford, Ontario

**MTE File No.: 43789-200**

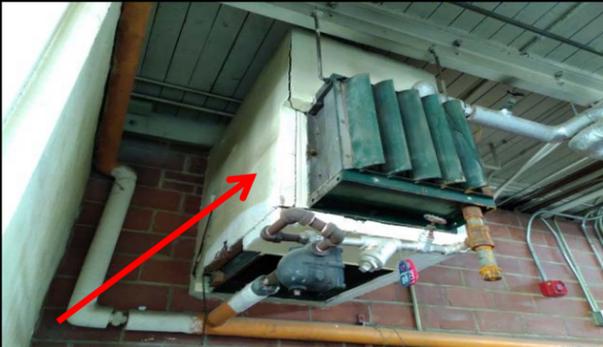
Avoncrest						
Material	Location	Material Description	Approximate Quantity	Photograph	Management Requirements If No Impacts to Material	Recommended Actions If Material Will Be Or Likely Be Impacted By Maintenance, Renovation, Construction or Demolition Activities
<b>Damaged Asbestos Friable</b>	Power Plant	Insulation on Pipe Fitting	1	-	Removal/Repair in accordance with O. Reg. 278/05 as a Type 2 Glove Bag Operation	Removal/Repair in accordance with O. Reg. 278/05 as a Type 2 Glove Bag Operation
	Laundry	Insulation on Pipe Fittings	2	-		
	037B	Insulation on Pipe Fitting	1	-		
	Basement Corridor	Insulation on Pipe Fitting	1	-		
	North Wing Basement Rooms 001 to 008 (Area Not inspected, Potential Damage is Present)	Insulation on Pipe Fittings	-	-		
	Second Floor Corridor	Insulation on Pipe Fitting	1	-		
<b>Damaged Asbestos Friable</b>	Laundry Ceiling Mounted Heaters	Cracked Parging on Cork Insulation	~1 m <sup>2</sup>

Repair in accordance with O. Reg. 278/05 as a Type 2 Operation	Repair in accordance with O. Reg. 278/05 as a Type 2 Operation

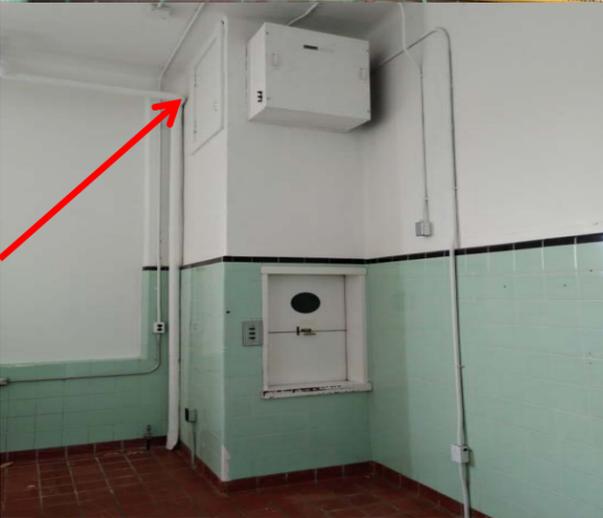
Material	Location	Material Description	Approximate Quantity	Photograph	Management Requirements If No Impacts to Material	Recommended Actions If Material Will Be Or Likely Be Impacted By Maintenance, Renovation, Construction or Demolition Activities
<b>Asbestos Friable</b>	Throughout Power Plant, Laundry, First Floor and Second Floor	Insulation on Pipe Fittings	~1000

In place management in accordance with O. Reg. 278/05	Removal in accordance with O. Reg. 278/05 as a Type 2/Type 2 Glove Bag or Type 3 Operation
<b>Asbestos Friable</b>	Power Plant Office	Air Cell and Mag Block Insulation on Piping	3 metres

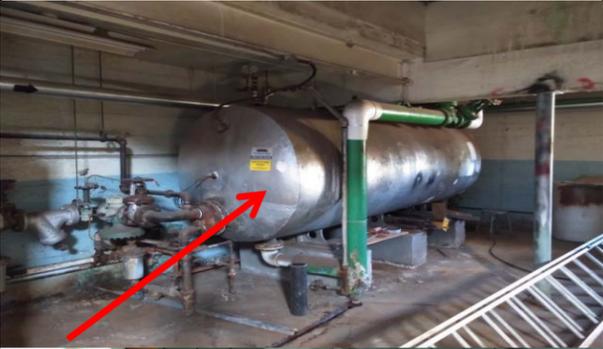
<b>Asbestos Friable</b>	035	CPOSITE Insulation on Hot Water Pipe	3 metres	-		
<b>Asbestos Friable</b>	Room, Building System, Exterior/Interior of Building	Mag Block Insulation on Tank and Boilers	~10-30 m <sup>2</sup>

In place management in accordance with O. Reg. 278/05	Removal in accordance with O. Reg. 278/05 as a Type 3 Operation

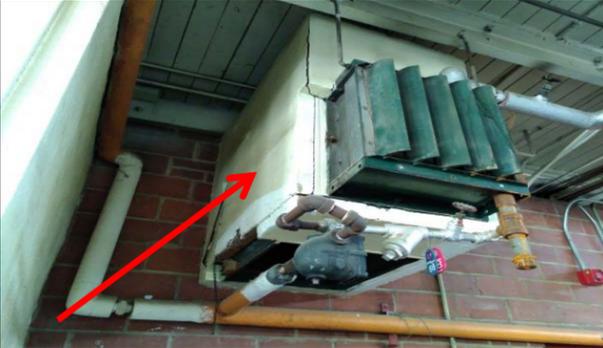
Avoncrest						
Material	Location	Material Description	Approximate Quantity	Photograph	Management Requirements If No Impacts to Material	Recommended Actions If Material Will Be Or Likely Be Impacted By Maintenance, Renovation, Construction or Demolition Activities
<b>Asbestos Friable</b>	Laundry Ceiling Mounted Heaters	Parging on Cork Insulation	~2 m <sup>2</sup> on 4 Units

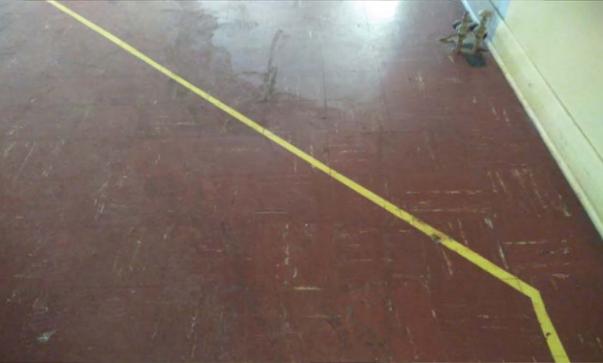
<b>Asbestos Non-Friable</b>	Room, Building System, Exterior/Interior of Building	9" x 9" Floor Tiles: Grey with White Fleck & Associated Mastic, Beige with Rust Fleck (Associated Mastic is Non-ACM), Red with White Fleck (Associated Mastic is Non-ACM), bLue with White Streak, Dark Grey with White/Red Streak	~700 m <sup>2</sup>

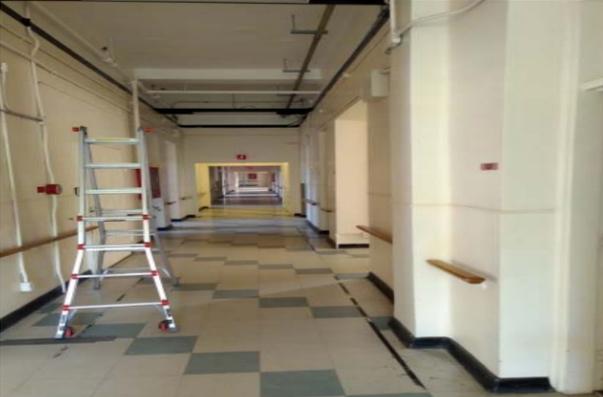
In place management in accordance with O. Reg. 278/05	Removal in accordance with O. Reg. 278/05 as a Type 1 Operation
<b>Asbestos Non-Friable</b>	Room, Building System, Exterior/Interior of Building	12" x 12" Floor Tiles: Beige with Brown Streak & Associated Mastic, White with Maroon Streak (Associated Mastic is Non-ACM), Grey with White Fleck (Associated Mastic is Non-ACM), White with Green Fleck/Green with White Fleck (Associated Mastic is Non-ACM), Green, White with Multi-Coloured Fleck, White with Black Fleck

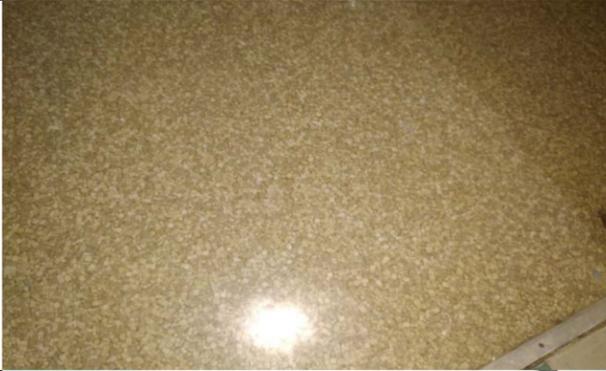
Avoncrest						
Material	Location	Material Description	Approximate Quantity	Photograph	Management Requirements If No Impacts to Material	Recommended Actions If Material Will Be Or Likely Be Impacted By Maintenance, Renovation, Construction or Demolition Activities
<b>Asbestos Non-Friable</b>	Room, Building System, Exterior/Interior of Building	Beige, Brown, Red, Yellow/Green Vinyl Sheet Flooring	~450 m <sup>2</sup>

In place management in accordance with O. Reg. 278/05	Removal in accordance with O. Reg. 278/05 as a Type 1 Operation (if paper layer is in good condition, and can be removed in tact)
<b>Asbestos Non-Friable</b>	North Building and Power Plant	Exterior Window/Door Frame Sealant	~75 metres

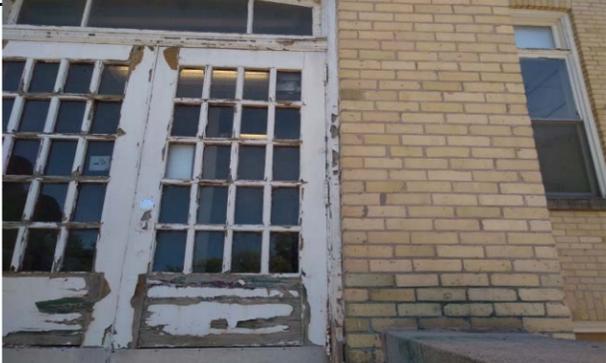
In place management in accordance with O. Reg. 278/05	Removal in accordance with O. Reg. 278/05 as a Type 1 Operation
<b>Asbestos Non-Friable</b>	West Building and Laundry	Exterior Grey Door Frame Sealant	~15 metres

In place management in accordance with O. Reg. 278/05	Removal in accordance with O. Reg. 278/05 as a Type 1 Operation

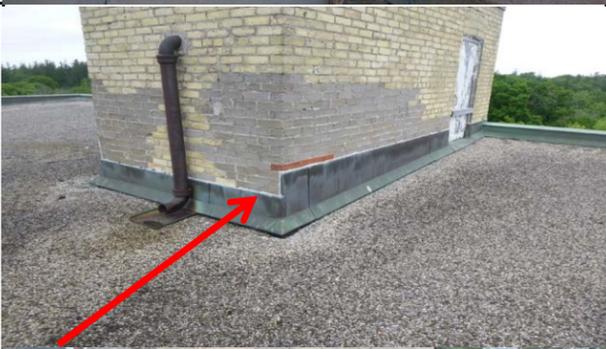
<b>Asbestos Non-Friable</b>	West Wing Roof	Exterior Flashing Sealant	~100 metres

In place management in accordance with O. Reg. 278/05	Removal in accordance with O. Reg. 278/05 as a Type 1 Operation

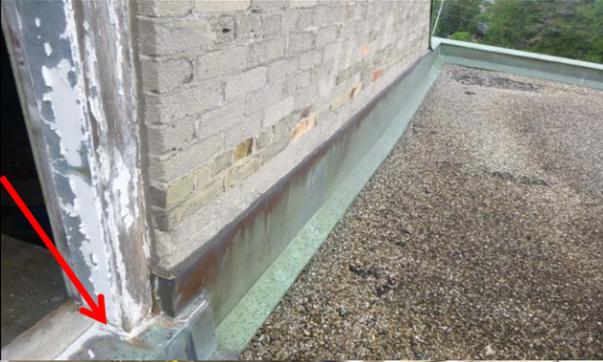
Material	Location	Material Description	Approximate Quantity	Photograph	Management Requirements If No Impacts to Material	Recommended Actions If Material Will Be Or Likely Be Impacted By Maintenance, Renovation, Construction or Demolition Activities
Asbestos Non-Friable	West Wing Roof	Exterior White Door Frame	~5 metres

In place management in accordance with O. Reg. 278/05	Removal in accordance with O. Reg. 278/05 as a Type 1 Operation
Asbestos Non-Friable	Power Plant	Plaster	Throughout

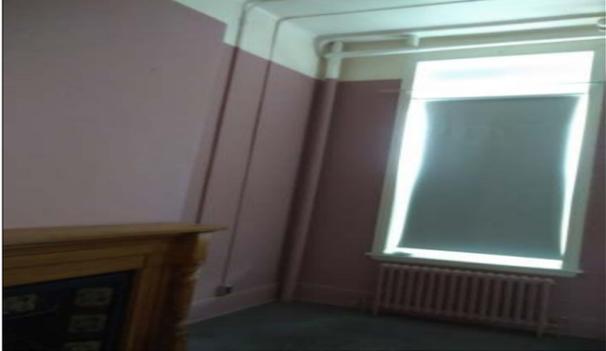
Potentially Concealed Asbestos	Elevator Shafts	Elevator Brakes	-	-		
Lead-Based Paint	North Wing - Room 109	Dark Pink Paint on Plaster Walls	-

In place management in accordance with EACO's Lead Guideline	<p>If Renovation, removal as required prior in accordance with EACO's Lead Guideline as a: Class 1, Class 2A, Class 3A, or a Class 3B Operation . If Demolition, operating construction or demolition equipment (excavator/bulldozer) as a: Class 1 Operation in accordance with EACO's Lead Guideline</p> <p>If paint is not removed prior to disposal of building finishes, these materials require analysis of Leachable Lead according to Ontario Regulation 558/00. If confirmed or deemed hazardous, materials must then be manifested and disposed of off-site at a Ministry of Environment facility that is licensed to accept hazardous waste.</p>

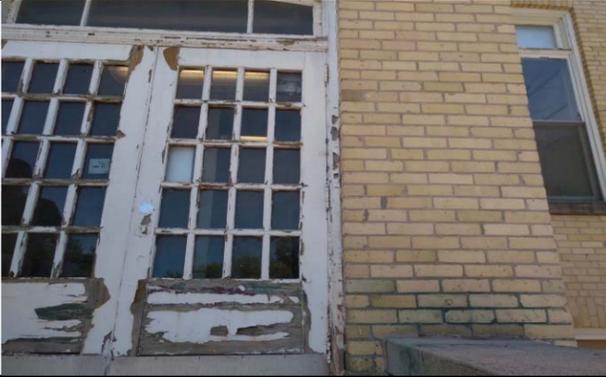
Avoncrest						
Material	Location	Material Description	Approximate Quantity	Photograph	Management Requirements If No Impacts to Material	Recommended Actions If Material Will Be Or Likely Be Impacted By Maintenance, Renovation, Construction or Demolition Activities
Lead-Based Paint	West Wing - Stair No. 2	White Paint on Wood Doors	-

In place management in accordance with EACO's Lead Guideline	If Renovation, removal as required prior in accordance with EACO's Lead Guideline as a: Class 1, Class 2A, Class 3A, or a Class 3B Operation . If Demolition, operating construction or demolition equipment (excavator/bulldozer) as a: Class 1 Operation in accordance with EACO's Lead Guideline  If paint is not removed prior to disposal of building finishes, these materials require analysis of Leachable Lead according to Ontario Regulation 558/00. If confirmed or deemed hazardous, materials must then be manifested and disposed of off-site at a Ministry of Environment facility that is licensed to accept hazardous waste.

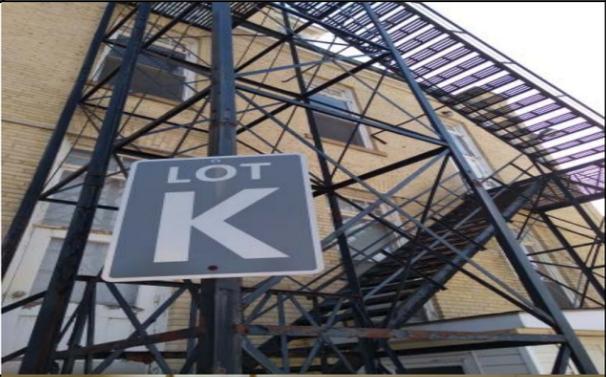
Lead-Containing Paint	Throughout Interior of Building	Yellow, Light Orange, Beige, Light Pink, Light Grey, Green, Pink, White, Blue Paint on Walls, Ceilings and Trim	-	-	-	-
Lead-Containing Paint	Exterior Fire Escape	Black Paint on Metal Stairs	-

In place management in accordance with EACO's Lead Guideline	If Renovation, removal as required prior in accordance with EACO's Lead Guideline as a: Class 1, Class 2A, Class 3A, or a Class 3B Operation . If Demolition, operating construction or demolition equipment (excavator/bulldozer) as a: Class 1 Operation in accordance with EACO's Lead Guideline  If paint is not removed prior to disposal of building finishes, these materials require analysis of Leachable Lead according to Ontario Regulation 558/00. If confirmed or deemed hazardous, materials must then be manifested and disposed of off-site at a Ministry of Environment facility that is licensed to accept hazardous waste.

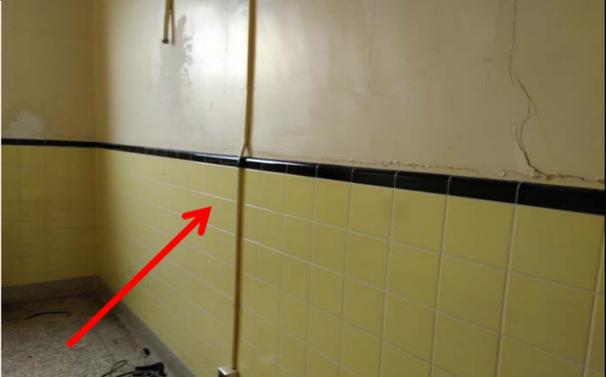
Lead-Containing Glazing on Ceramic Tile	Ceramic Tile	All Pink, Green, Yellow, Black Ceramic Tile Glaze	-

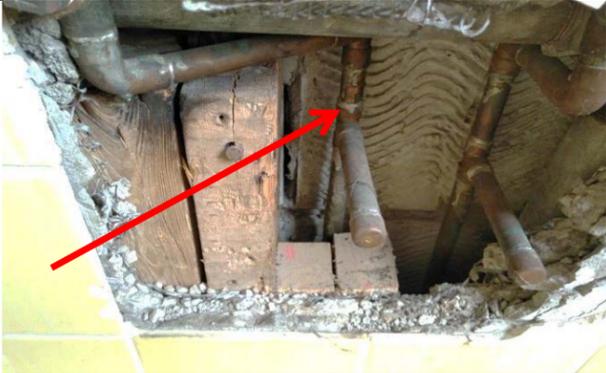
Avoncrest						
Material	Location	Material Description	Approximate Quantity	Photograph	Management Requirements If No Impacts to Material	Recommended Actions If Material Will Be Or Likely Be Impacted By Maintenance, Renovation, Construction or Demolition Activities
Lead	Throughout Interior of Building on Plumbing Connections	Lead Solder on Copper Pipe	-

In place management in accordance with EACO's Lead Guideline	Removal prior to renovation/demolition activities in accordance with EACO's Lead Guideline as a: Class 1 Operation
Lead	Throughout Building on Sanitary/Waste Lines	Lead Packed Pipe Gaskets	-

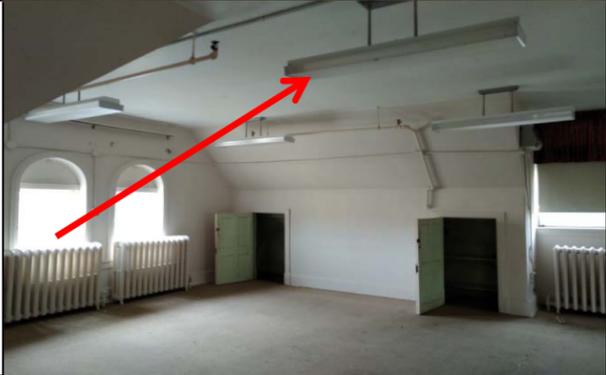
In place management in accordance with EACO's Lead Guideline	Removal prior to renovation or demolition activities in accordance with EACO's Lead Guideline as a: Class 1 Operation
Mercury	Throughout Interior of Building in Light Fixtures	Fluorescent Light Tubes and Thermostats	-

None	Intact removal and storage with no on-site crushing and disposal of materials to a licensed facility

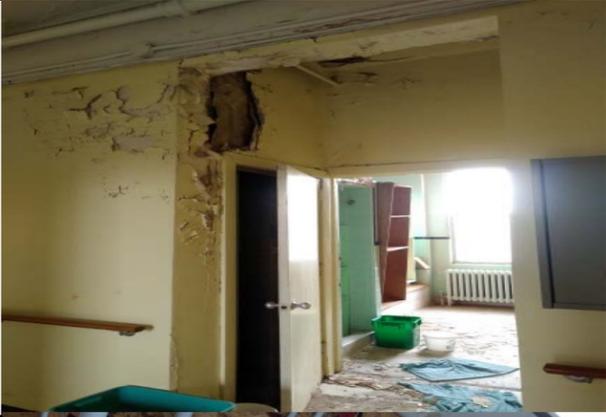
Material	Location	Material Description	Approximate Quantity	Photograph	Management Requirements If No Impacts to Material	Recommended Actions If Material Will Be Or Likely Be Impacted By Maintenance, Renovation, Construction or Demolition Activities
Mould	Corridor at Room 332	Mould Growth on Building Finishes	-

Removal in accordance with EACO 2015 Mould Abatement Guidelines	Implement worker hygiene program to control worker exposure Provide general dust control and hygiene measures, including but not limited to; air purifying full-face-piece respirator with N-95, N-100, R-100 or P-100 particulate filter, disposable coveralls and gloves, the washing of hands and face at on-site facilities and ensure no smoking, eating, chewing gum or drinking occurs in the work area.
Mould	Washrooms, North Wing Basement Rooms 001 to 008, Room 329, Corridor connecting the North and West Wing	Mould Growth on Building Finishes	-

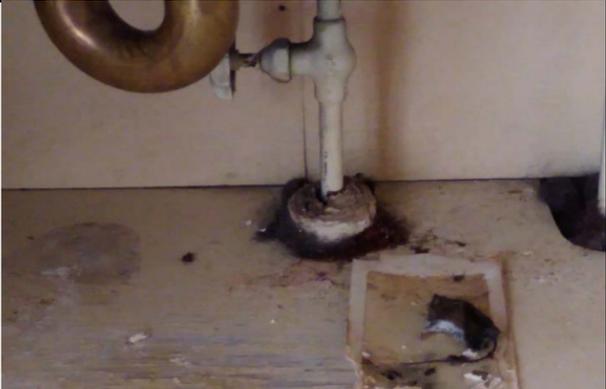
Potentially Concealed Mould	Behind Wall and Ceiling Finishes	Mould Growth	-			Implement worker hygiene program to control worker exposure Provide general dust control and hygiene measures, including but not limited to; air purifying full-face-piece respirator with N-95, N-100, R-100 or P-100 particulate filter, disposable coveralls and gloves, the washing of hands and face at on-site facilities and ensure no smoking, eating, chewing gum or drinking occurs in the work area.
Bat/Bird/Rodent Droppings and Carcasses	Throughout Building	Bat/Bird/Rodent Droppings and Carcasses	-

Removal in accordance with EACO Mould Abatement Guidelines, Appendix B: Procedures for Clean-up of Bird and Bat Droppings
