**Re: Site Inspection Report for June 29, 2023
Avon Crest Building Demolition Project
Avon Crest Facility – Stratford General Hospital
86 John Street South, Stratford, Ontario (Site)**

Safetech personnel were on-site on June 29, 2023 to conduct a progress inspection. Details of Budget's progress towards abatement completion are presented below.

Progress Inspection #1 -
June 29, 2023

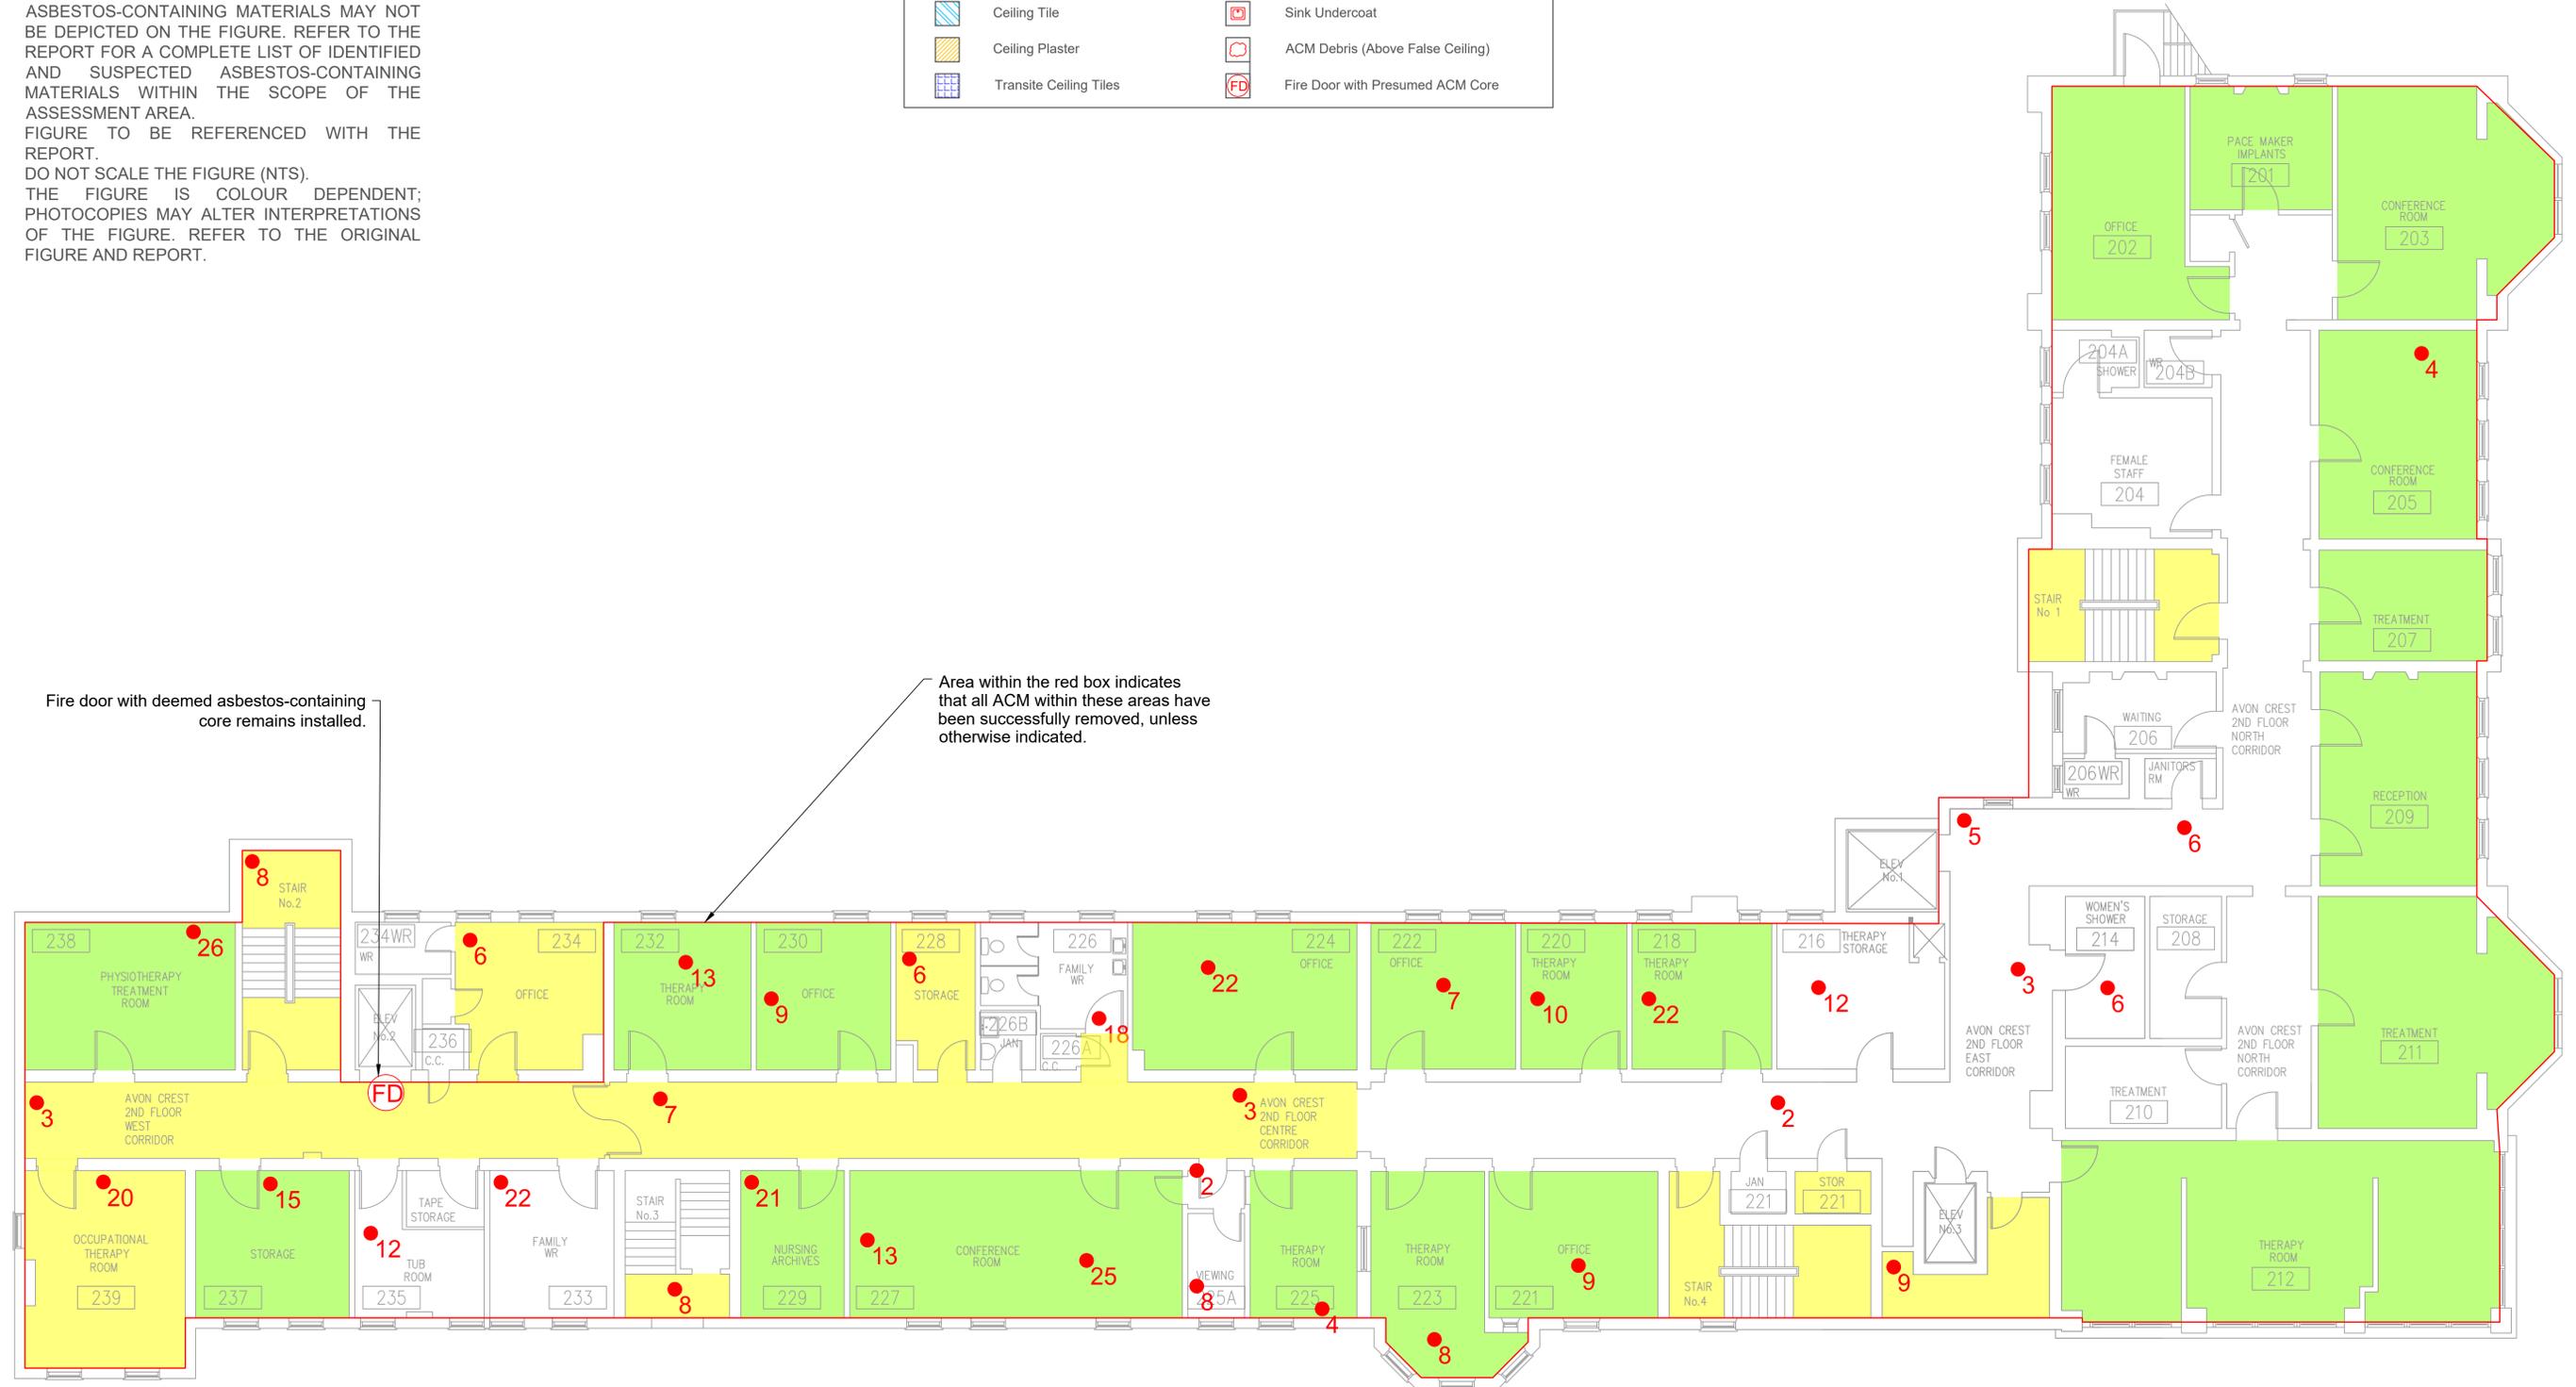
PR02

Fire door with deemed asbestos-containing core remains installed.

Area within the red box indicates that all ACM within these areas have been successfully removed, unless otherwise indicated.

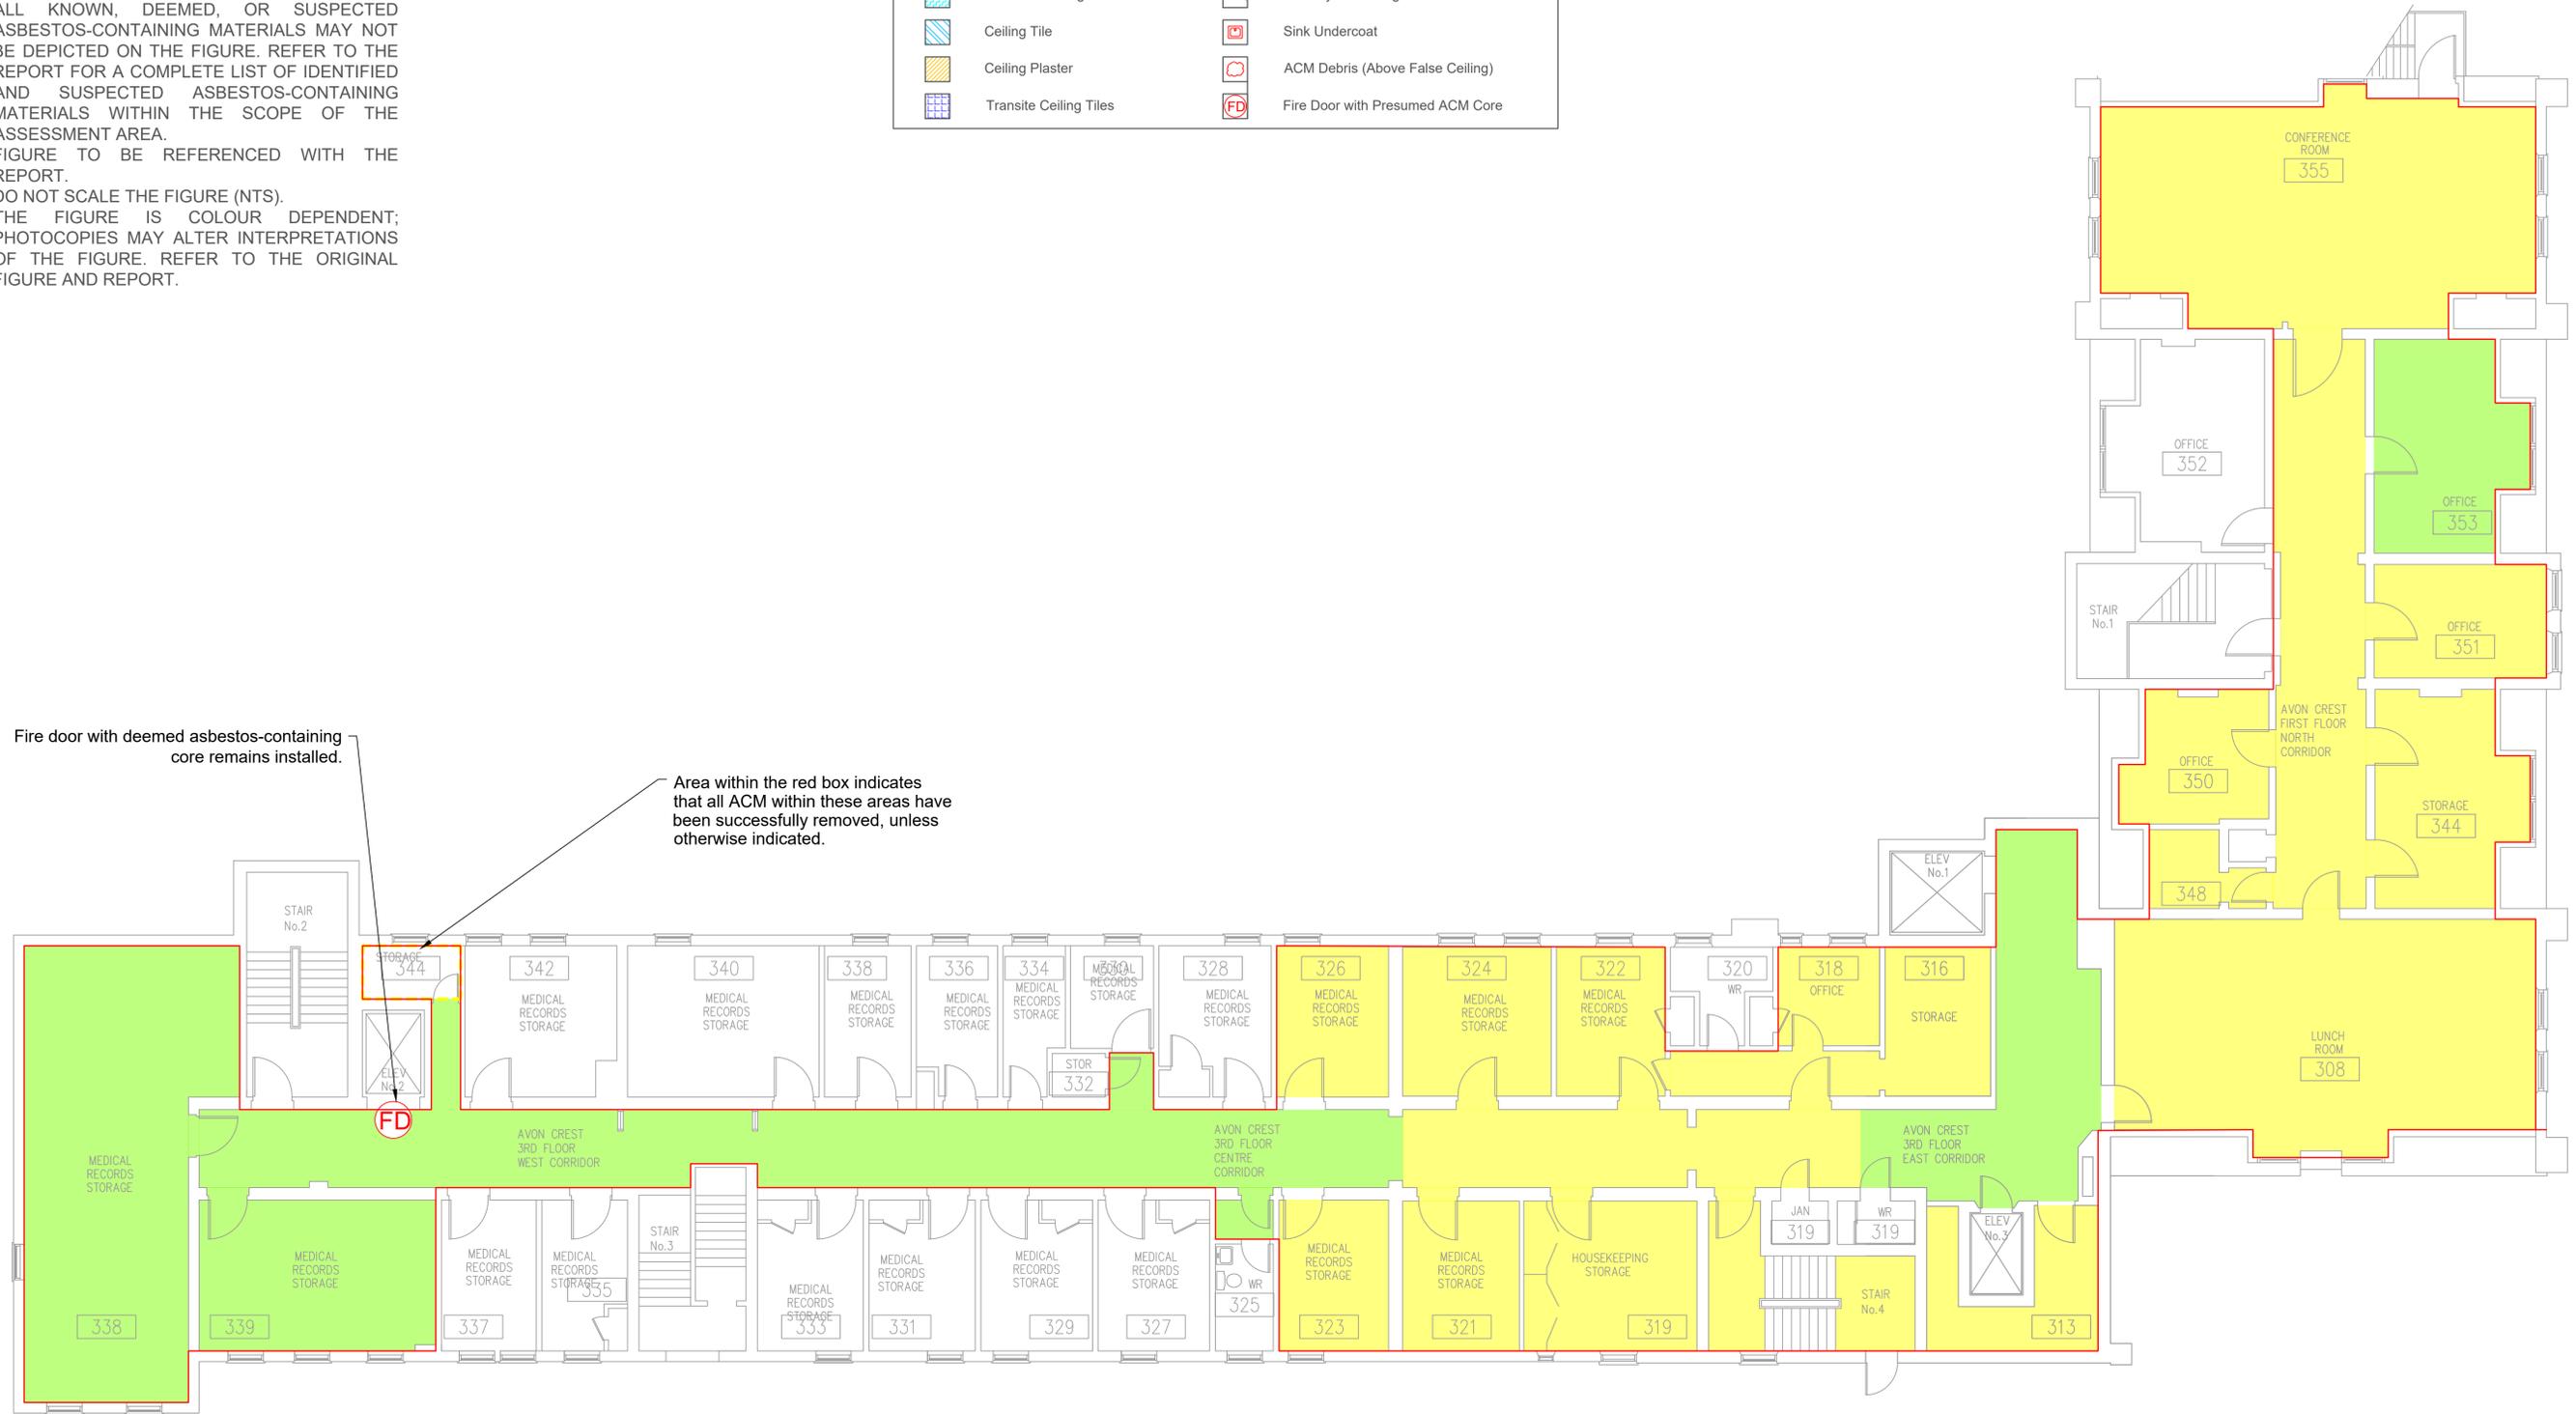
PROJECT NO: PR03

Fire door with deemed asbestos-containing core remains installed.

Area within the red box indicates that all ACM within these areas have been successfully removed, unless otherwise indicated.

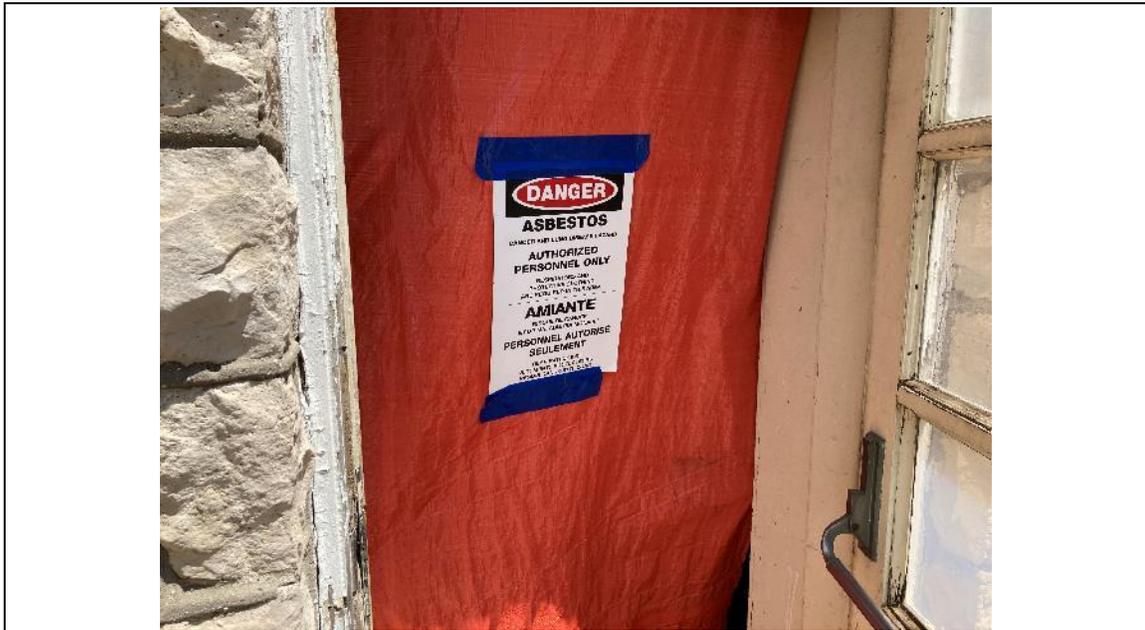
P1 – West Side Entrance

- Polyethylene double-flap doors were set-up on the inside of each set of doors leading into the building. Each set of doors also had appropriate signage posted to warn about the hazards of asbestos (**P1**).

Polyethylene sheeting was observed at the entrances to the building with appropriate signage warning of the hazards of asbestos exposure.

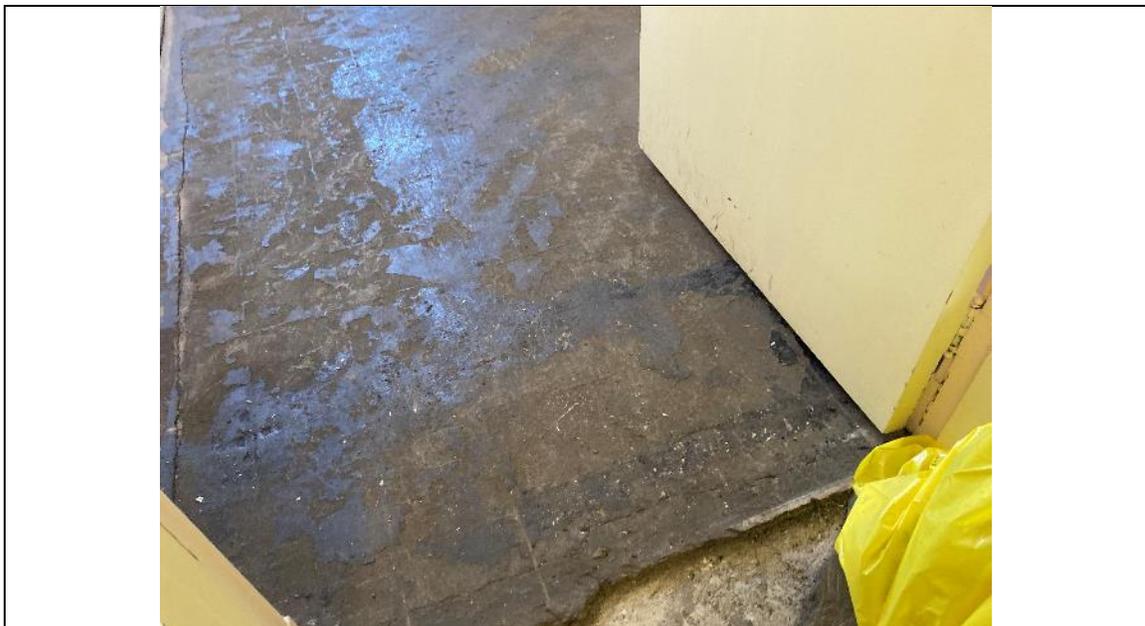
P2 – Room 236

- At the time of this assessment, the building's lighting systems remained in use (i.e. fluorescent light tubes had not been removed);
- Asbestos-containing vinyl floor tiles have been removed in their entirety from the first floor, second floor, and third floor of the building (**P2**). These floor tiles were removed by Type 1 asbestos abatement measures and procedures as per the Project Specifications (02 82 13.1).

Asbestos-containing vinyl floor tiles have been removed. The associated mastic remnants remains on wood subfloor and will be removed as part of demolition operations.

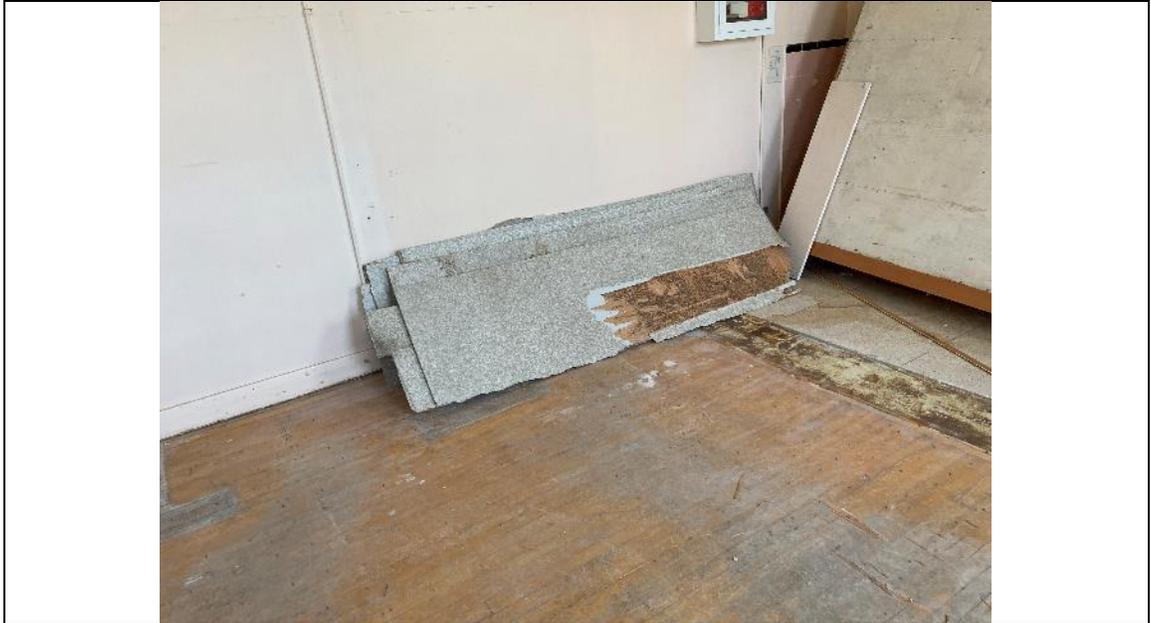
P3 – Room 339

- Budget reportedly conducted removal of this material following Type 1 asbestos measures and procedures by removing the material with the subfloor, mostly intact. This is a variant on the Project Specifications (02 82 13.2) (**P3**).

Asbestos-containing vinyl sheet flooring has been removed by removing the wood flooring with the sheet flooring still attached.

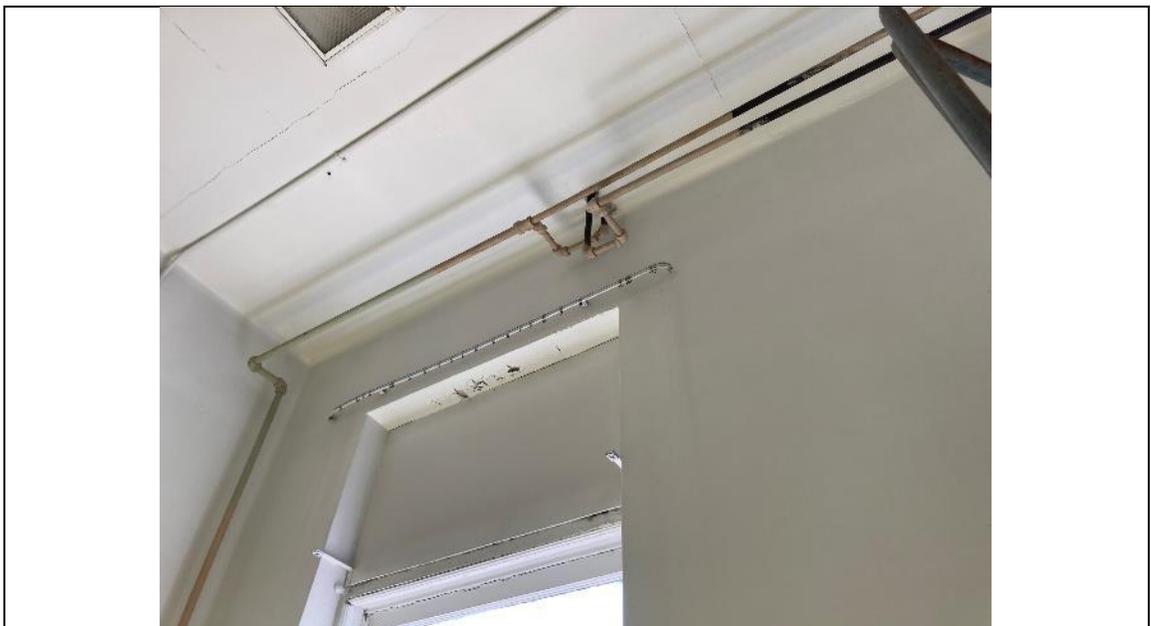
P4 – Room 224

- All asbestos-containing parged cement pipe fitting insulation has been removed from the first floor, second floor, and third floor of the building (**P4**), with the exception of the office on the second floor (Room 234). Budget reports that the pipe fitting insulation was removed following Type 2 Glove Bag procedures as per the Project Specifications (02 82 13.4) (**P5**).

Asbestos-containing pipe fitting insulation removed.

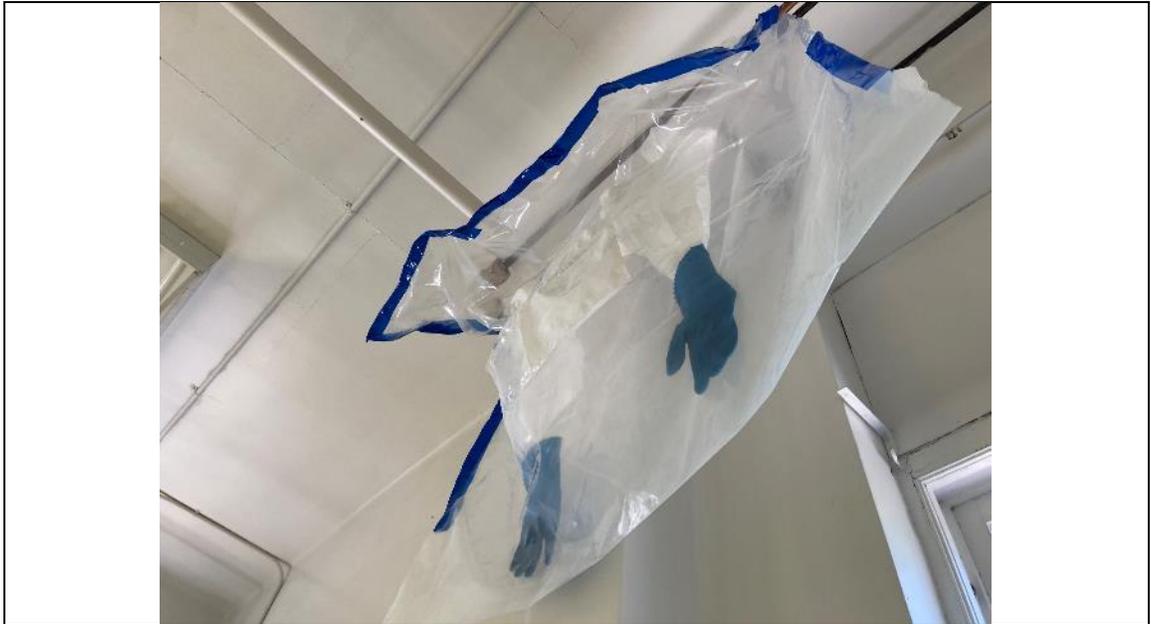
P5 – Room 239

Glove bag set up was observed within the building and was reported to be used to remove asbestos-containing pipe fitting insulation.

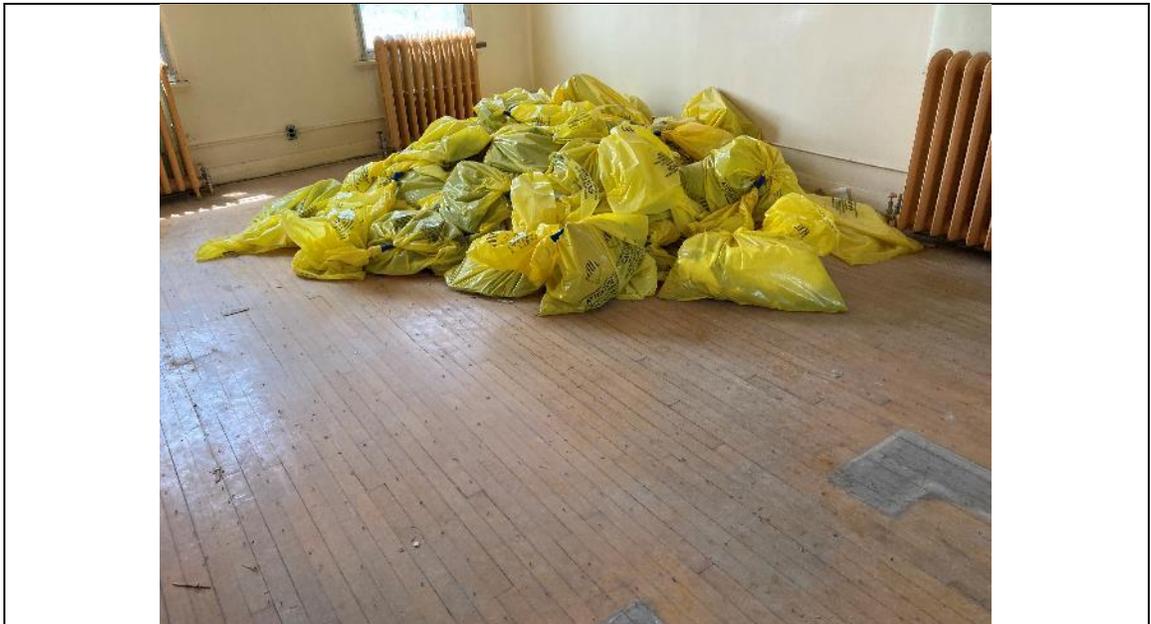
P6 – Room 238

- Asbestos waste generated from the abatement up to the time of this assessment remains present within the building in appropriate waste bags (**P6**). Budget reported that no asbestos waste has left the building and will remain within the building until the waste bin arrives on site, which is scheduled to occur early next week (i.e. week of July 3, 2023). Asbestos waste bags are stored in clean rooms, which are then sealed, until they are transported to the waste bins;

Full asbestos waste bags were observed within the building and will be disposed of when the waste bin arrives on site.
