**Re: Site Inspection Report for July 11, 2023  
Avon Crest Building Demolition Project  
Avon Crest Facility – Stratford General Hospital  
86 John Street South, Stratford, Ontario (Site)**

## Figure PR04: Progress Inspection #4 – July 11, 2023

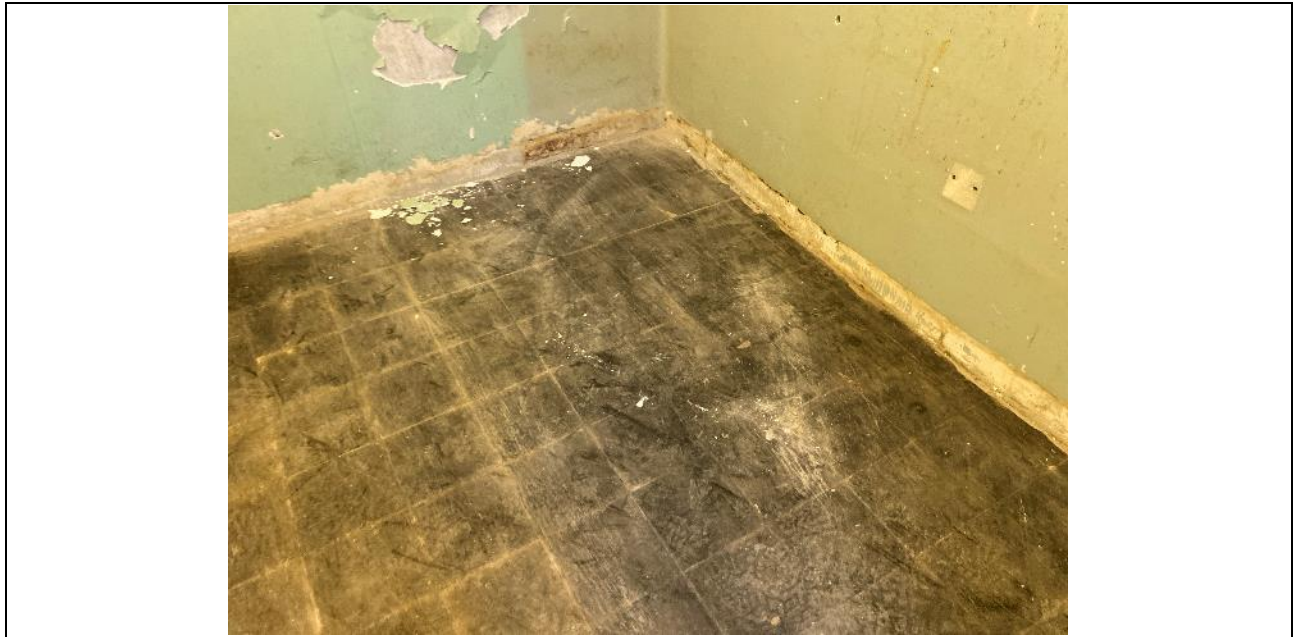
**P1 – Room 037**

Asbestos-containing vinyl floor tiles were removed from areas in the basement.

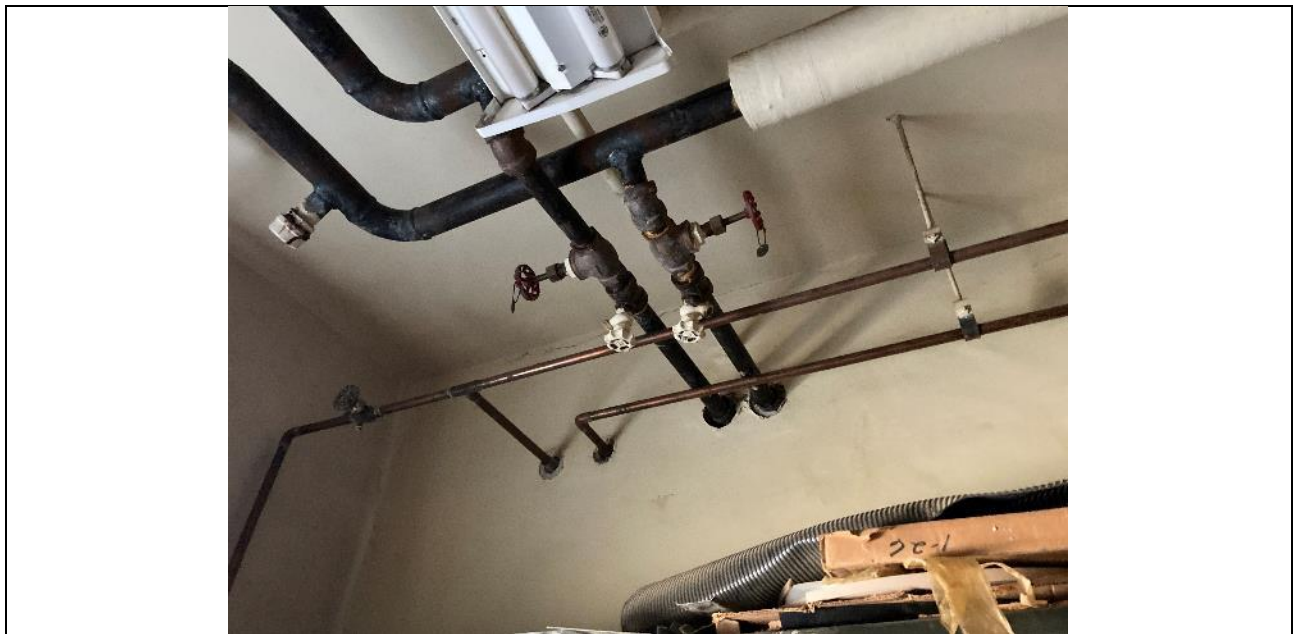
**P2 – Room 037B**

Asbestos-containing pipe fitting insulation was removed from areas in the basement.

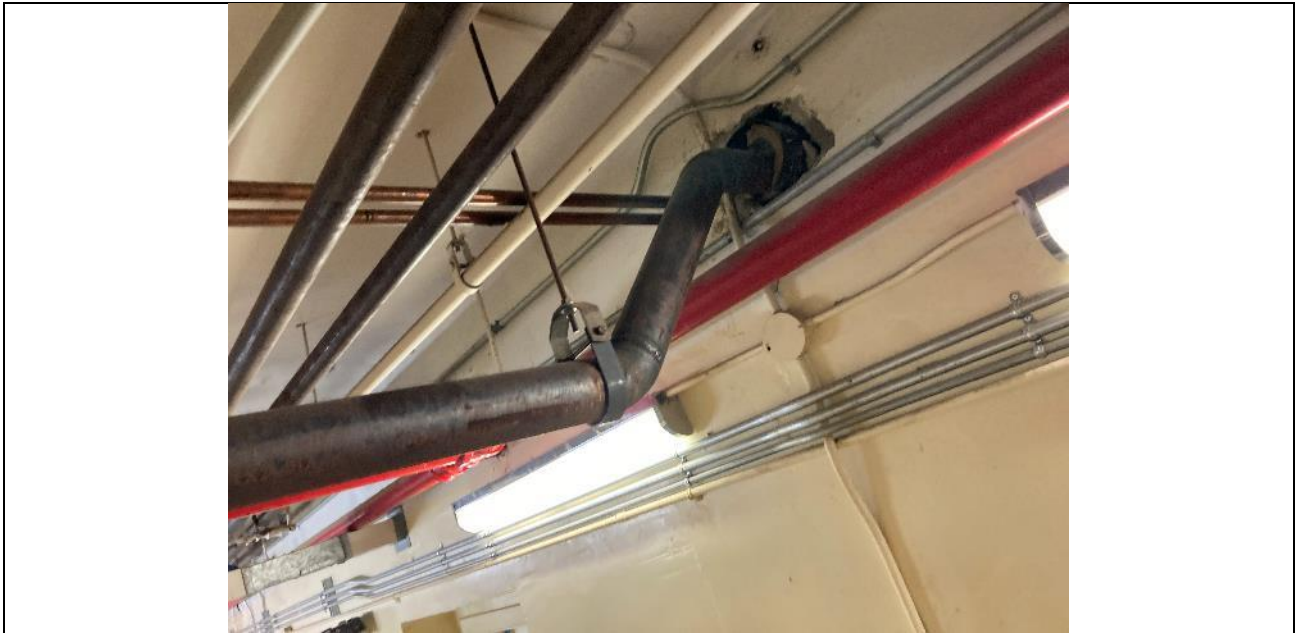
**P3 – Basement Centre Corridor**

Asbestos-containing pipe insulation was removed from areas of the basement.

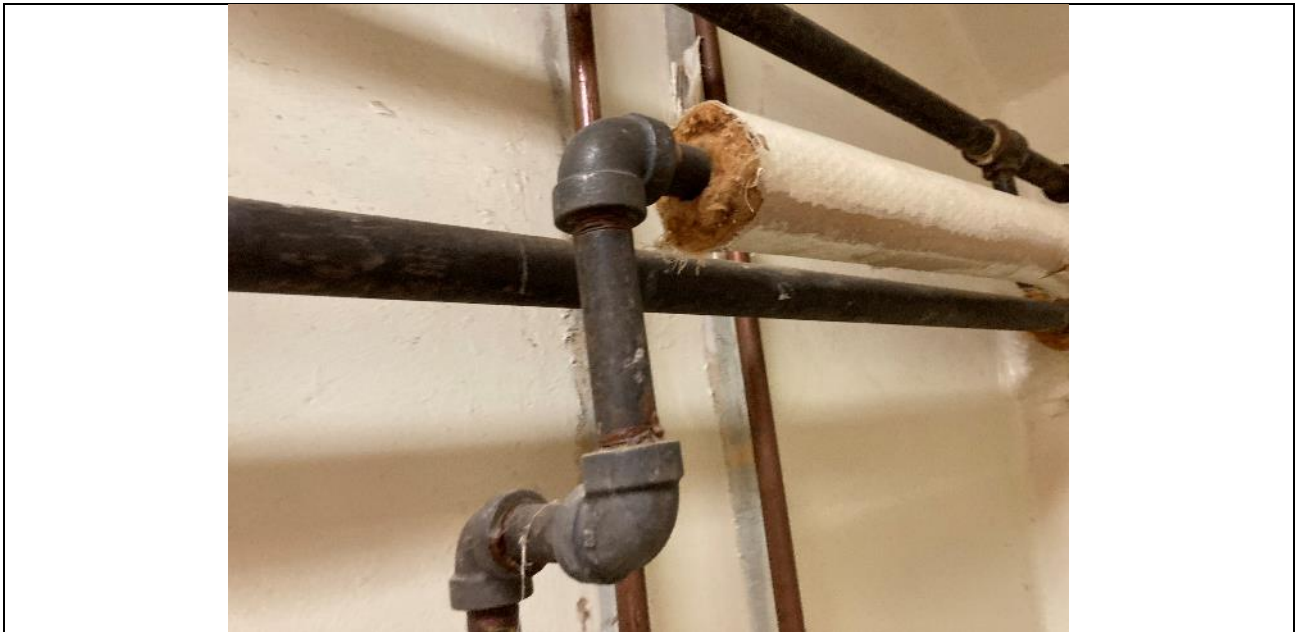
**P4 – Pipe Insulation Removed**

Asbestos-containing parge cement pipe fitting insulation was removed adequately throughout the majority of the basement.
