**Re: Site Inspection Report for July 6, 2023  
Avon Crest Building Demolition Project  
Avon Crest Facility – Stratford General Hospital  
86 John Street South, Stratford, Ontario (Site)**

## 2.0 RESULTS OF PROGRESS INSPECTION – JULY 6, 2023

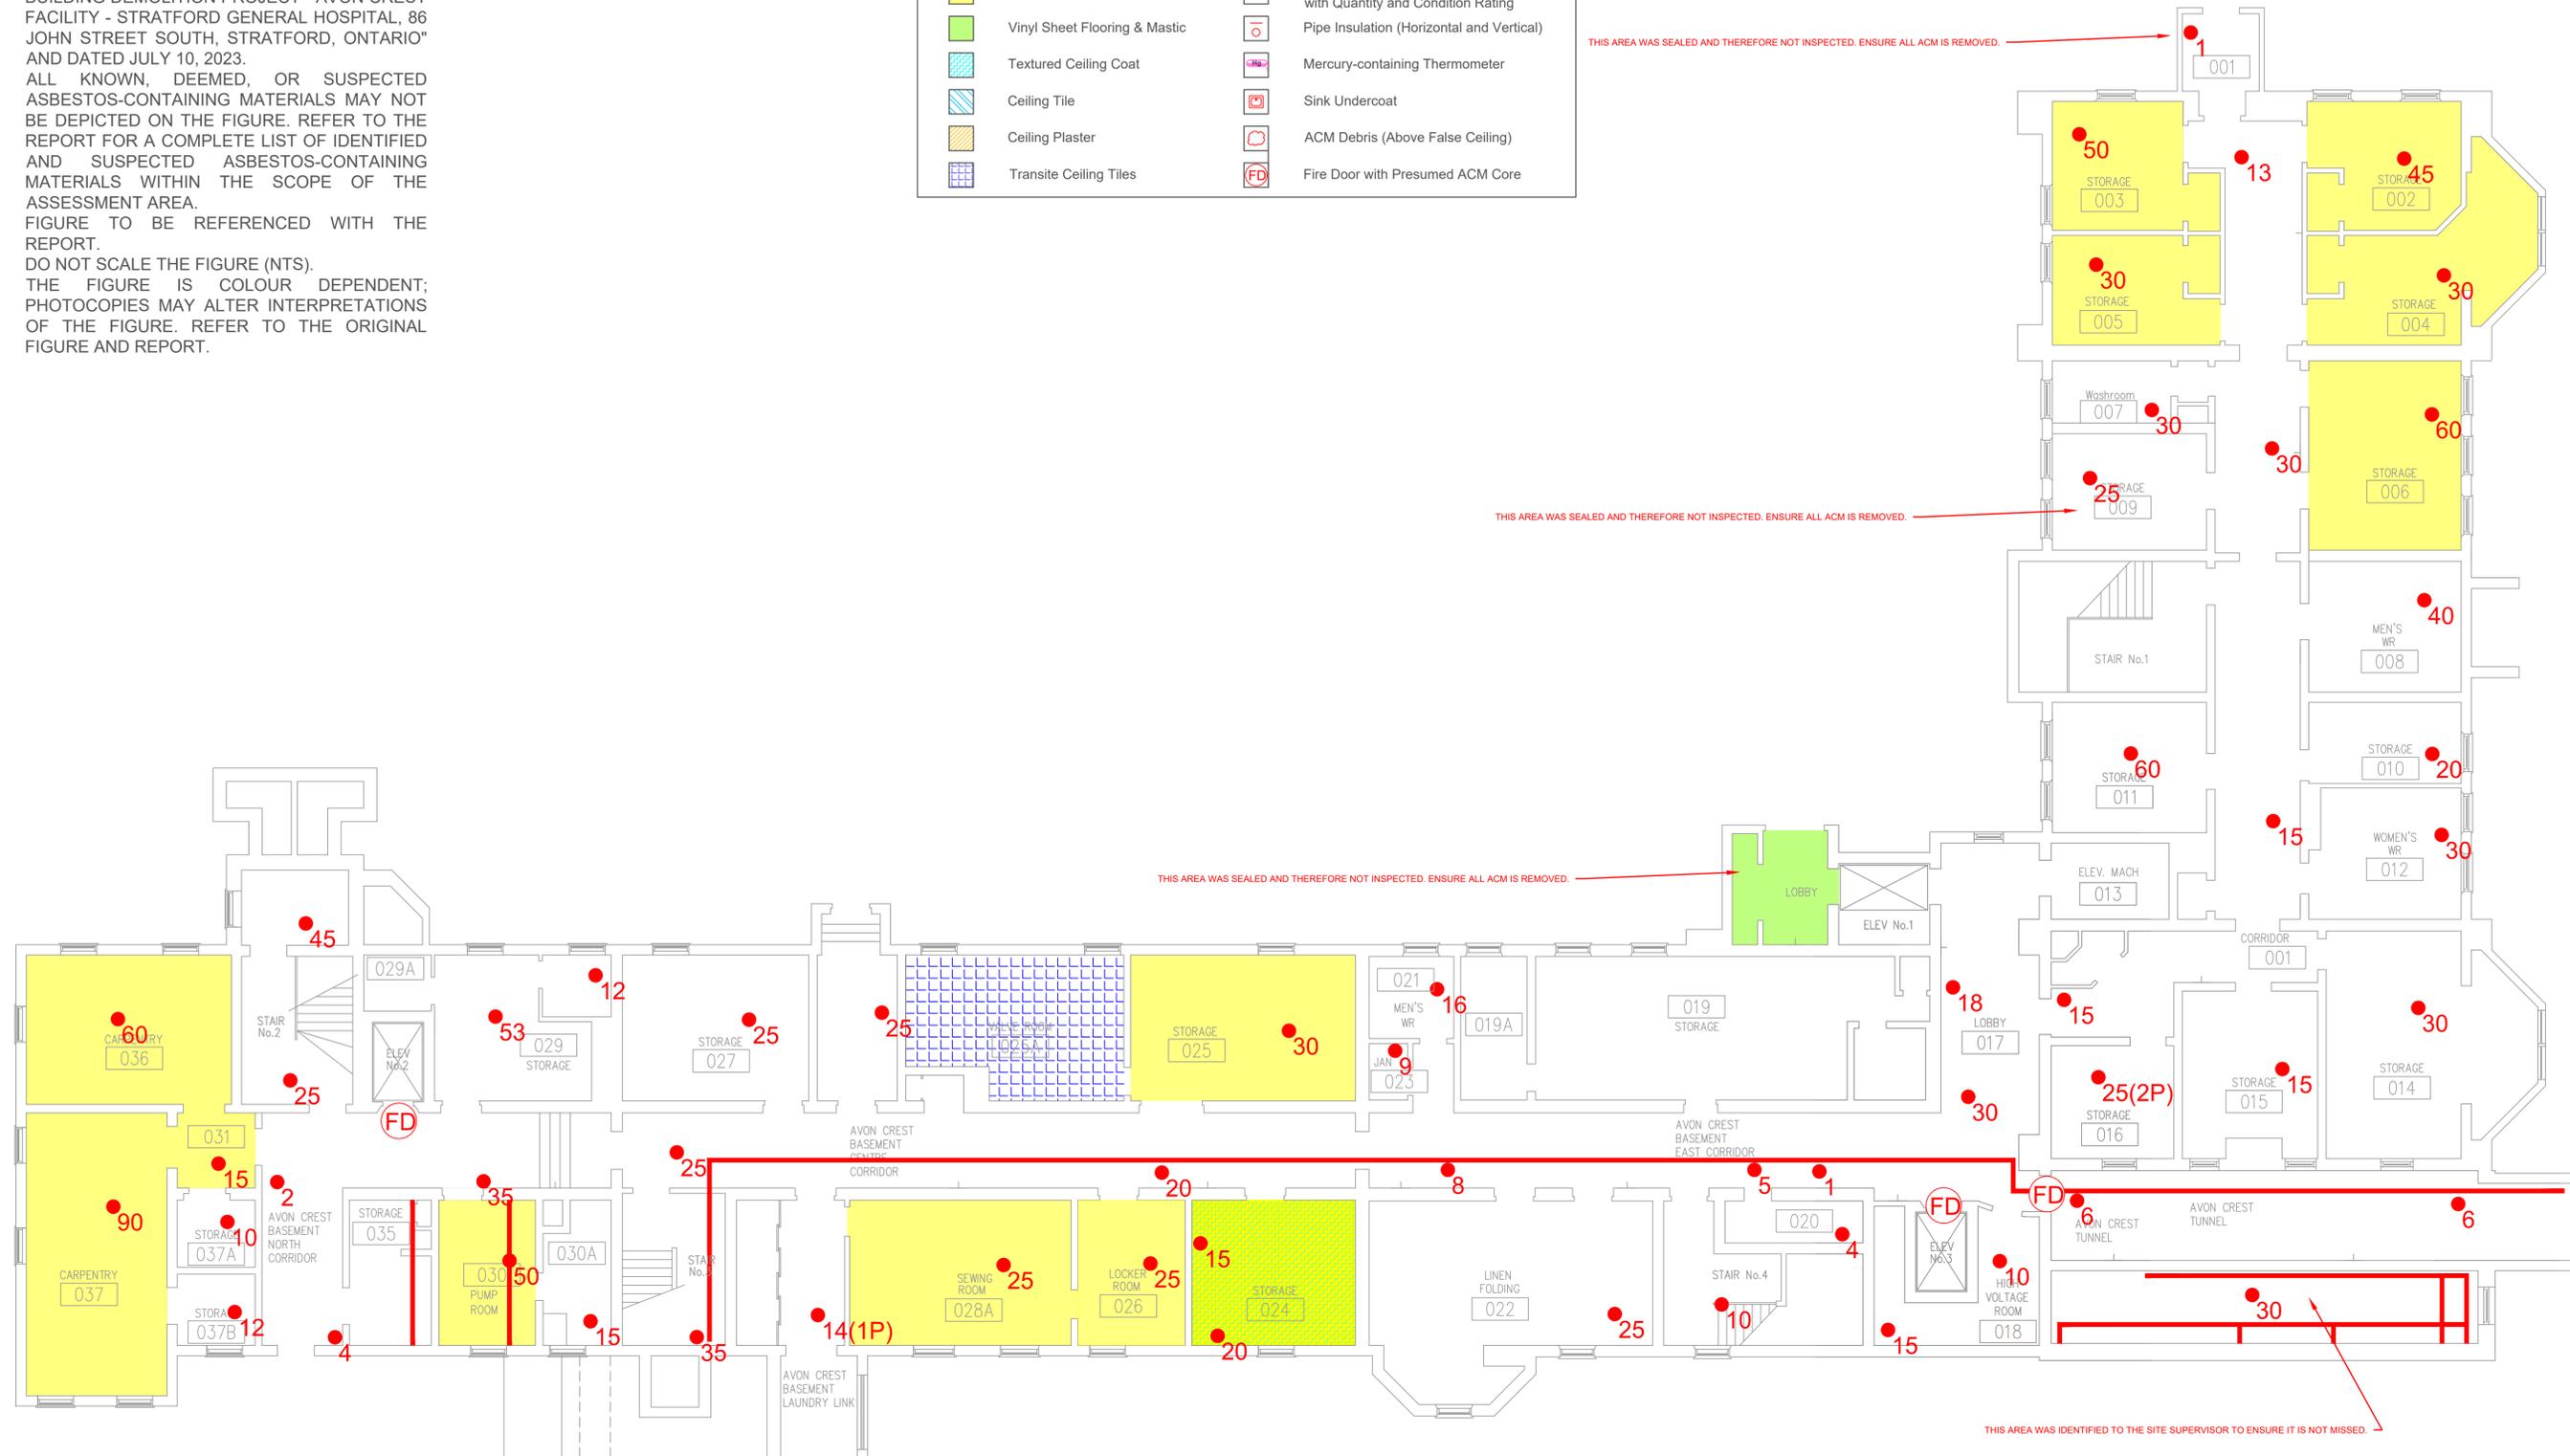
AVONCREST, WEST WING – BASEMENT

- The majority of asbestos-containing materials have been removed from the basement between Room 025A and Room 001, including:
  - Vinyl floor tiles;
  - Parged Cement Pipe Fitting Insulation;

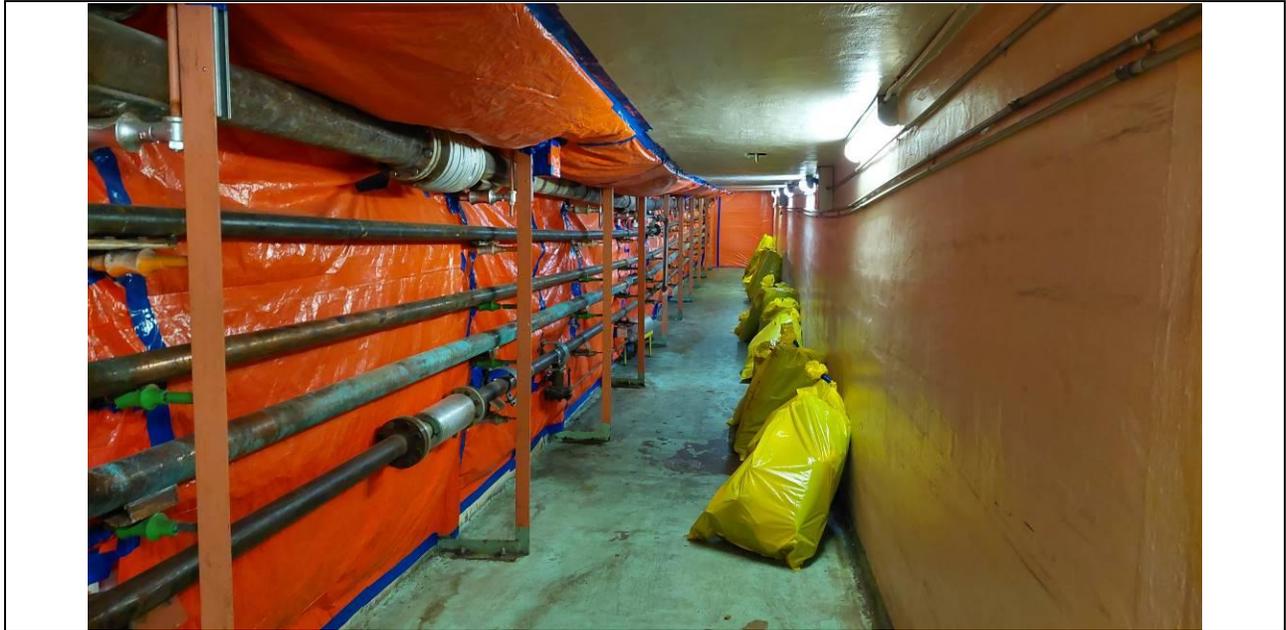
**P1 – Avon Crest Tunnel**

- Asbestos and non-asbestos pipe insulation were removed from the Avon Crest Tunnel during abatement and bagged as asbestos waste. The waste bags were lined up neatly and the tunnel was noted to be clean of dust and debris. The waste bags were being transported to a secured storage room to await a waste bin (**P1**);

Pipe insulation was removed from the Avon Crest Tunnel. The work area was neat and tidy. Waste was being transported to a secure location to await a waste bin.

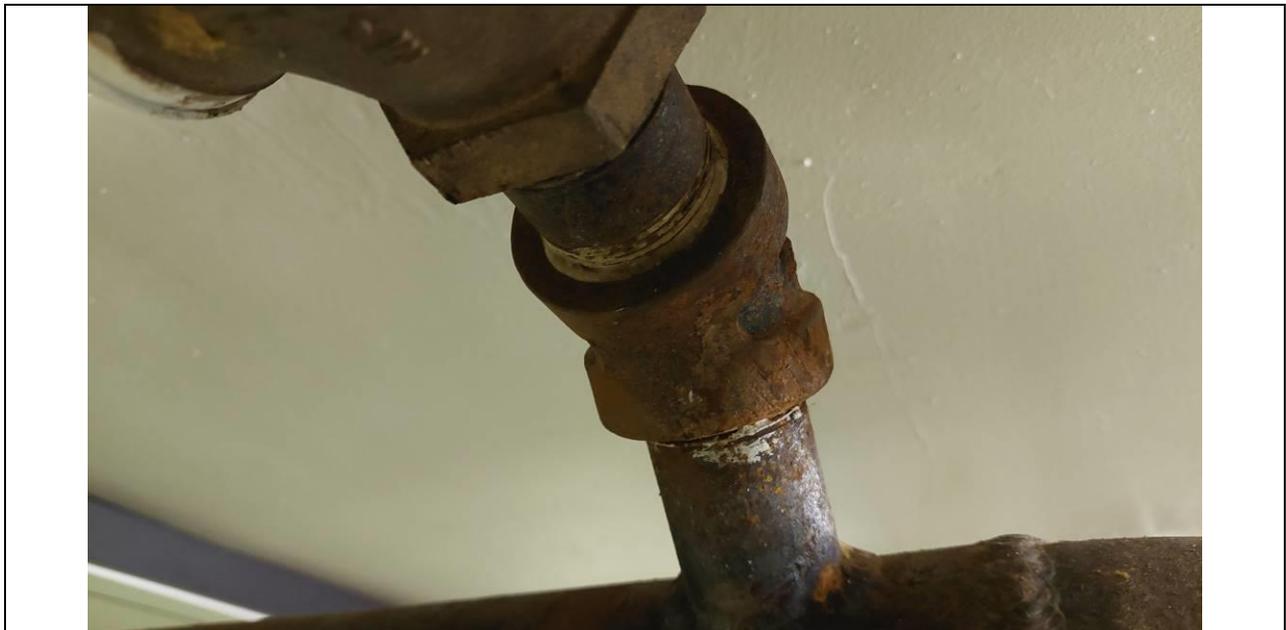
**P2 – Pipe Insulation Removed**

- Pipes were inspected for parging cement insulation remnants and were observed to be visually clean (**P2**);
- The work site appeared to be clean and tidy during the inspection (**P3**);

Asbestos-containing parged cement pipe fitting insulation was removed adequately throughout the majority of the basement.

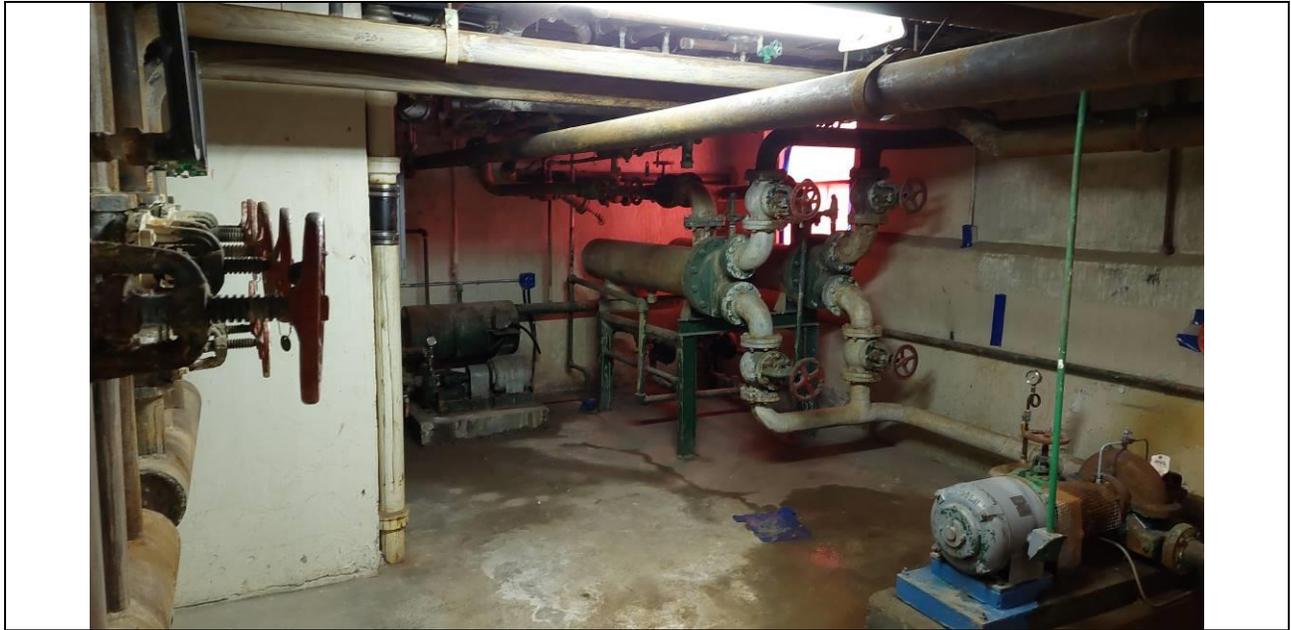
**P3 – Room 025A**

The work site, including all abatement areas, was clean and tidy during the inspection.

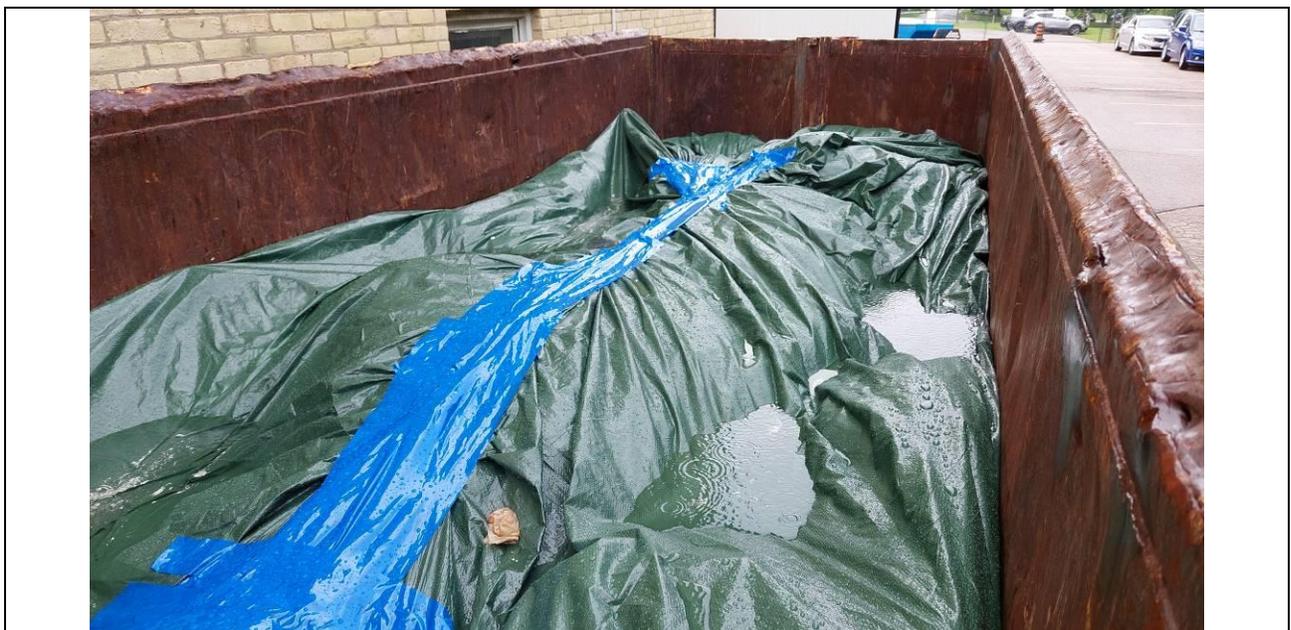
**P4 – Asbestos Waste Bin**

- A waste bin was observed on site. Waste within the bin was wrapped with polyethylene sheeting, sealed with tape (**P4**).

The asbestos waste bin was lined. The liner was closed and sealed.
