86 JOHN STREET SOUTH STRATFORD, ON

Phase One Environmental Site Assessment

Project Location:
86 John Street South
Stratford, ON N5A 2Y6

September 6, 2018

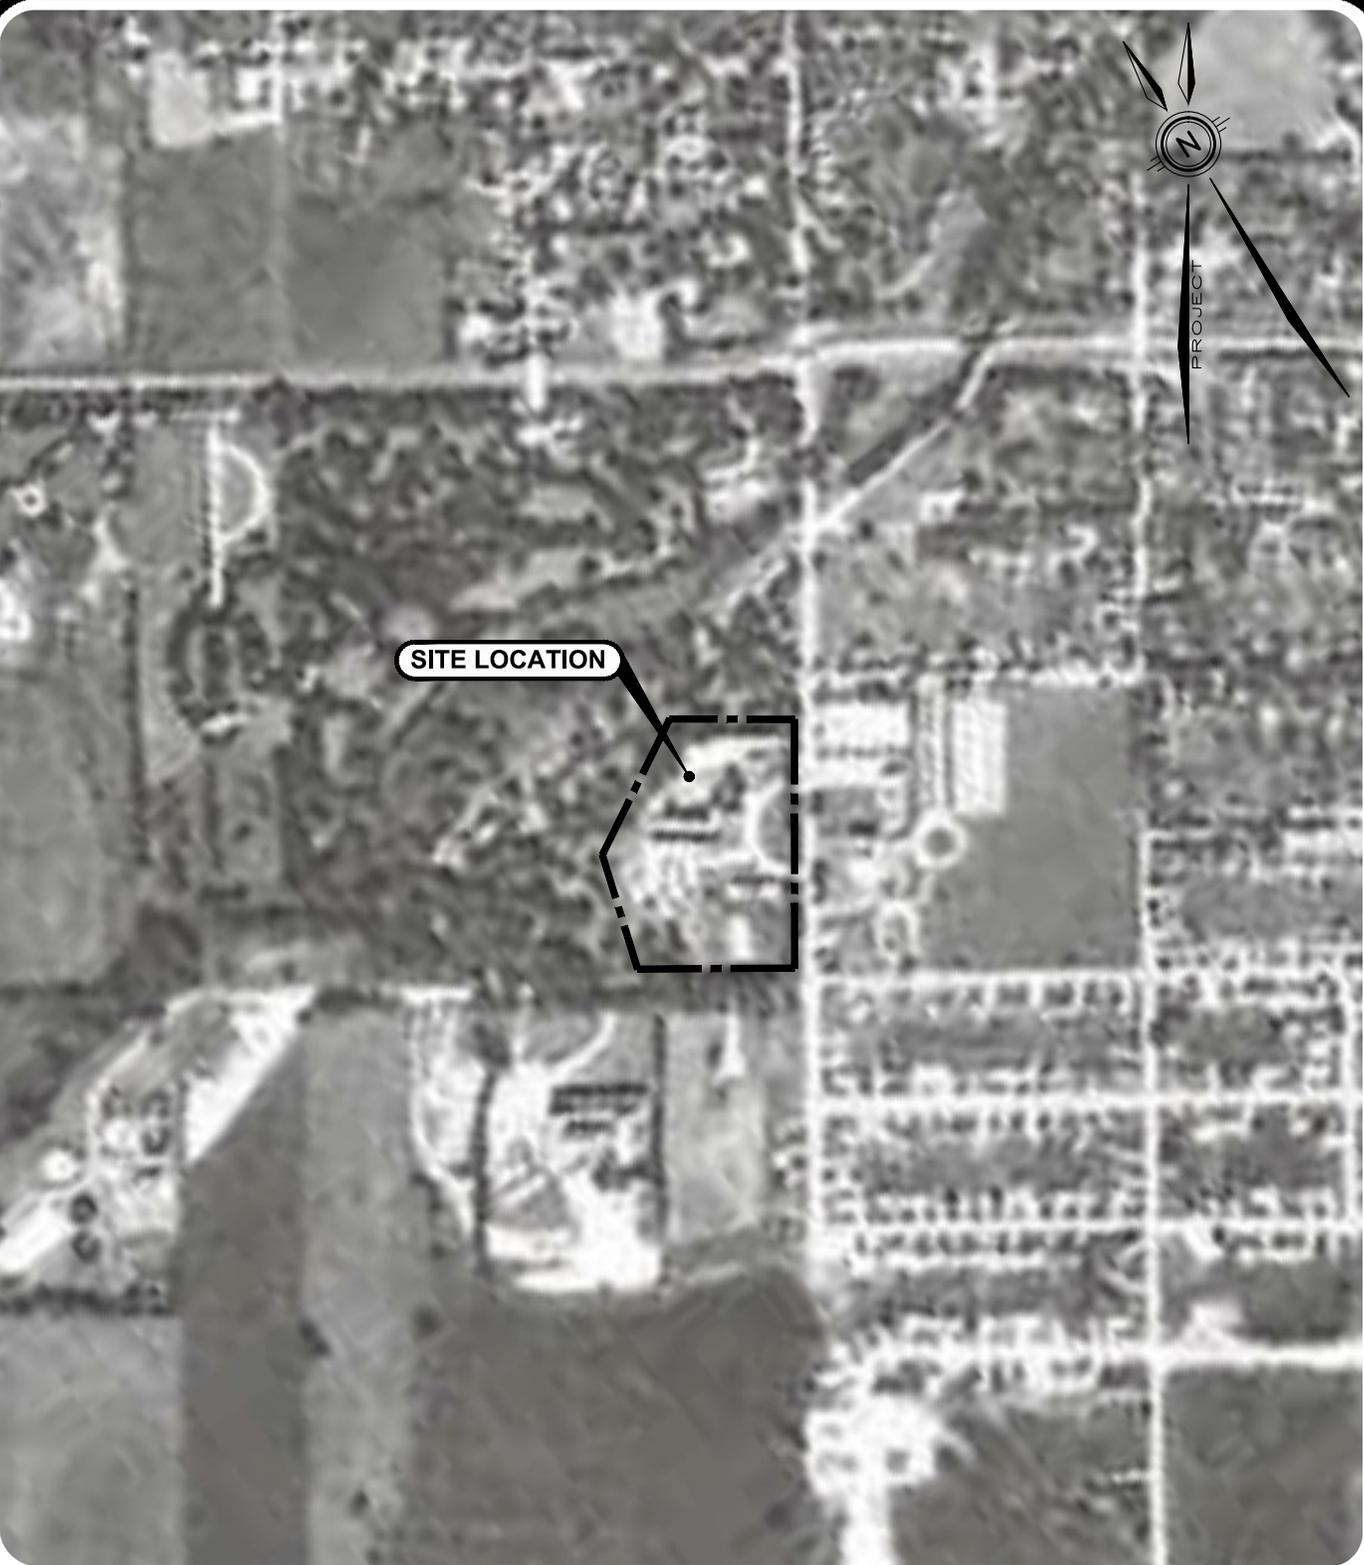
1965 AERIAL PHOTOGRAPH

The 1965 aerial photograph depicts the Phase One Property similar in configuration to the 1959 aerial photograph. The large irregular shaped area observed on the 1959 aerial photograph appears to have changed shape. It now appears to be a cleared, long, irregular shaped area on the north portion of the Site.

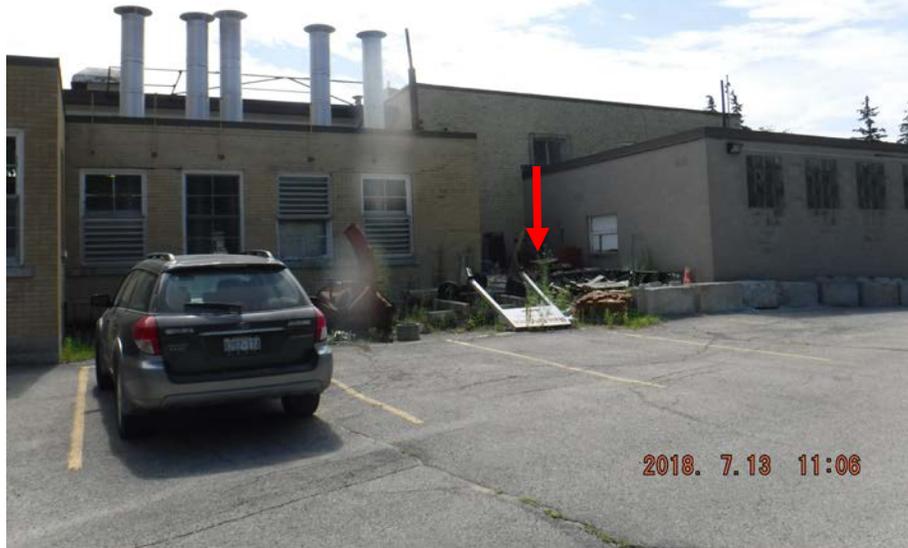
Photograph No. 5

Reportedly the salt tank in the west central portion of the Site leaked. There was a pipe break in the hydraulic elevator in the main building on the Site. The pipe was fixed and no other spills have been reported on the Site.

A salt tank is located outside the laundry facilities on the west central portion of the Site. Reportedly, the salt tank leaked. During the time of the Site inspection, piled and loose bricks were observed on and around the in ground tank as well as old wood pallets, plywood, cement parking blocks and other debris.

East facing view of location of in ground salt tank (see arrow) and debris located on the central west portion of the Site between the laundry room and boiler room.

A Phase Two ESA is recommended and would be required before a Record of Site Condition could be filed.

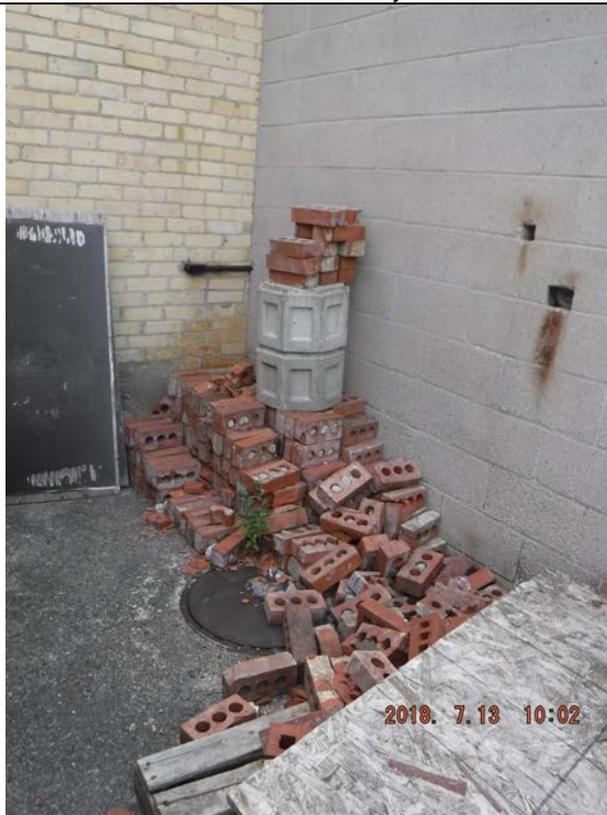
Photograph No. 6

Close up of the top of the salt storage, concrete tank partially located in ground.

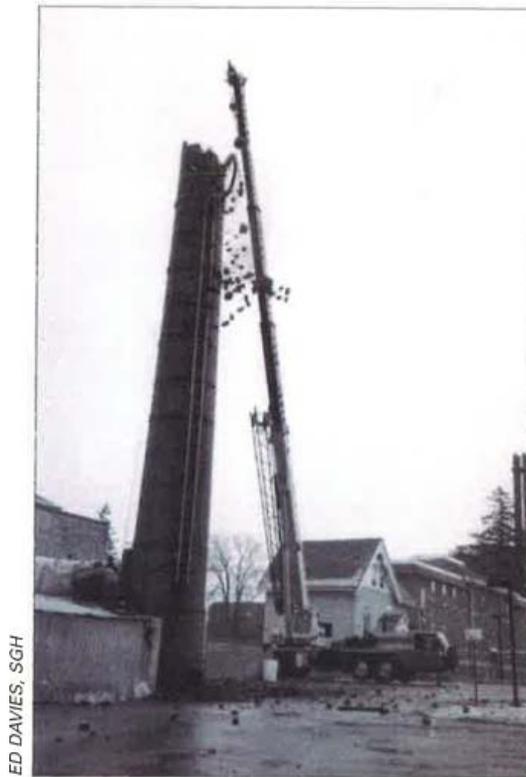
Photograph No. 8

Former incinerator, demolished in 2000 from the published book *“For your health - Stratford General Hospital 1891-2002”* by Dean Robinson and Carolyn Bart-Riedstra.

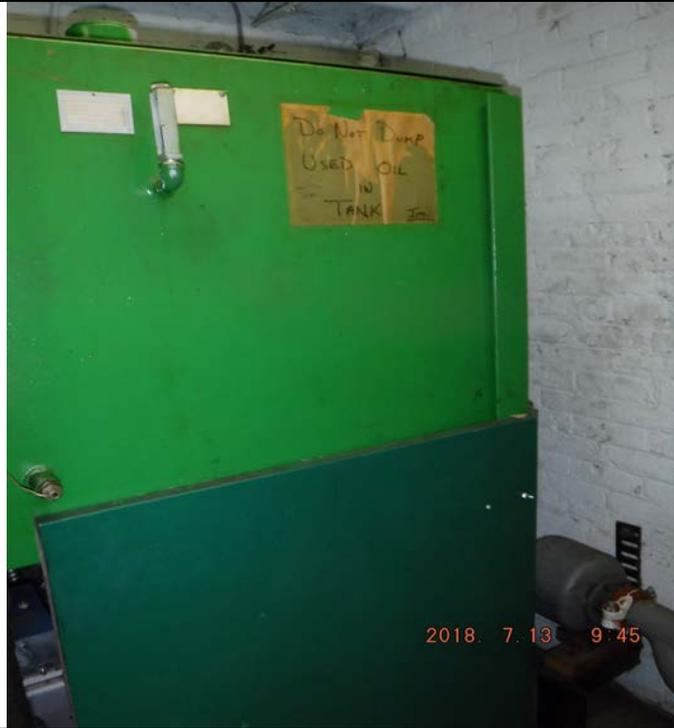
Photograph No. 9

two are traction elevators, and one is a hydraulic life elevator. The hydraulic lift elevator is located on the east end of the building and reportedly had a pipe leak in the past. A hydraulic oil tank is stored in this vicinity, some staining was observed on the floor. There are three interior transformers located in the vicinity of the traction elevator in the east end. Reportedly none use oil, and no staining was observed on the floor.

Hydraulic oil AST located near the hydraulic lift elevator in the main building on the east portion of the Site.

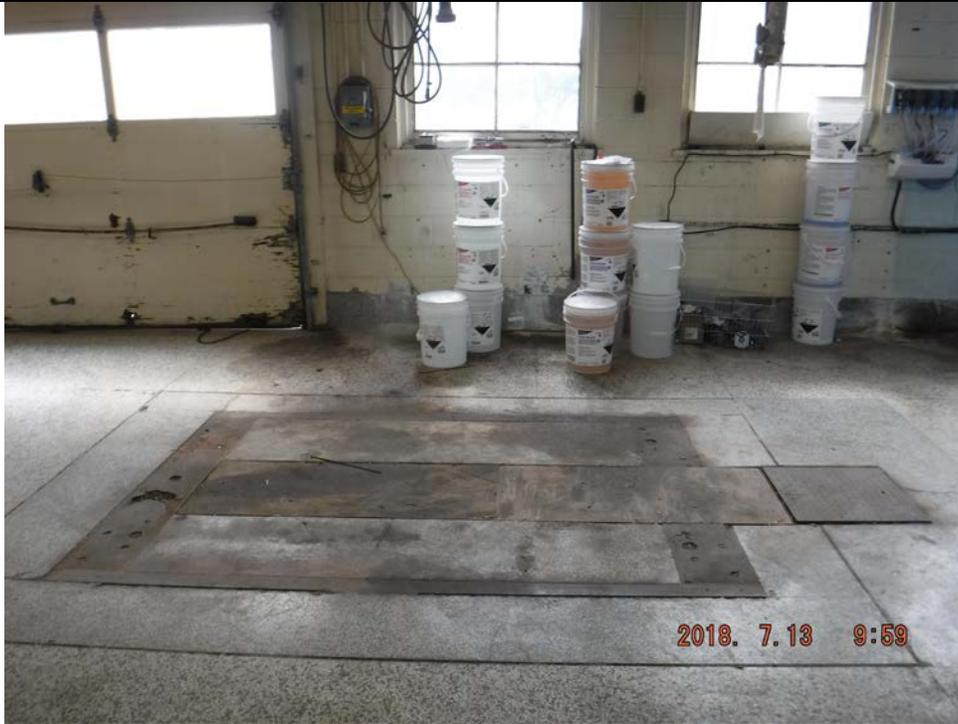
Photograph No. 11

The laundry facilities room occupies the first half of the south wing. The interior comprises red brick walls, concrete block walls, concrete floor, fluorescent industrial lights and a warehouse door. The laundry facilities room is large and contains two industrial sized washing machines, two dryers, soaps and detergents, a spill kit, microwave, tables and other miscellaneous furniture, a sink, laundry totes and cabinets. Two trenches were observed on the east side of the room which were reportedly formerly used to hold water from the laundry machine drains. A sanitary sewer line is reportedly connected to these trenches.

Former location of industrial washing machine and pit reportedly used to hold laundry waste water as it drains to sanitary.

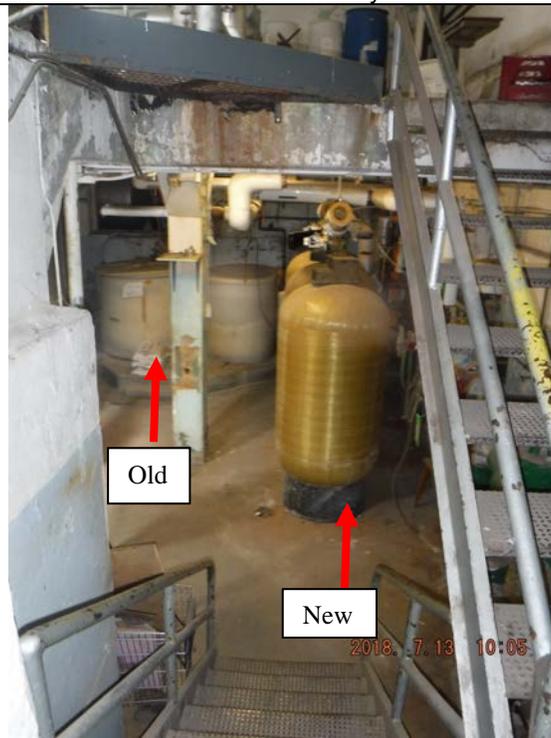
Photograph No. 12

The boiler room consists of a lower floor and upper mezzanine floor. The interior is comprised of concrete floors, concrete brick walls and plaster walls. The lower floor contains four water softener tanks, empty and near empty drums with labels such as glycol, used oil and steel, and varsol, two boilers, a bathroom and locker room, a storage closet containing small quantities of paint and miscellaneous items. There is a workshop area and an AST reportedly used as a hot water tank. A floor drain was observed in this vicinity, no staining was observed around the drain. The southwest corner of the room contained a raised concrete slab. This is reportedly where coal was stored. A room located west of the boilers was the location of the former water well. It had a 15,000 gallon AST reportedly used to hold water. Reportedly, two generators were formerly stored in the boiler room.

Old water softener tanks no longer in use (left), and newer water softeners in-use (right) located in the boiler room.

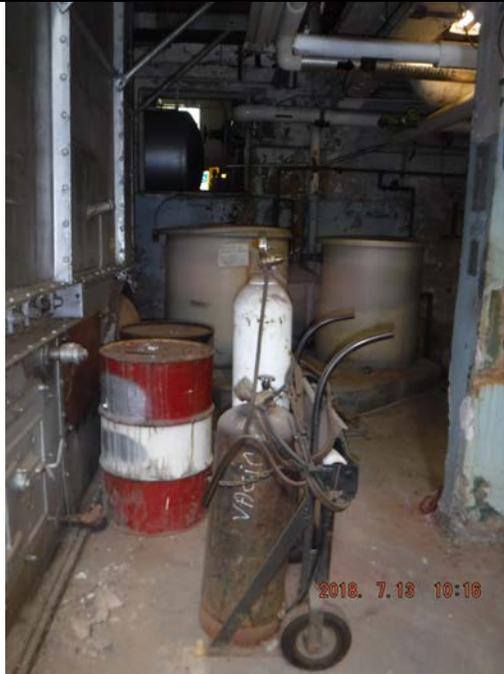
Photograph No. 13

Empty drum storage and compressors located in the boiler room near the no longer used water softeners.

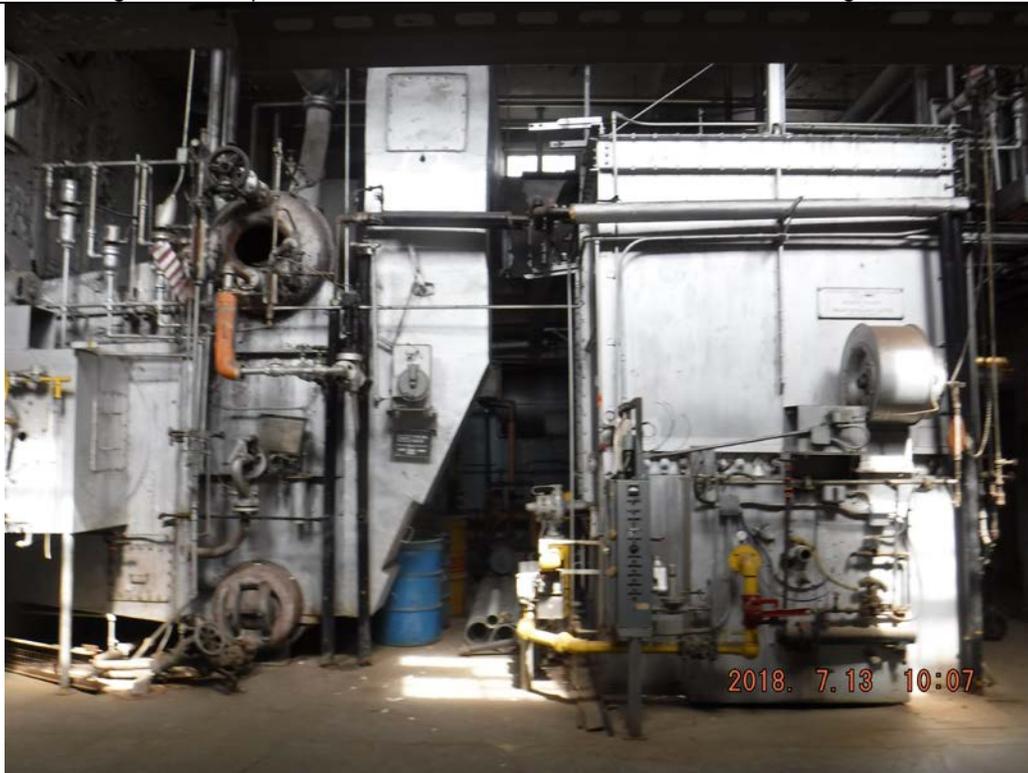
Photograph No. 14

Two natural gas fired boilers located in the boiler room of the main building and in the southwest portion of the Site.

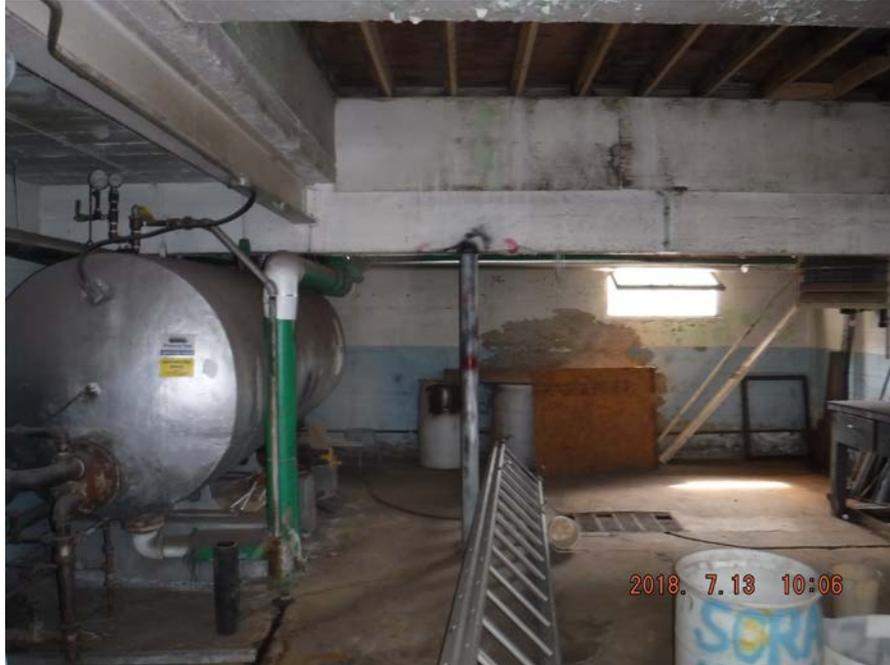
Photograph No. 15

View of hot water tank formerly used for the laundry services (left), floor drain and empty drum storage (right) located in the boiler room.

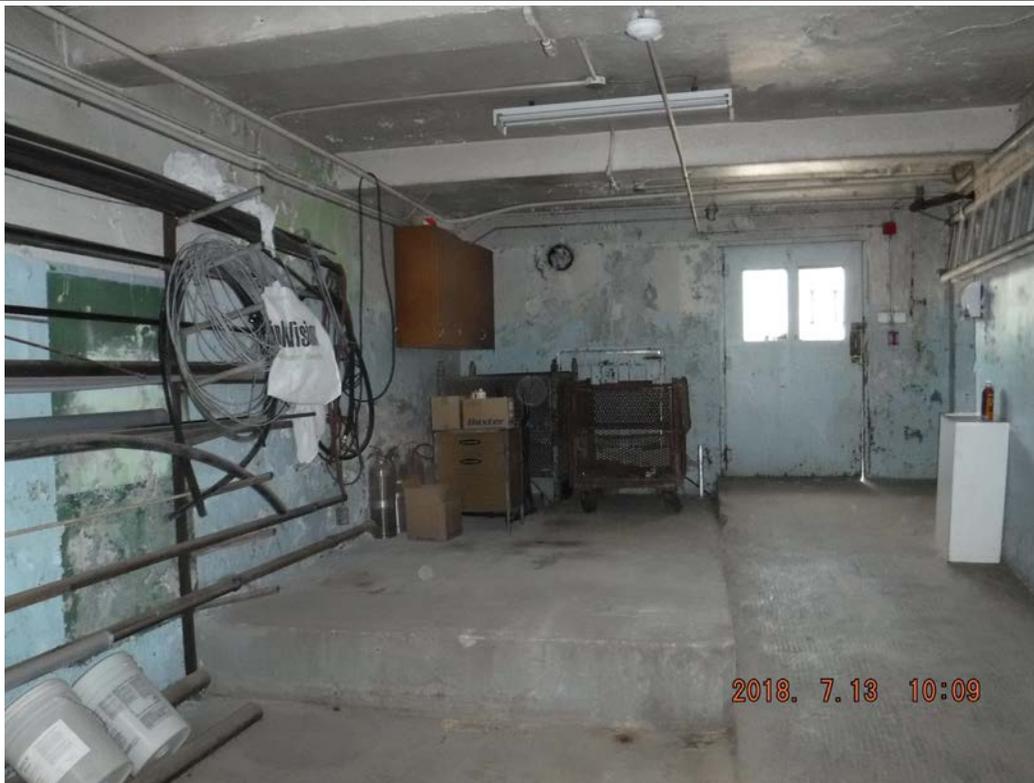
Photograph No. 16

Reportedly, the location of the former coal storage area within the boiler room on the southwest portion of the Site. Reportedly, two generators were also stored in this area.

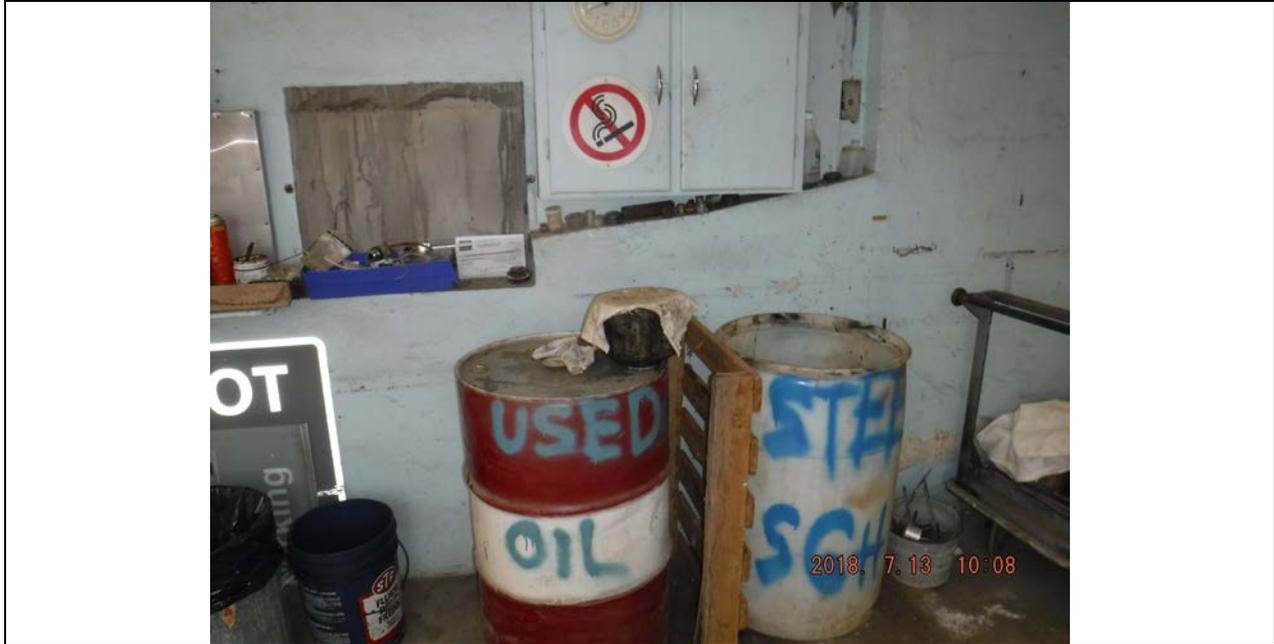
Photograph No. 17
Empty drums in boiler room.

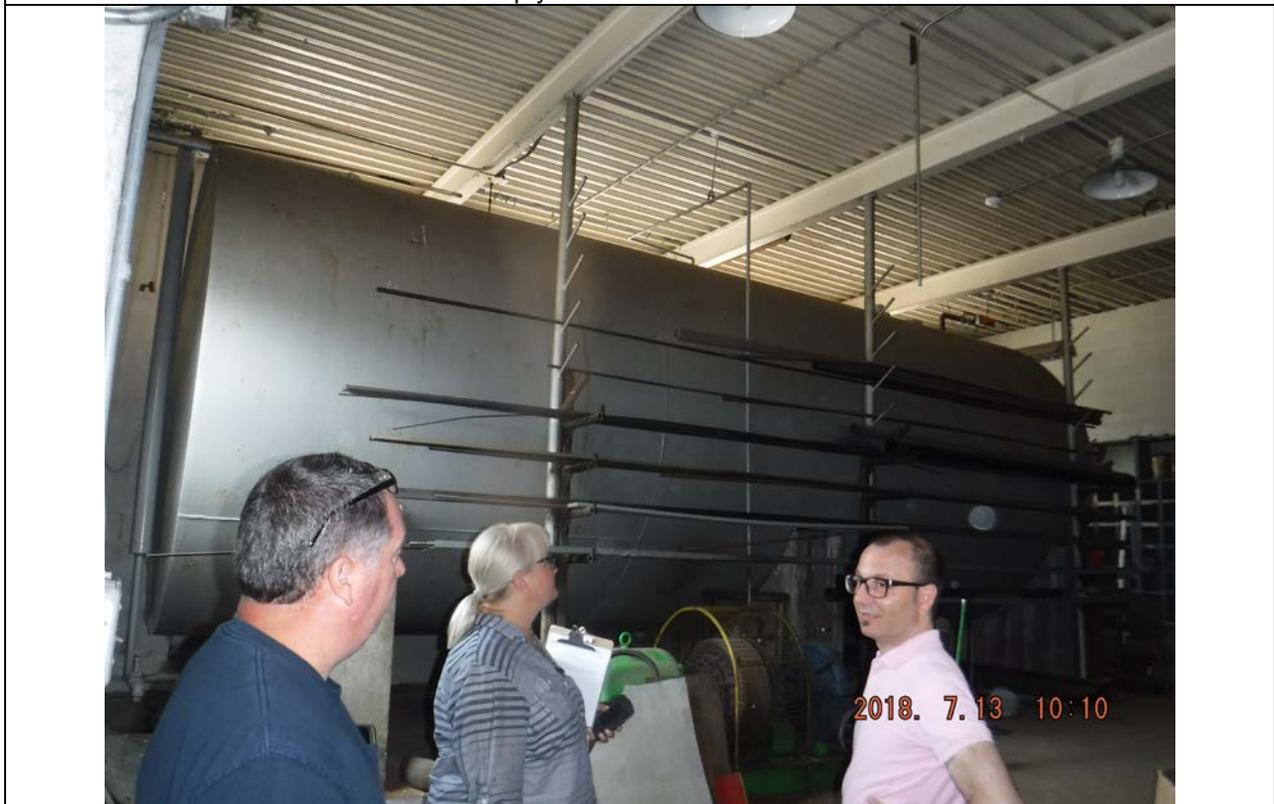
Photograph No. 18
15,000 gallon tank used to hold domestic water from the former water well, both located in a room to the west of the boiler room.

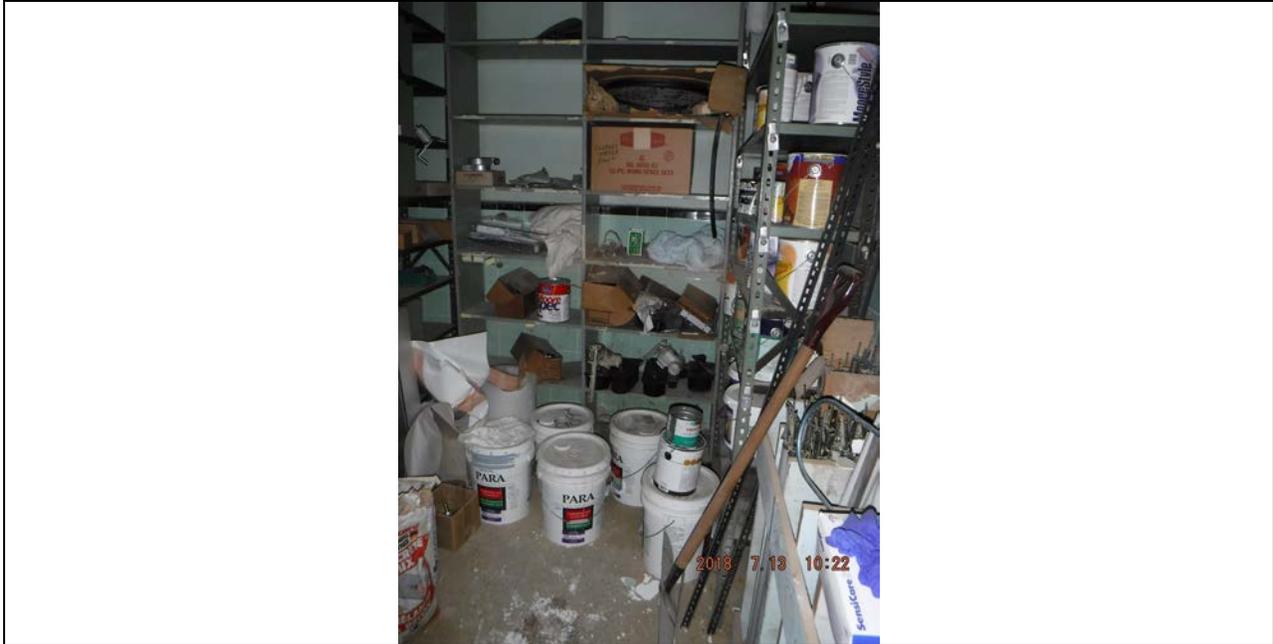
Photograph No. 19

Small quantities of paints, concrete, coatings, and other miscellaneous household items in the storage closet in the basement of the main building.

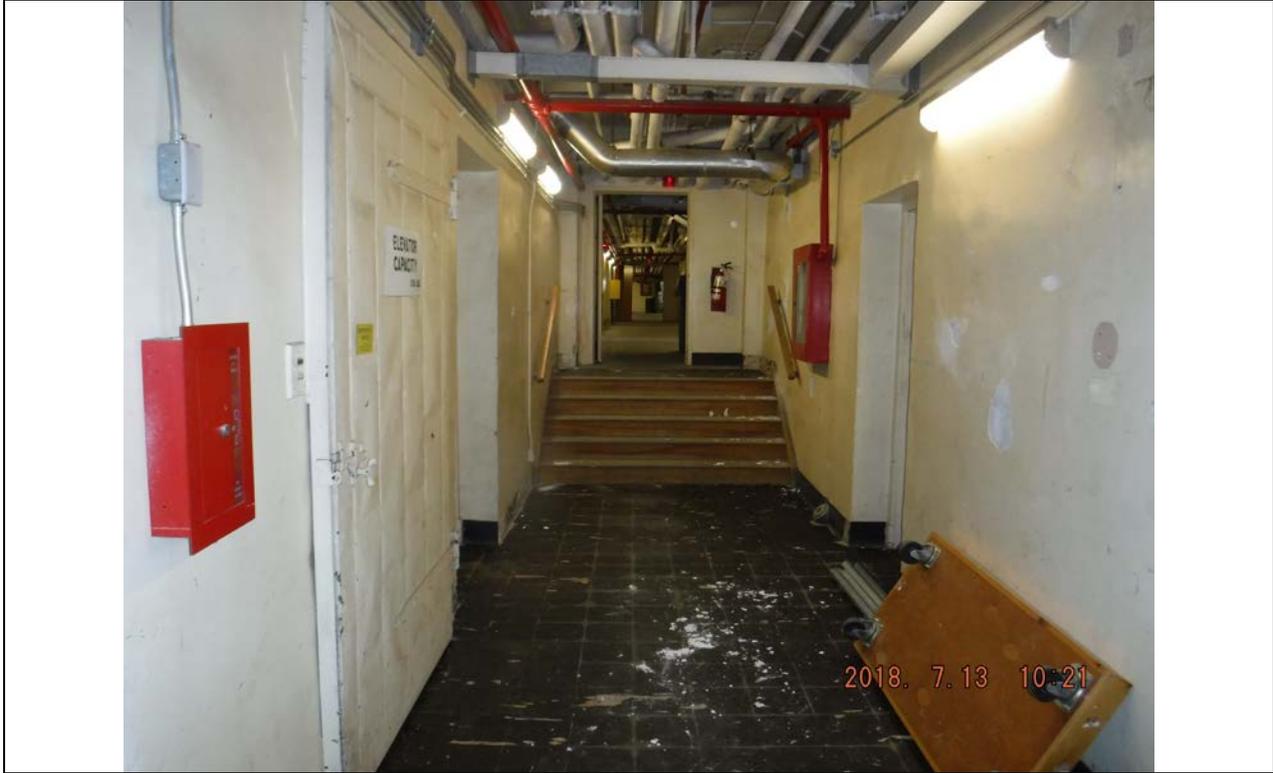
Photograph No. 20

Asbestos pipe insulation was observed in some mechanical rooms and asbestos tiles were observed in some portions of the main wing.

Basement hallway of the main building showing an elevator (left) and former area of asbestos floor tiles.

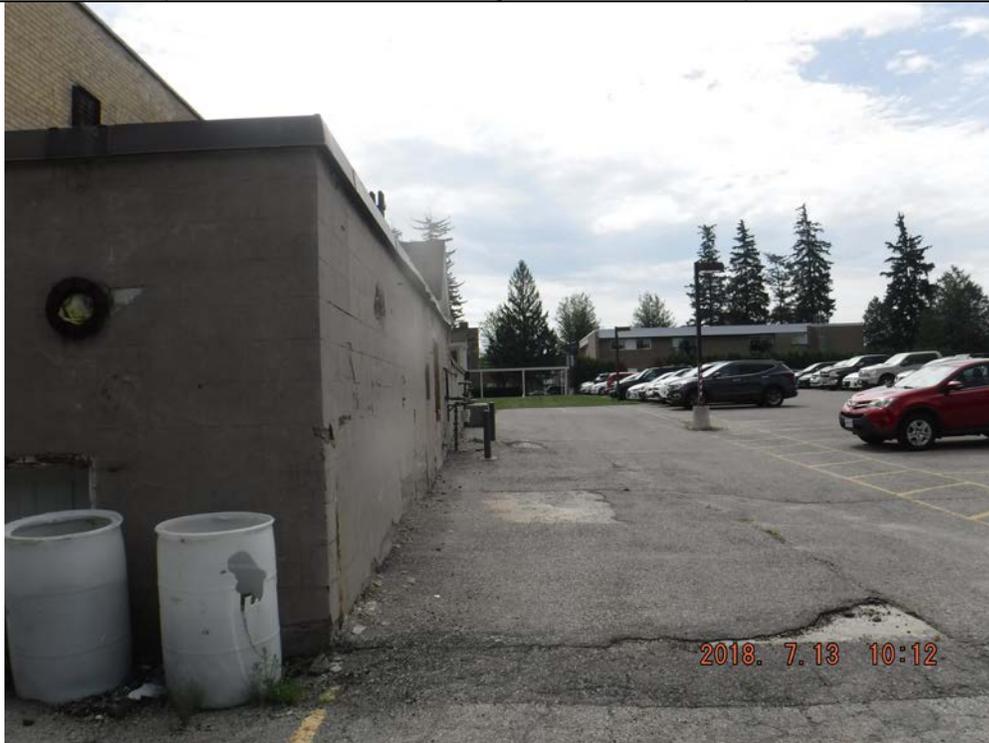
29. **Fires:** Mr. Mott indicated the tower at the front of the main building was struck by lightning and partially burned down. There was an incinerator at the Phase One Property and was removed in 2000. No other fires have occurred on the Site.

Photograph No. 22
East facing view of the location of the former incinerator, removed in 2000.

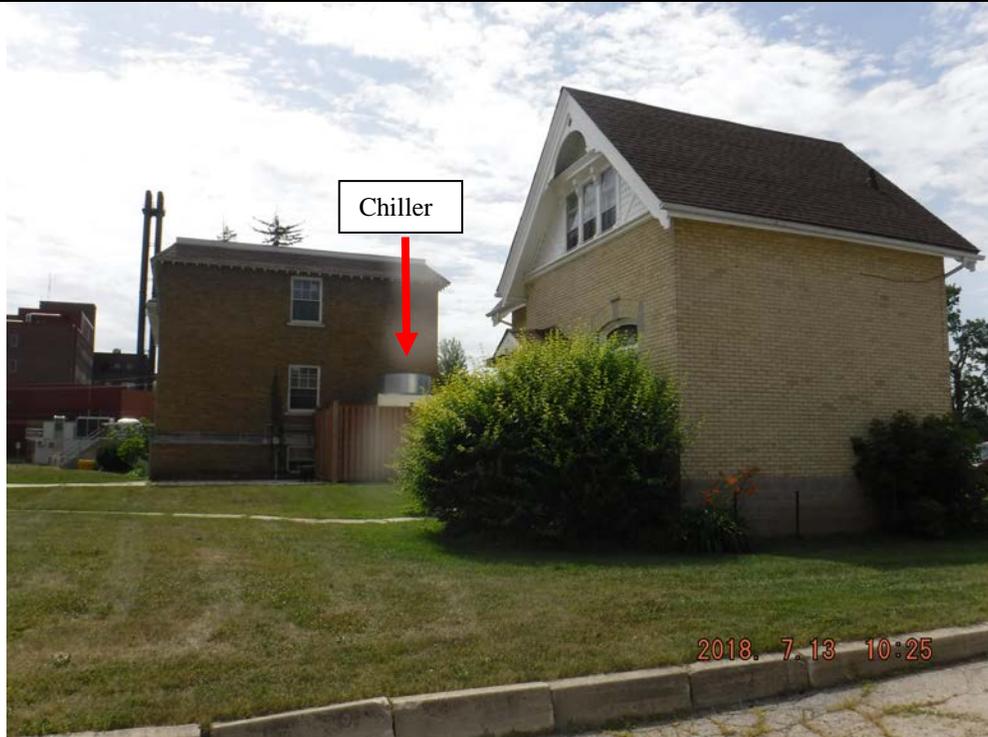
Photograph No. 23

rooms, storage closets, and a hot water tank. A chiller was observed outside along the west wall of the building. The chiller is used to cool the Special Services Unit. Steam from the boilers in the hospital heat the Special Services Unit via underground steam lines. Reportedly glycol is used in the chiller and is stored in the basement. There are two interior transformer located on a concrete pad, no staining was observed in this area.

Southeast facing view of Special Services Unit (left) and cottage (right) located in the south portion of the Site. Adjacent to the Special Services Unit, behind the fence is a chiller, which uses glycol.

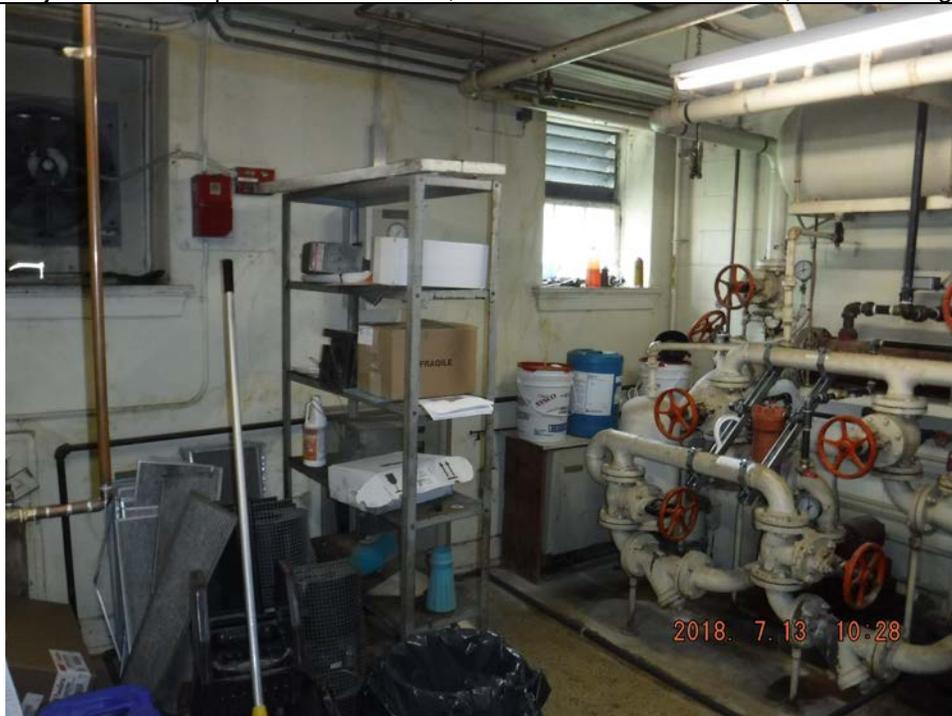
Photograph No. 24

Basement of Special Services Unit including glycol storage.

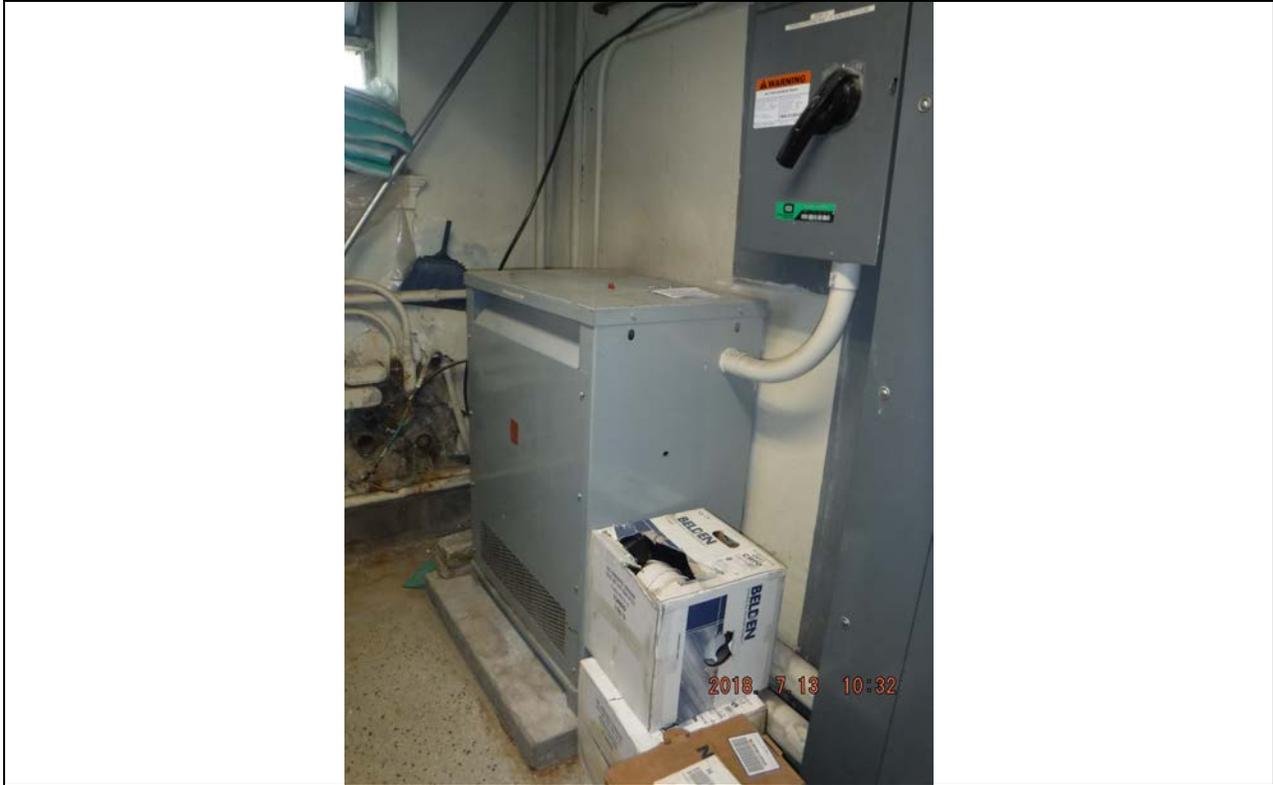
Photograph No. 25
Interior non-oil transformer in the Special Services Unit.

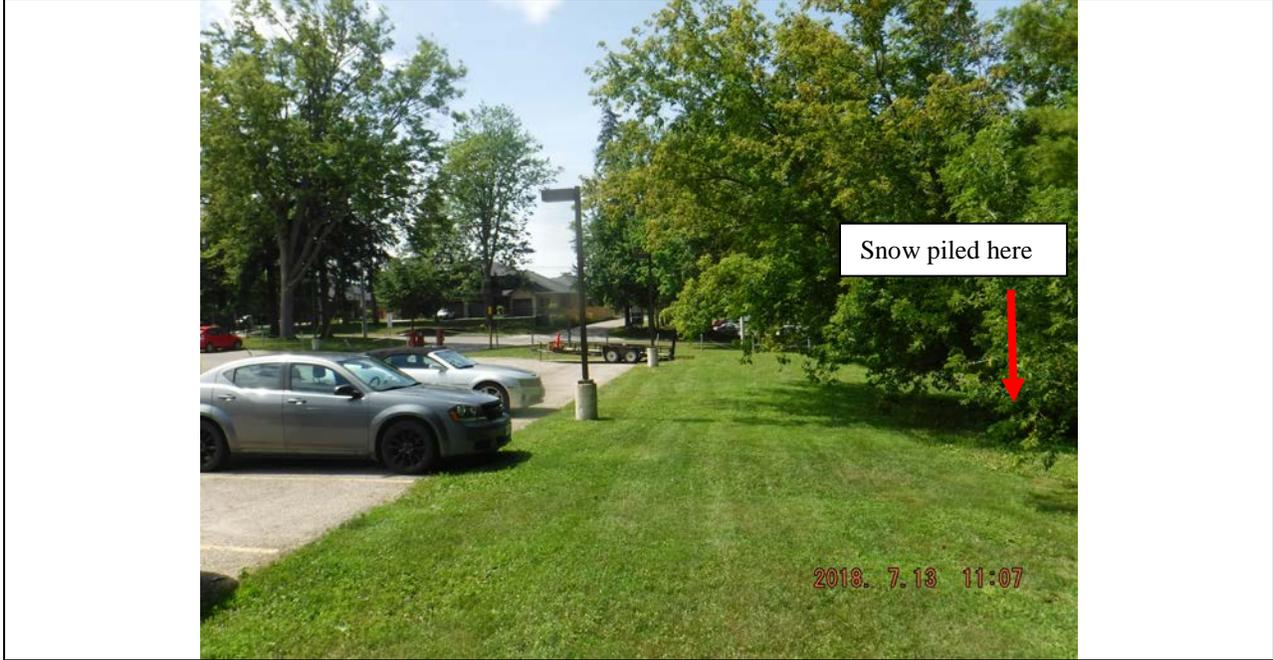
Photograph No. 26
South facing view of southwest portion of the Site depicting part of the south parking lot (left) where incinerator fill was used as fill and an area where snow is piled (right) in the winter.

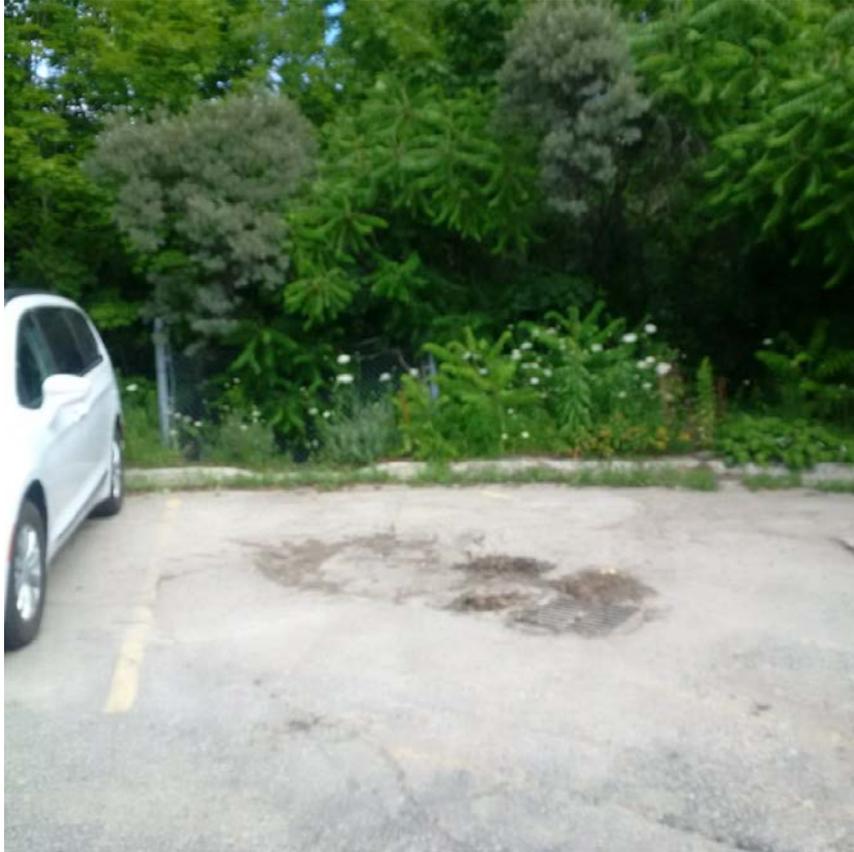
Photograph No. 27

West facing view of northwest corner of the Site showing snow pile area and adjacent woodlot.
