July 12, 2023

Re: Site Inspection Report for July 7, 2023
Avon Crest Building Demolition Project
Avon Crest Facility – Stratford General Hospital
86 John Street South, Stratford, Ontario (Site)

2.0 RESULTS OF PROGRESS INSPECTION – JULY 7, 2023

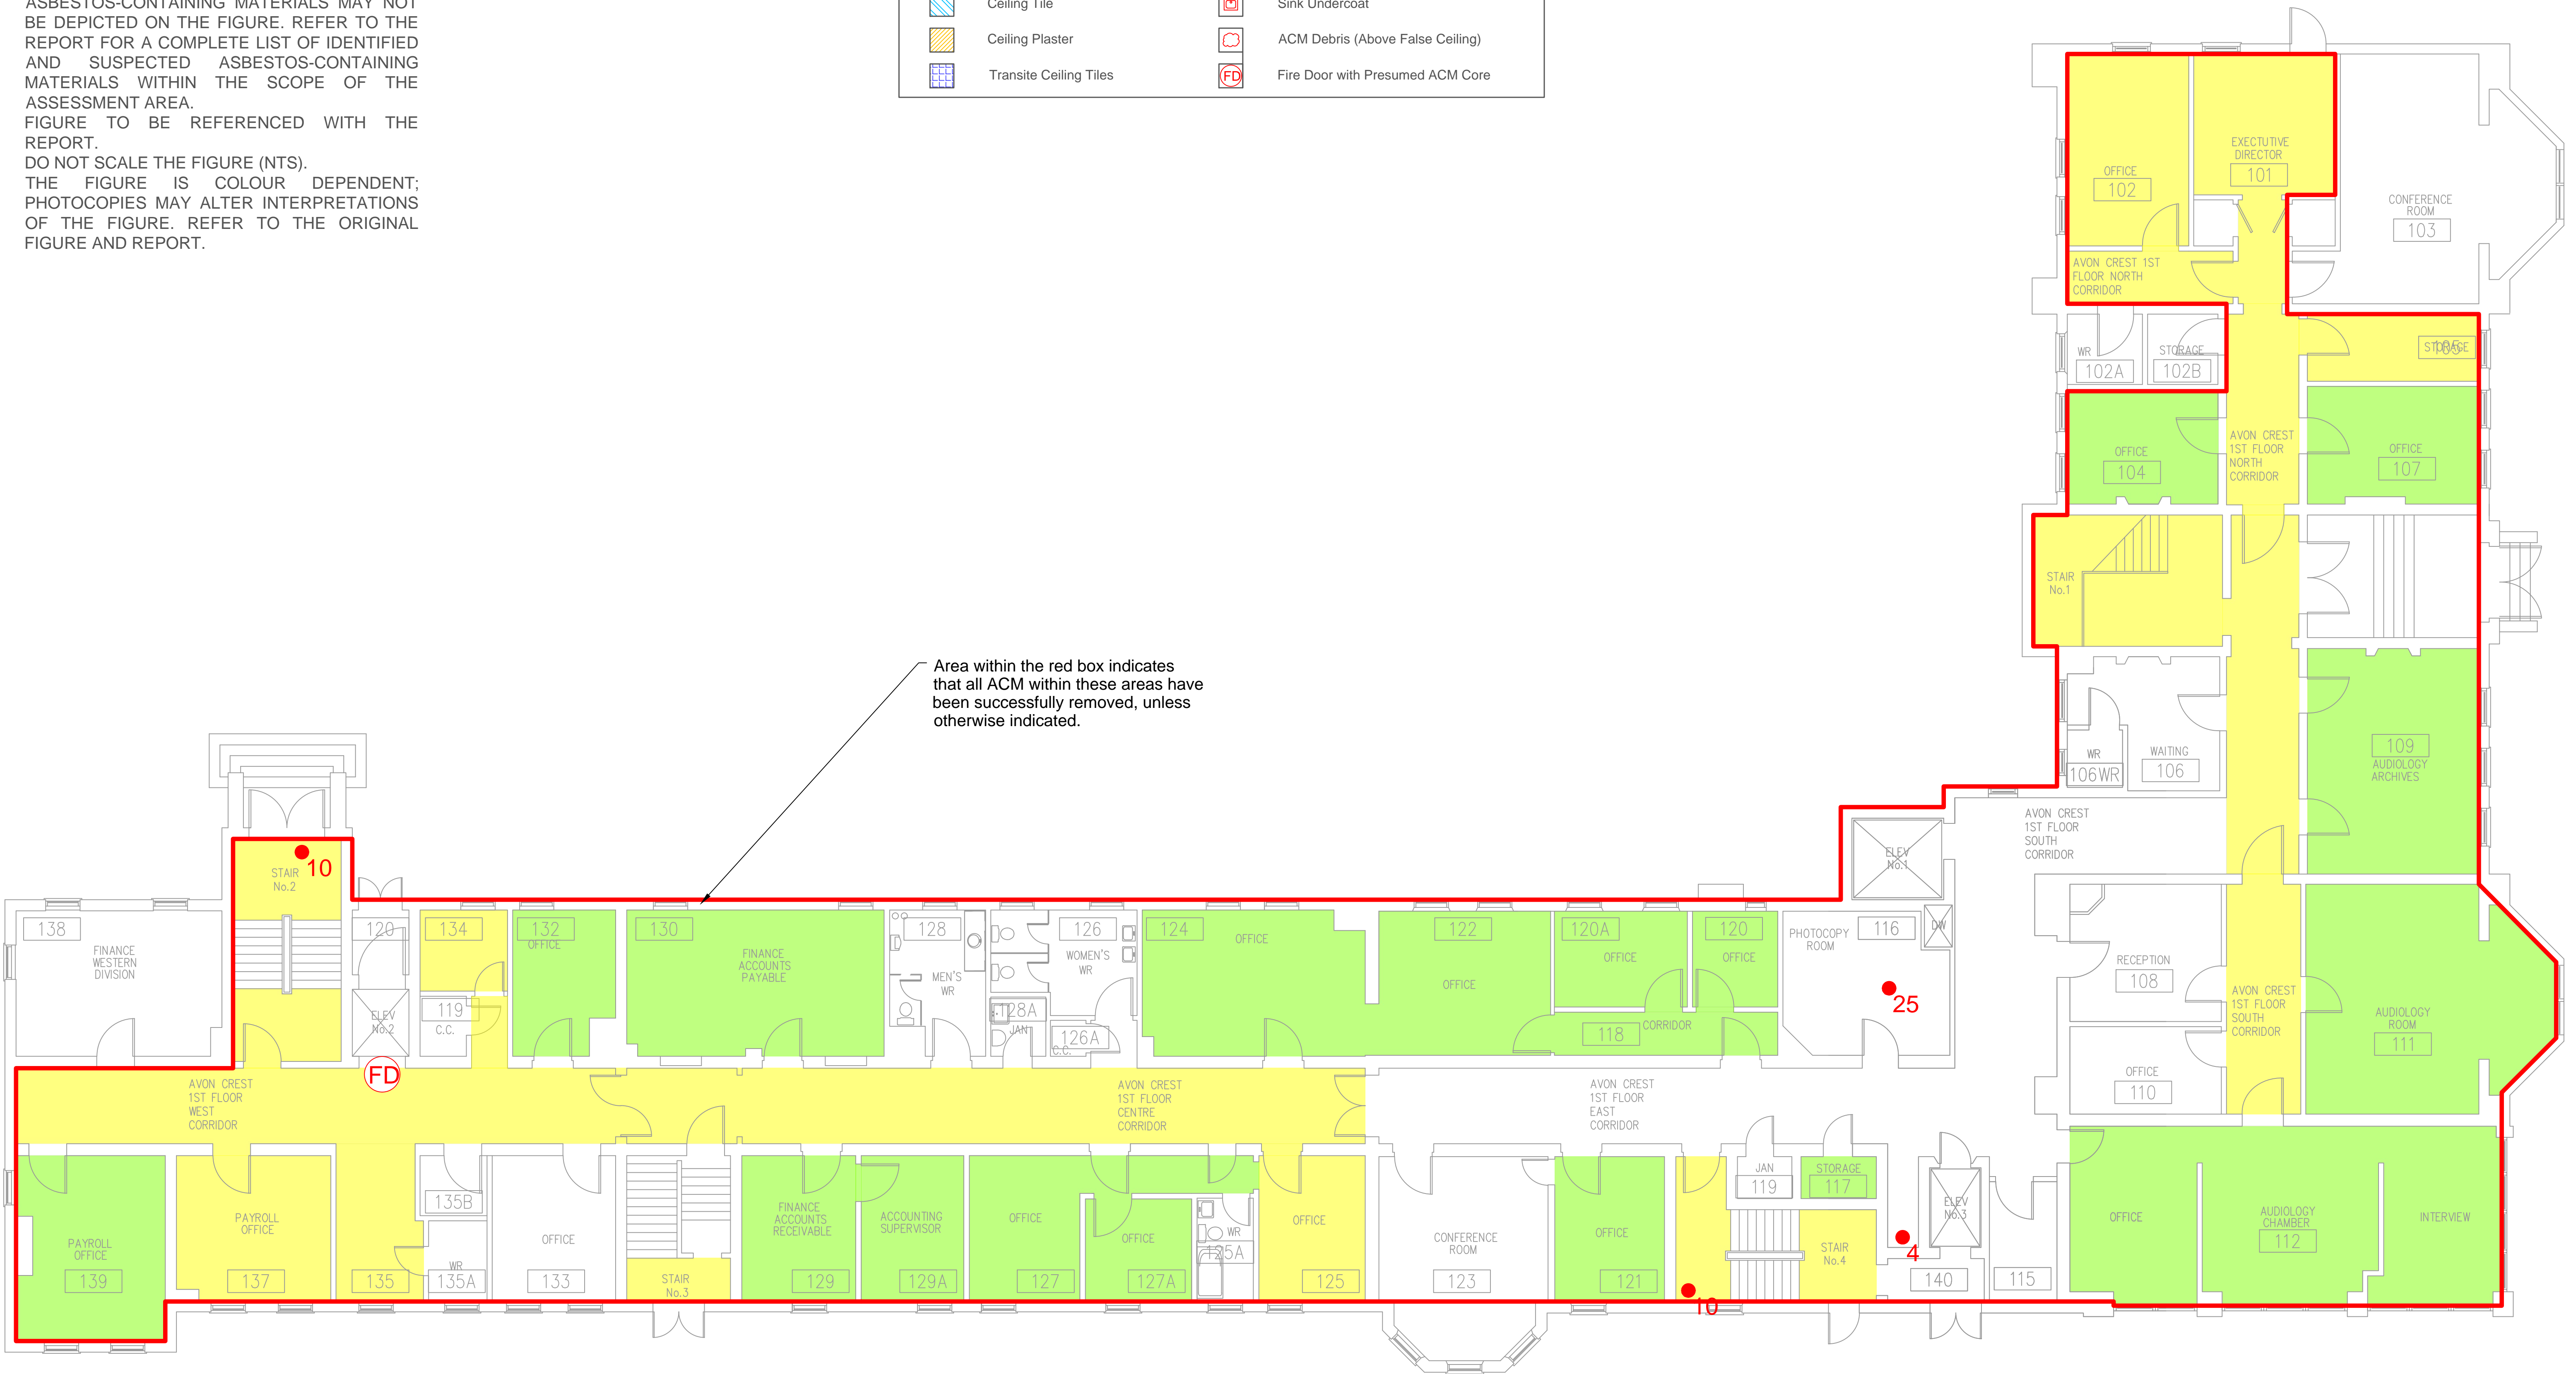
PR01

- Fire doors with asbestos-containing cores in the west corridor on the first, second and third floors were observed to have been removed (**P1**);
- Remaining asbestos-containing vinyl sheet flooring in the Accounting Supervisor Room on the first floor (Room 129A) was observed to have been removed (**P2**);

Area within the red box indicates that all ACM within these areas have been successfully removed, unless otherwise indicated.

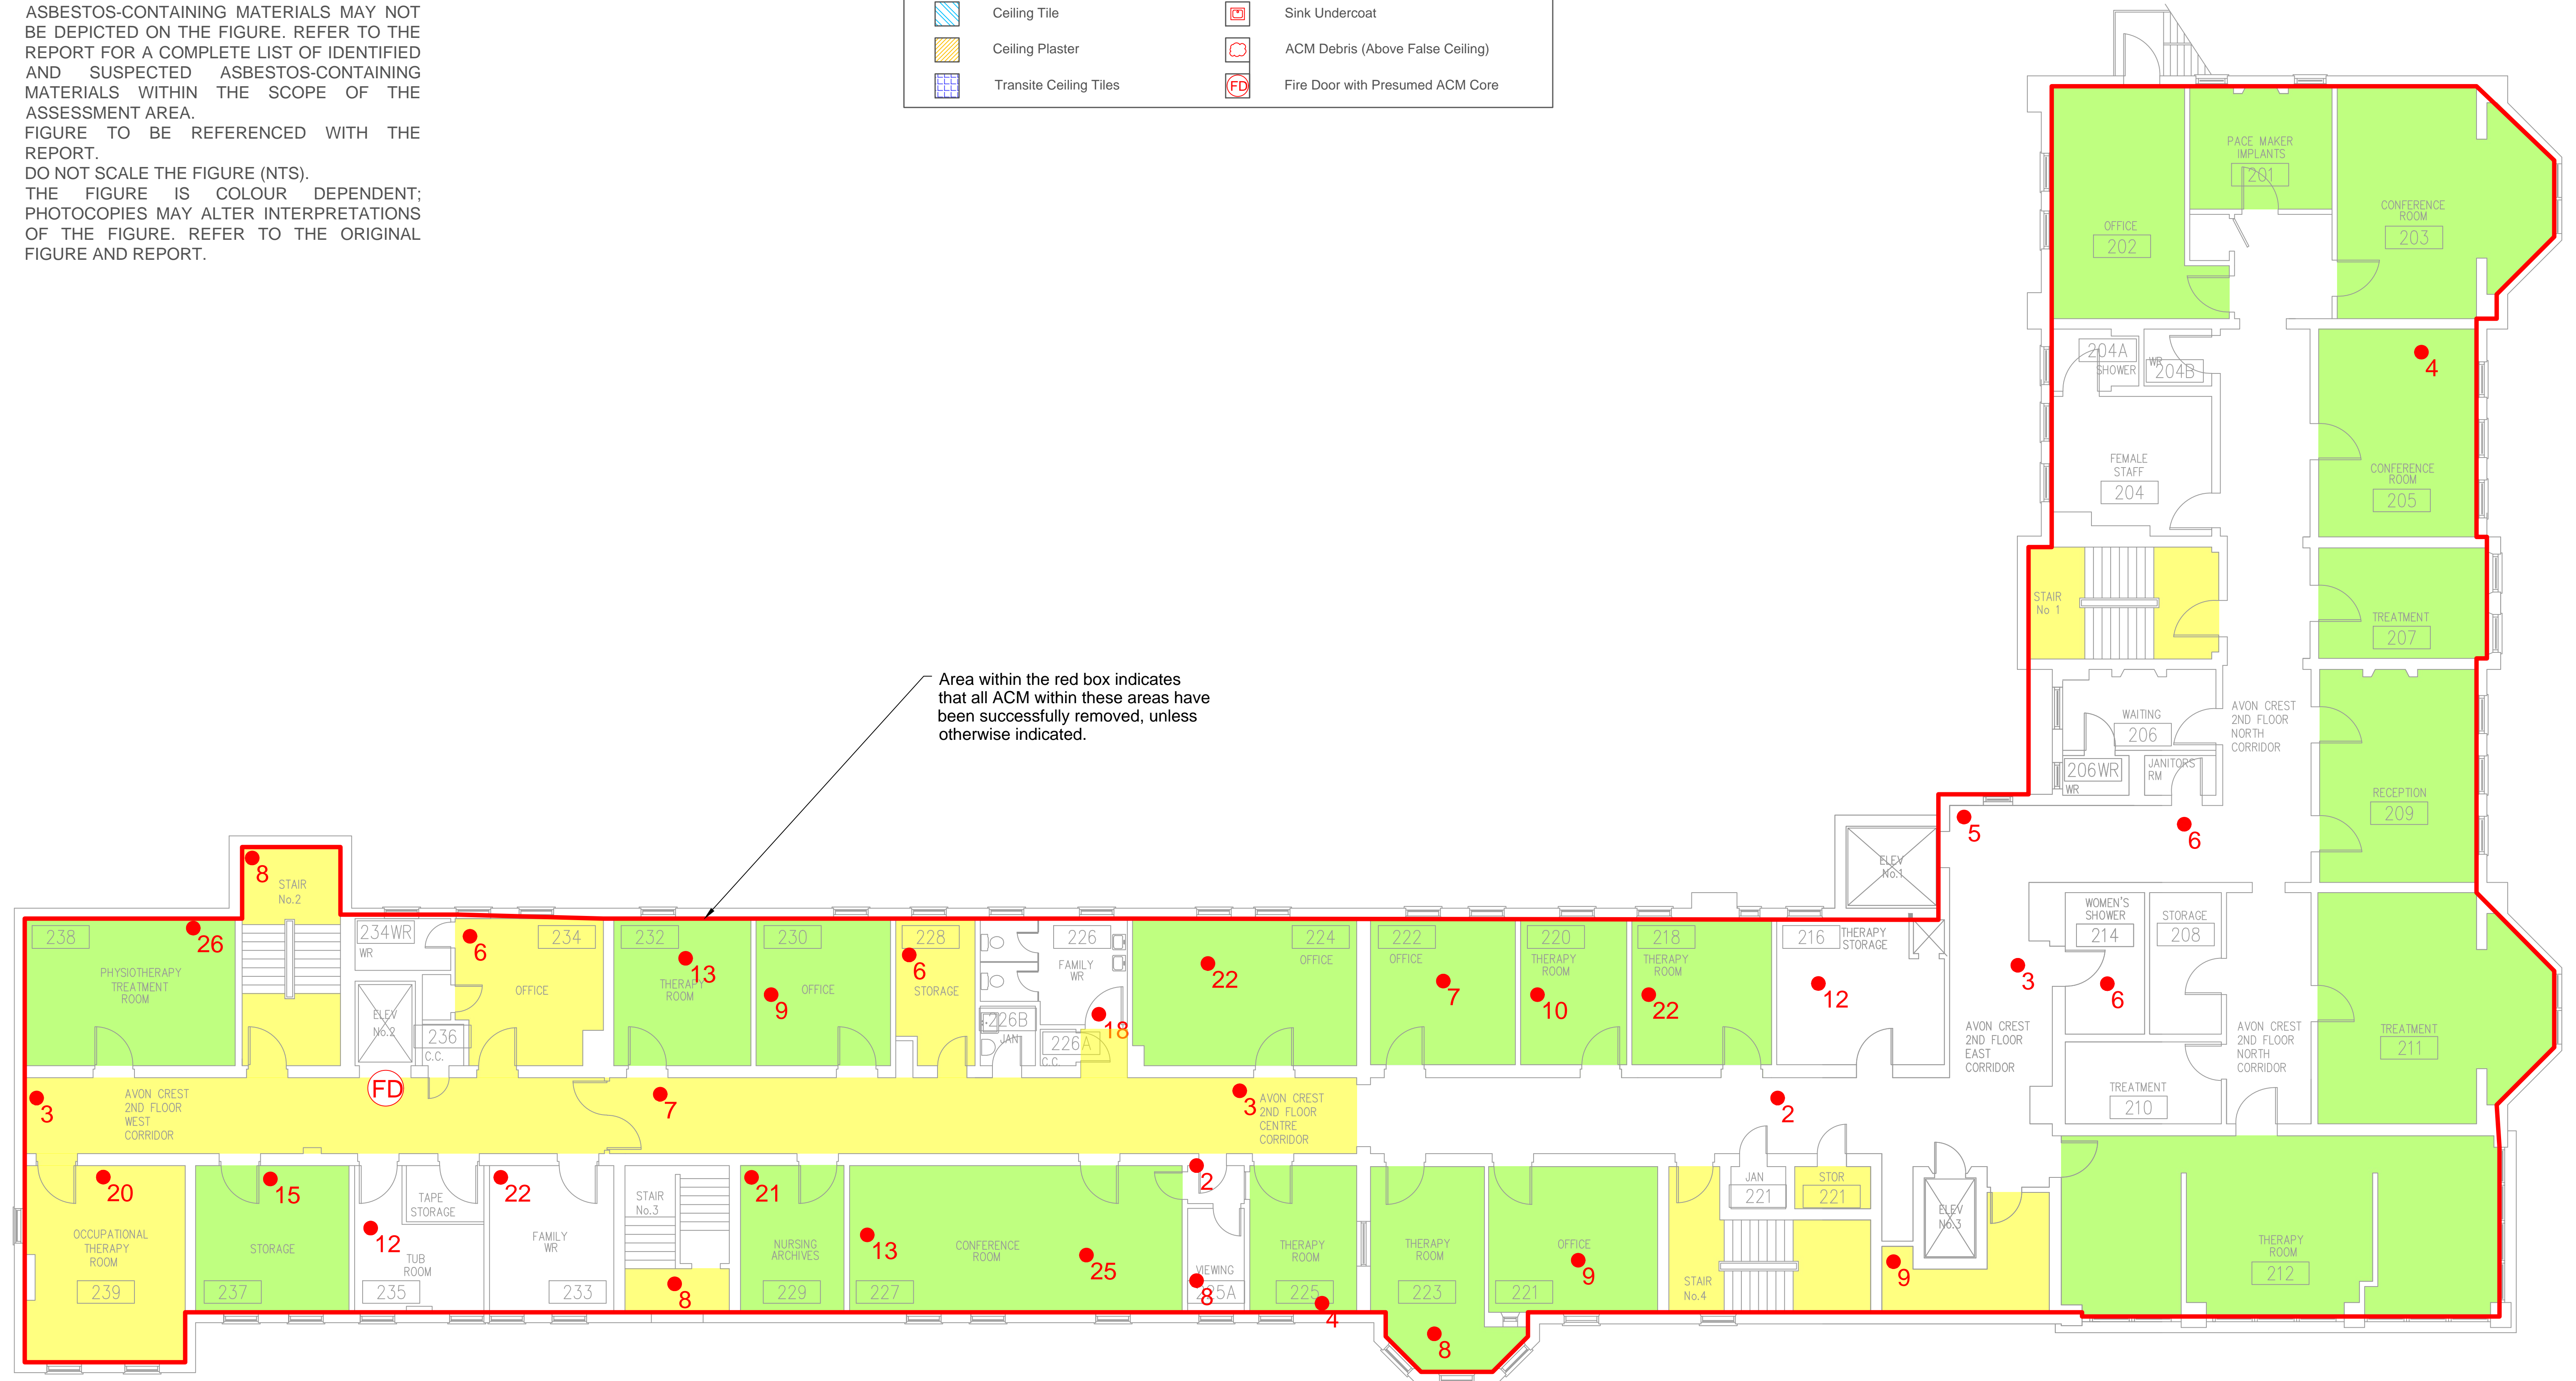
PR02

- Remaining asbestos-containing parged cement pipe fitting insulation in the office on the second floor (Room 234) was observed to have been removed (**P3**);

Area within the red box indicates that all ACM within these areas have been successfully removed, unless otherwise indicated.

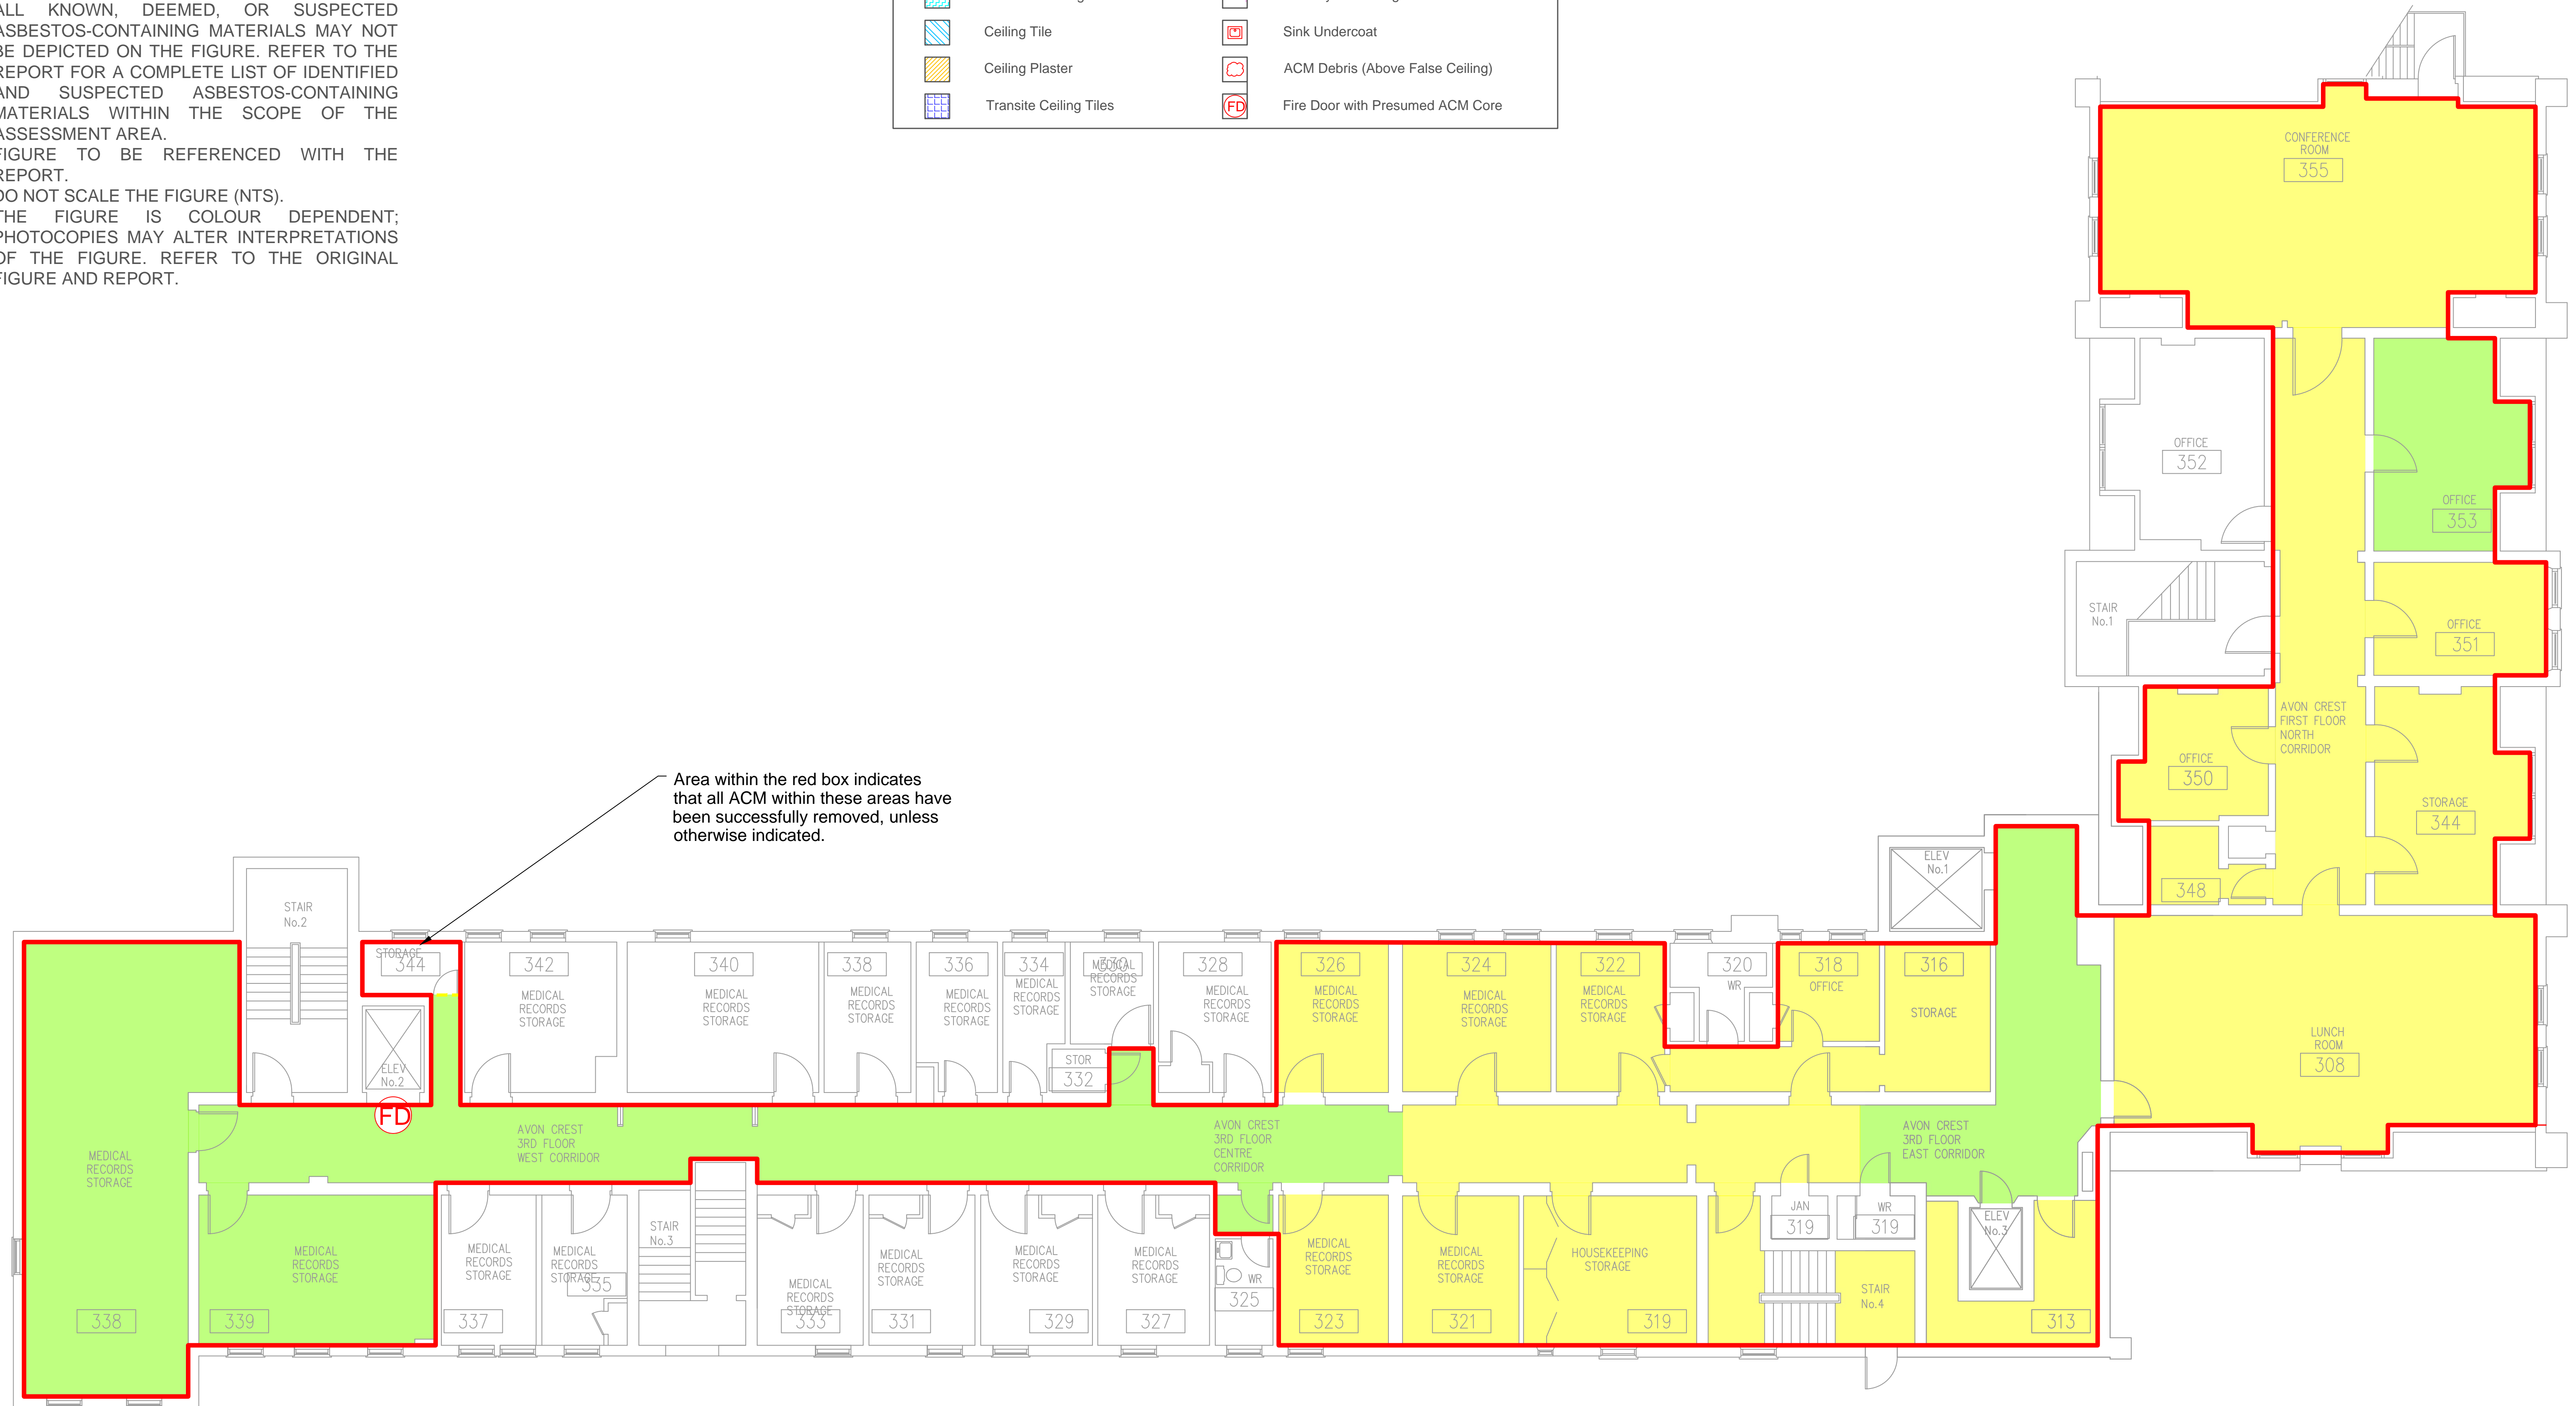
AVONCREST – 3RD FLOOR

Area within the red box indicates that all ACM within these areas have been successfully removed, unless otherwise indicated.

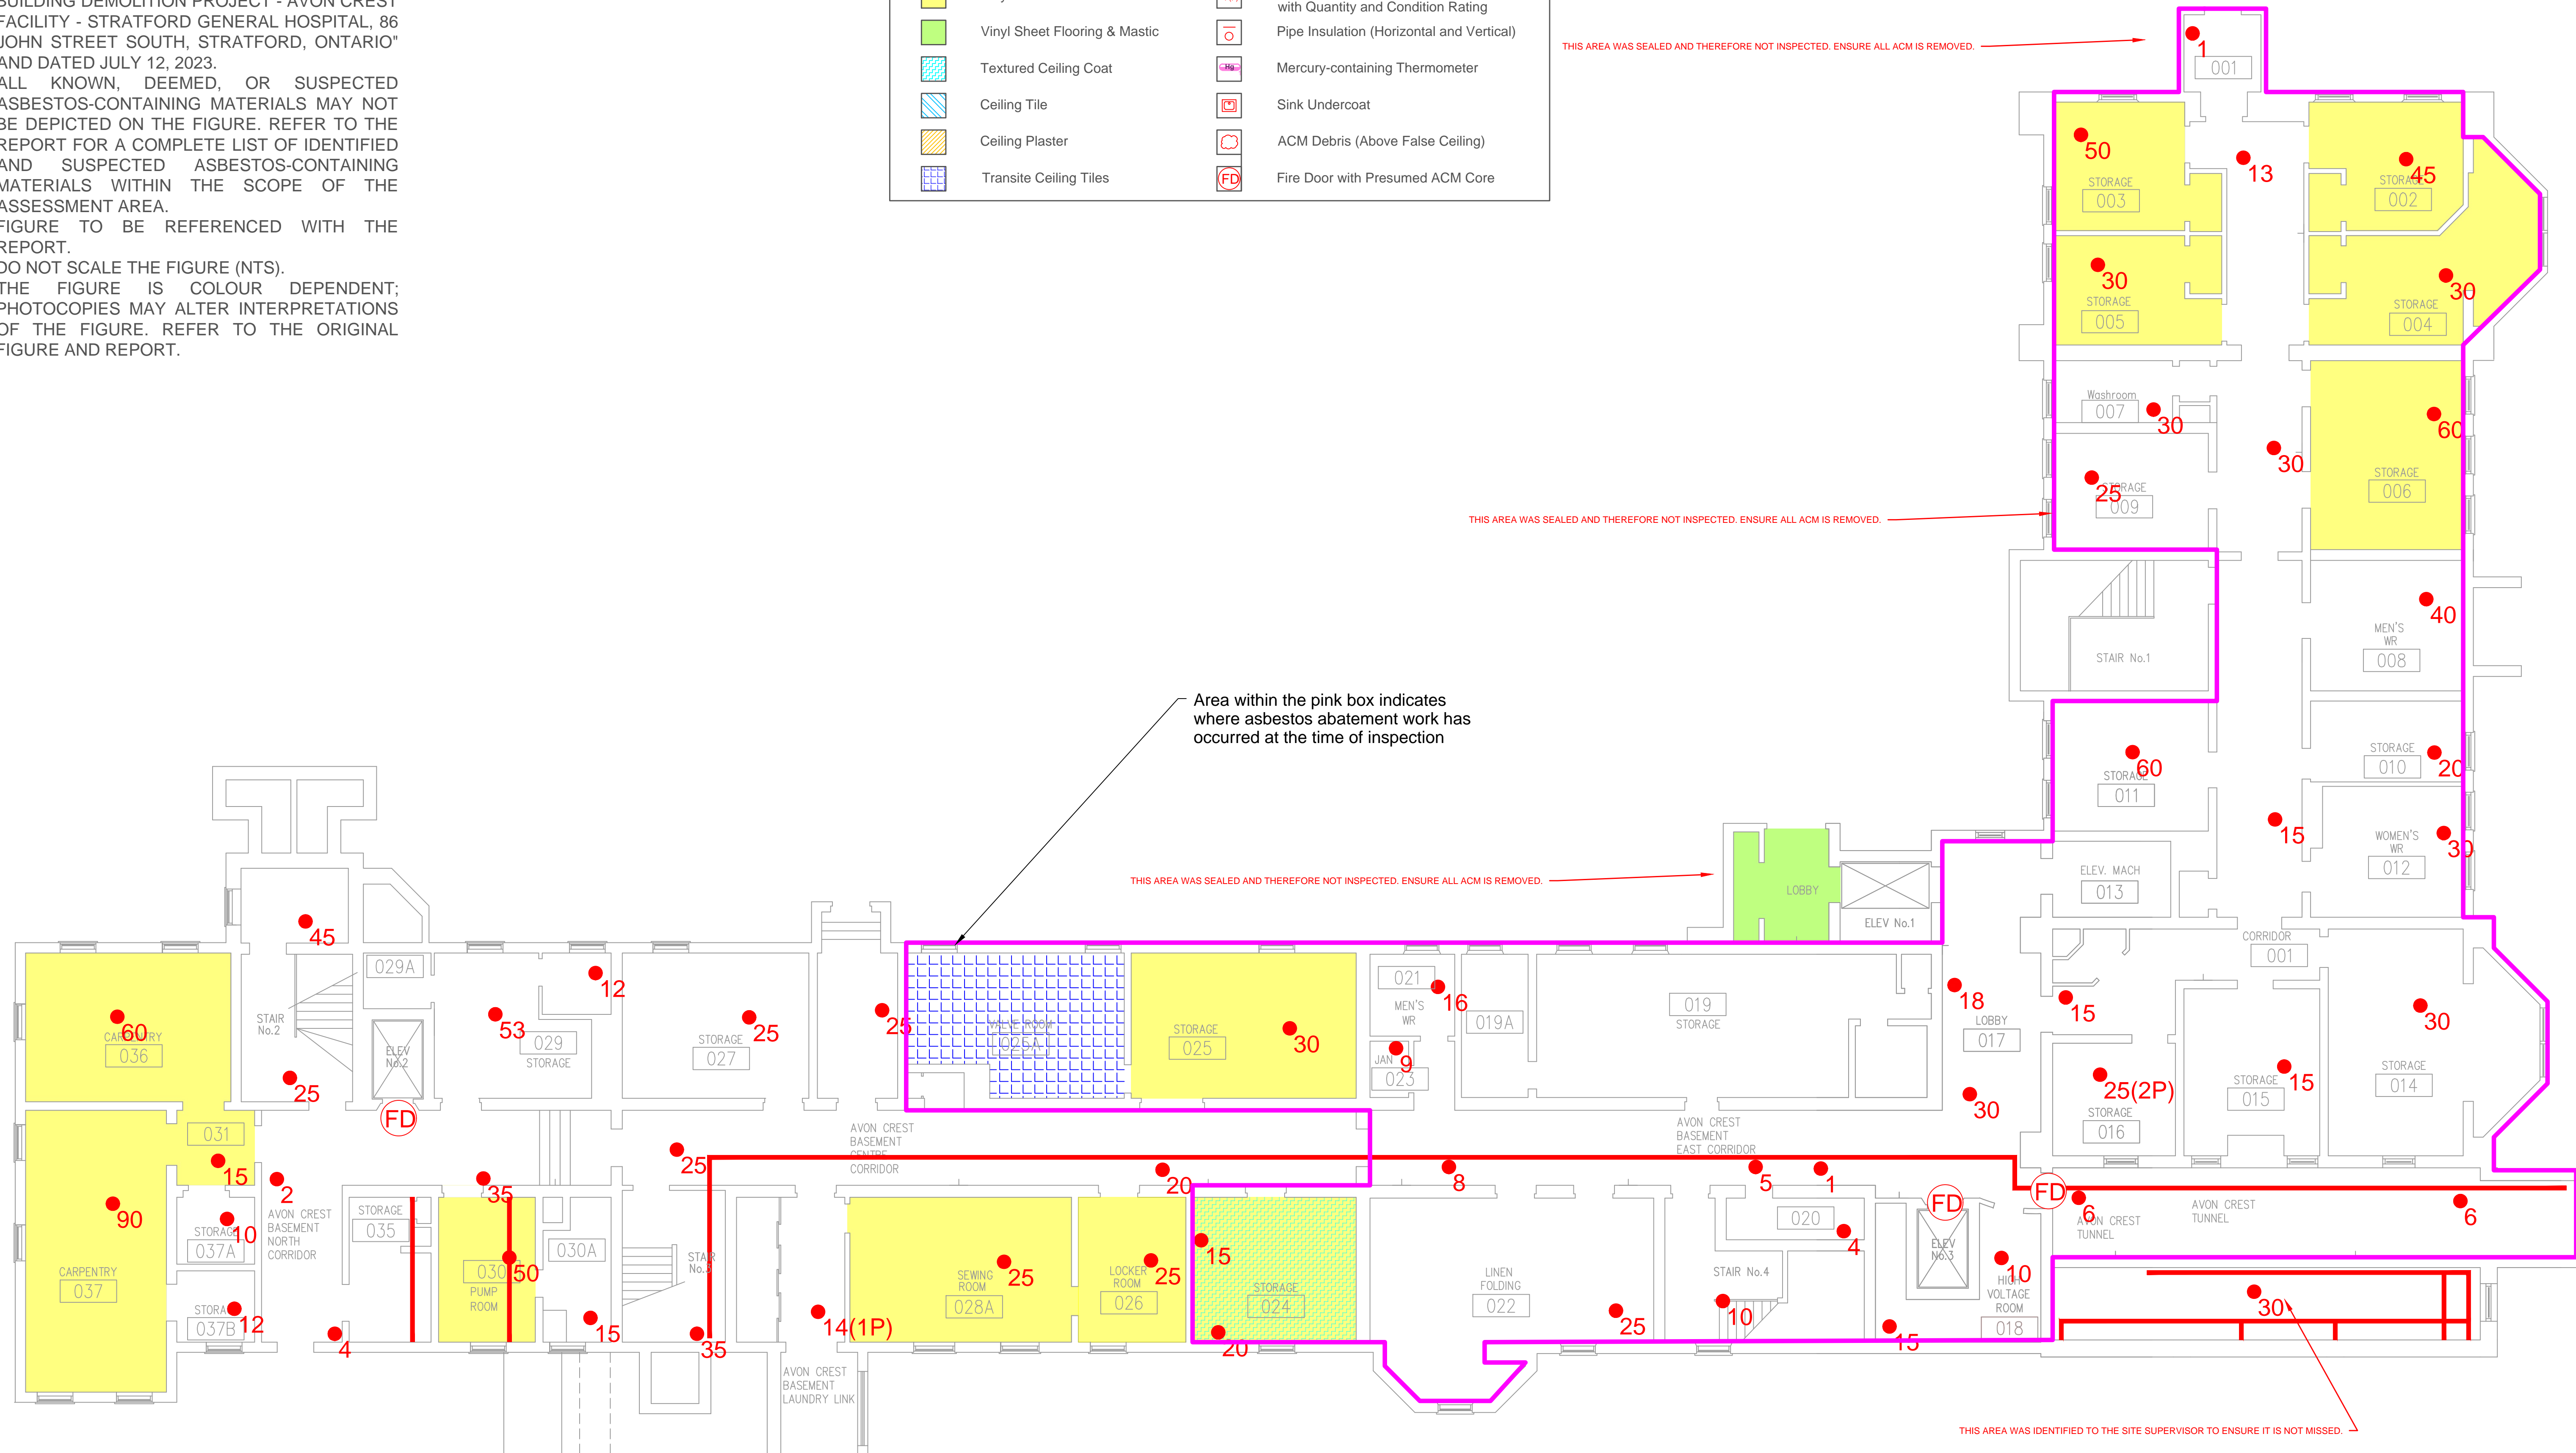
AVONCREST, WEST WING – BASEMENT

- At the time of inspection, workers were removing asbestos-containing insulation from pipe straights and pipe fittings from the east corridor within the basement of the Avon Crest building;

- Rooms in the basement between Room 001 and Room 025A that were previously observed to be sealed off during the inspection on July 6, 2023, remained sealed off at the time of inspection. These rooms will require additional inspection prior to clearance;
