# AVONCREST

## Designated Substance Audit Report

11 Avoncrest Drive  
Sratford, Ontario

**MTE File No.: 43789-200**

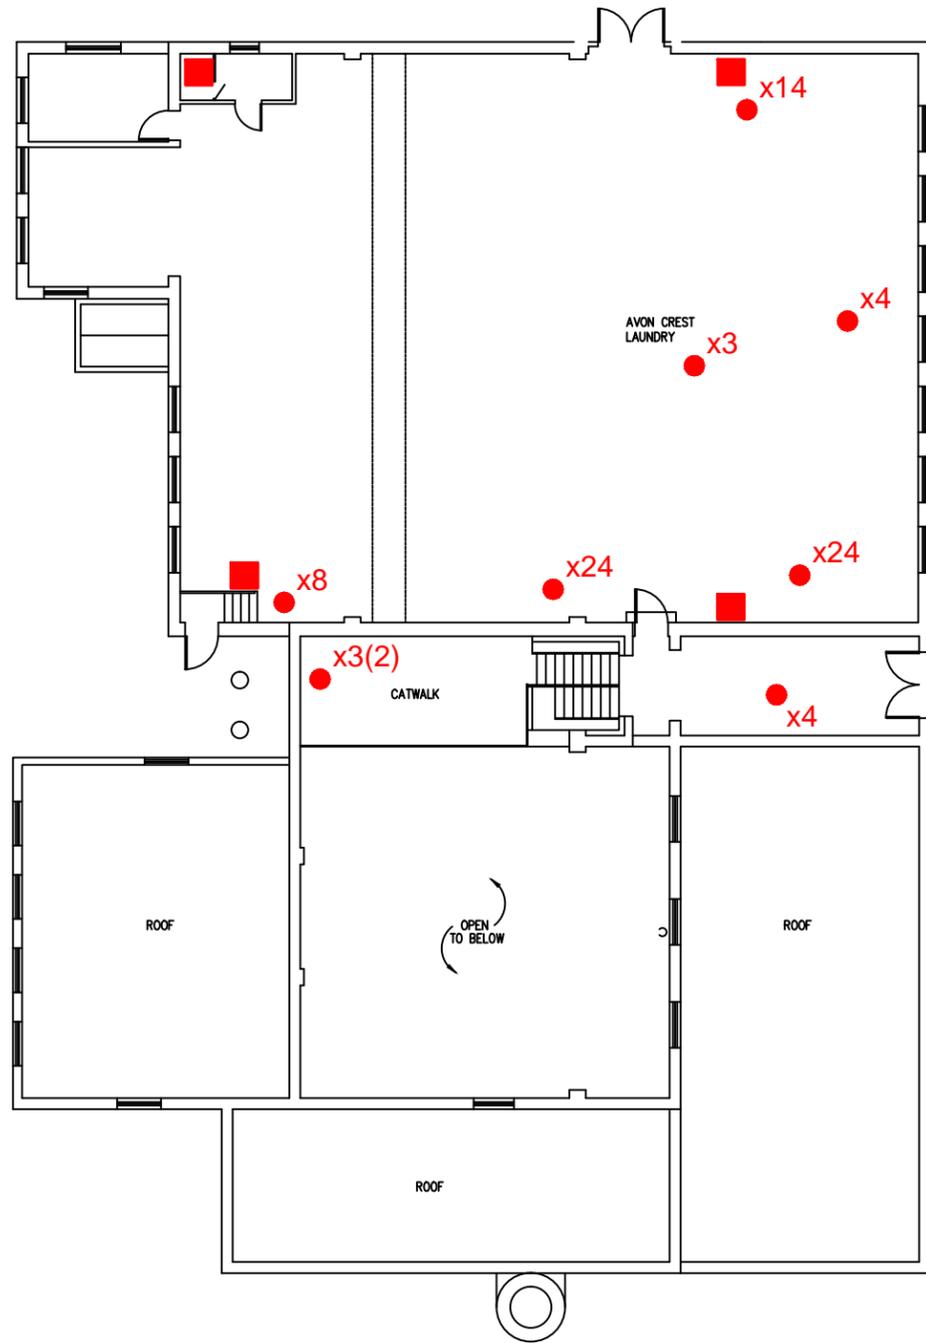
LAUNDRY (1947 Addition)

PLASTER IS ASBESTOS-CONTAINING THROUGHOUT.

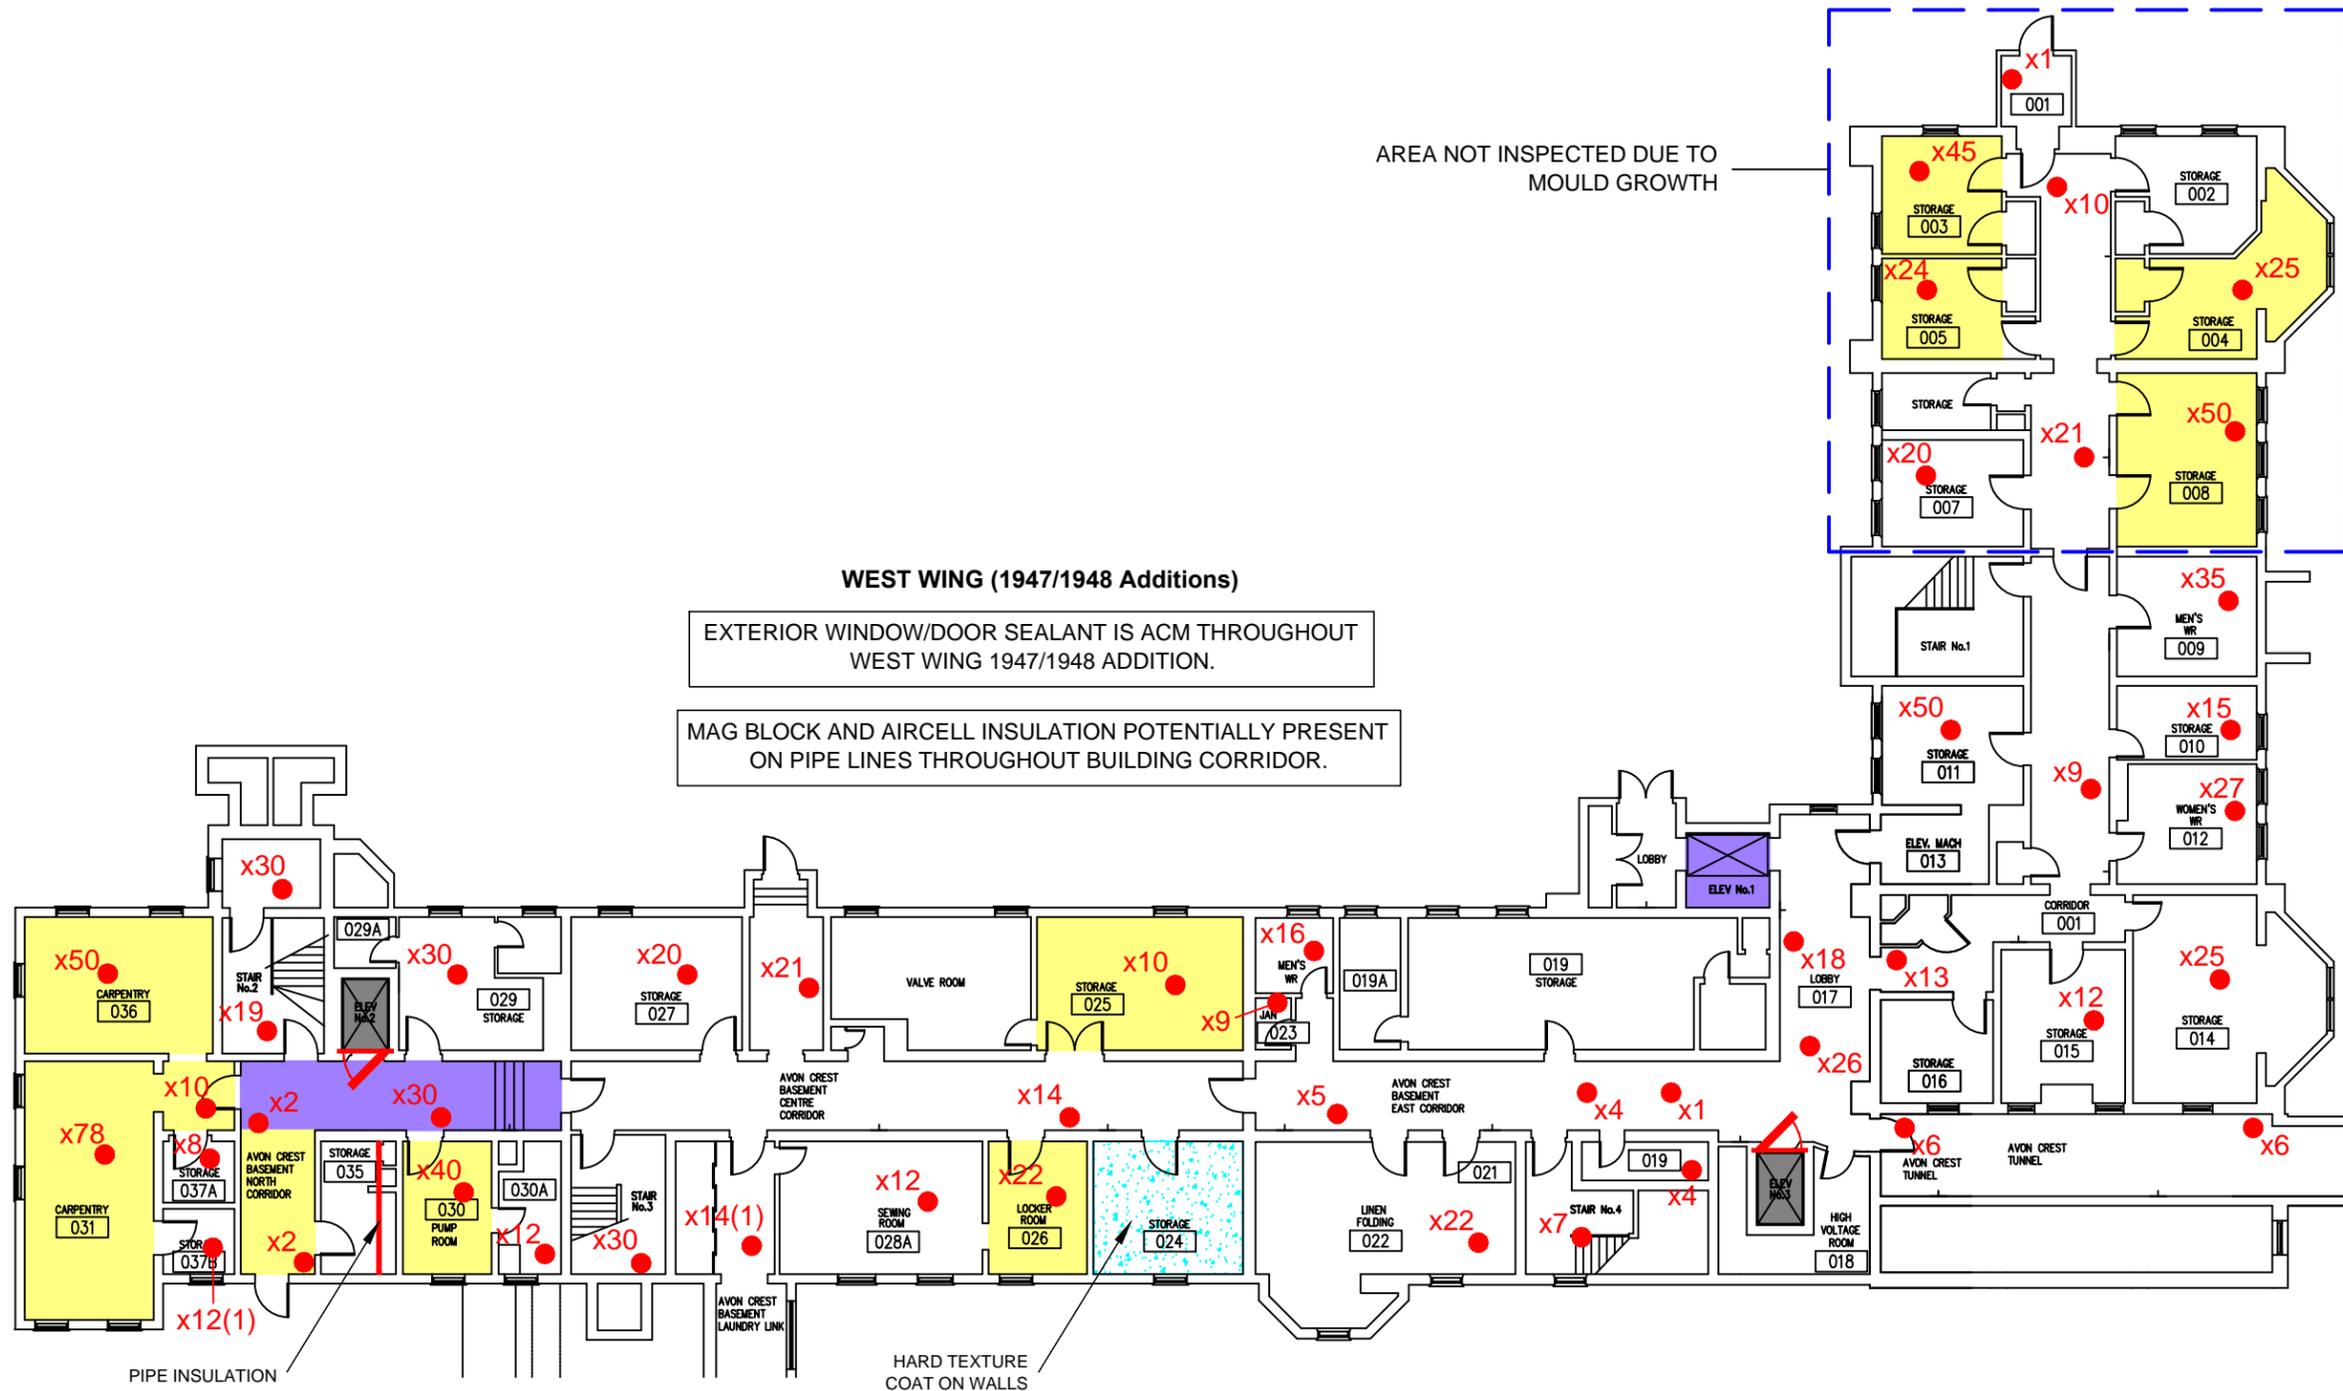
EXTERIOR WINDOW/DOOR SEALANT IS ACM THROUGHOUT WEST WING 1947/1948 ADDITION.

MAG BLOCK AND AIRCELL INSULATION POTENTIALLY PRESENT ON PIPE LINES THROUGHOUT BUILDING CORRIDOR.

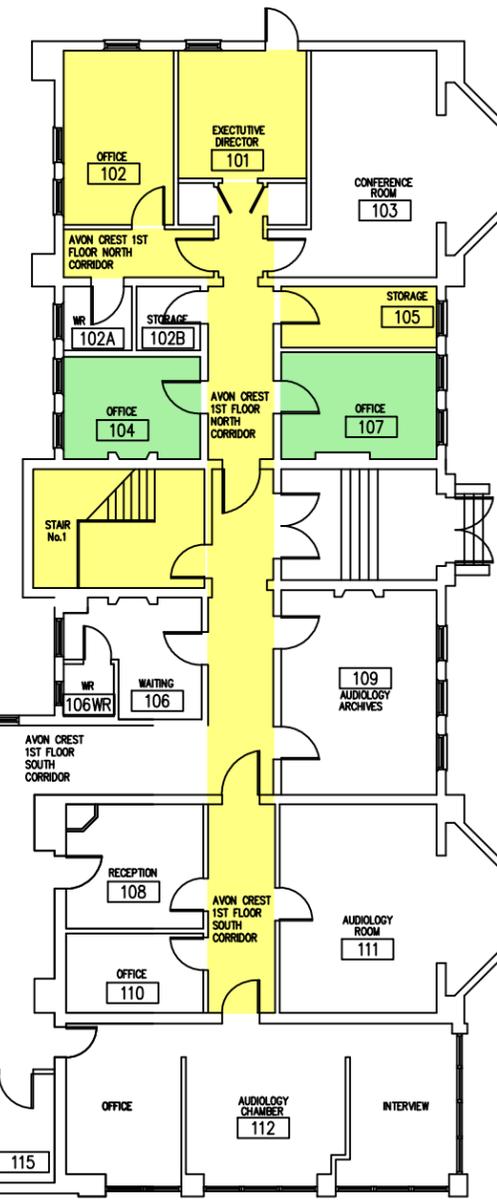
**NORTH WING (Original 1893)**

EXTERIOR WINDOW/DOOR SEALANT IS ACM THROUGHOUT NORTH WING ORIGINAL 1893 BUILDING SECTION.

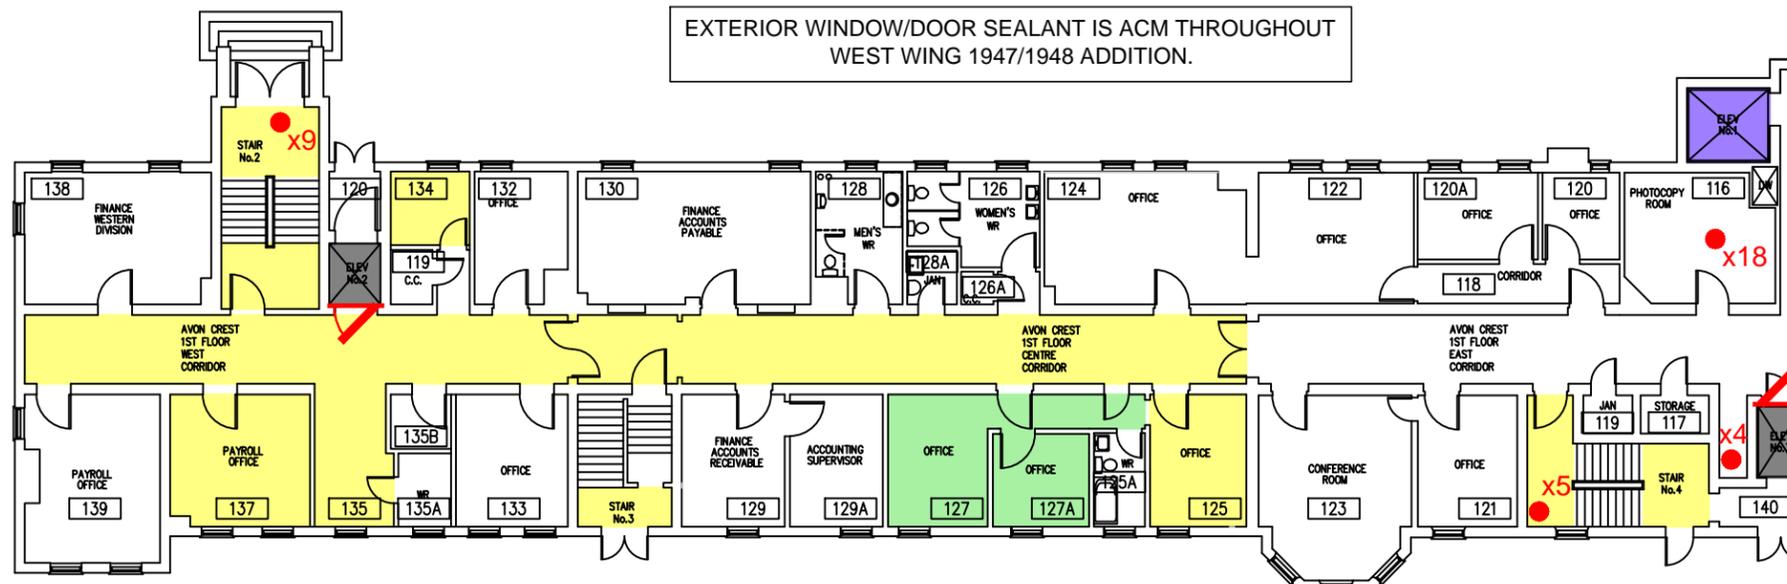
**WEST WING (1947/1948 Additions)**

EXTERIOR WINDOW/DOOR SEALANT IS ACM THROUGHOUT WEST WING 1947/1948 ADDITION.

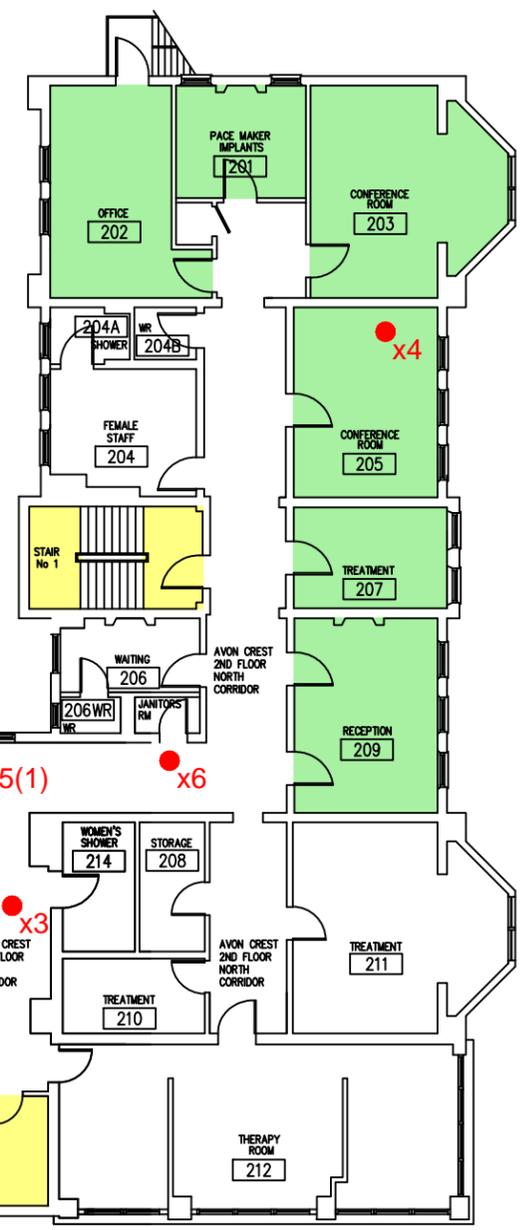
**NORTH WING (Original 1893)**

EXTERIOR WINDOW/DOOR SEALANT IS ACM THROUGHOUT NORTH WING ORIGINAL 1893 BUILDING SECTION.

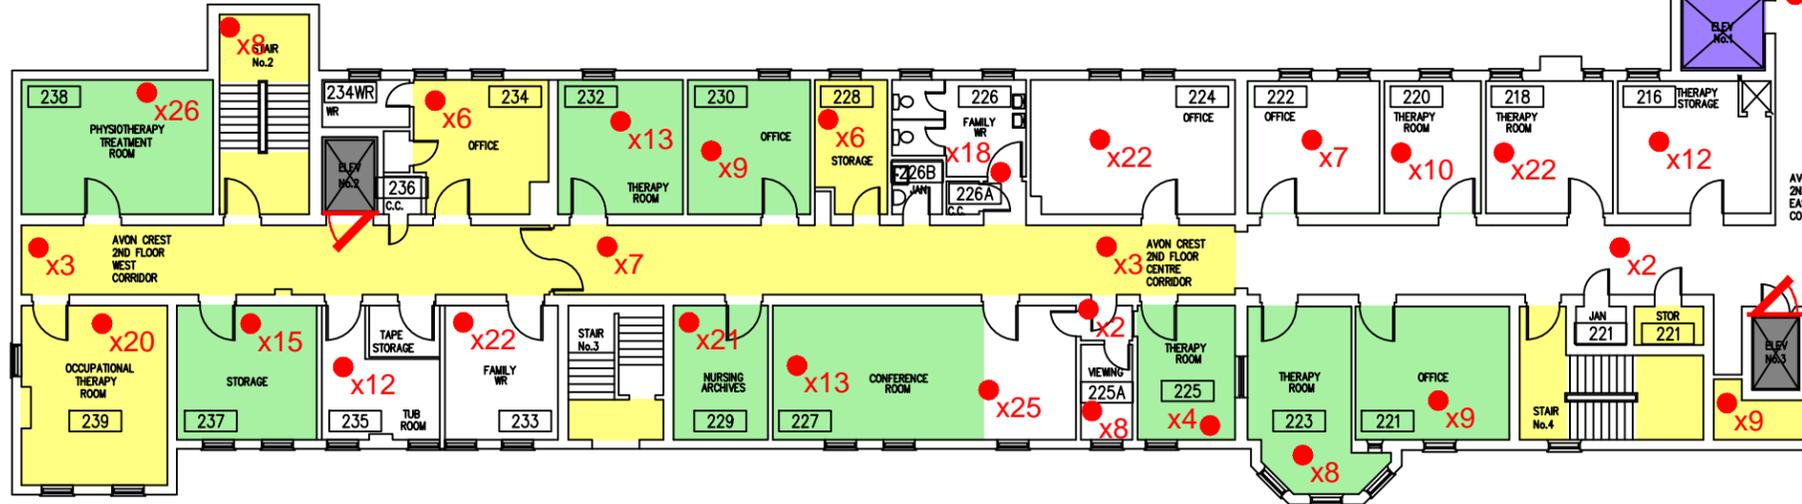
**WEST WING (1947/1948 Additions)**

EXTERIOR WINDOW/DOOR SEALANT IS ACM THROUGHOUT WEST WING 1947/1948 ADDITION.

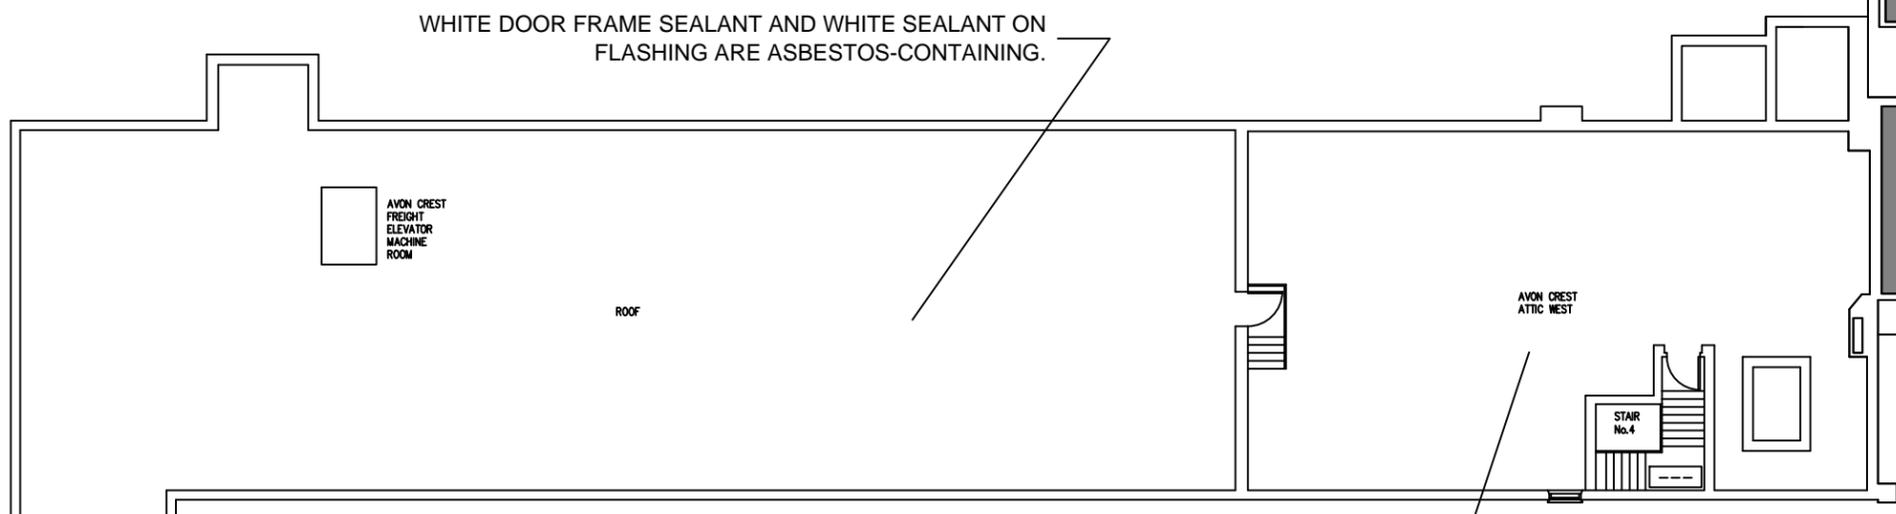
**WEST WING (1947/1948 Additions)**

WHITE DOOR FRAME SEALANT AND WHITE SEALANT ON FLASHING ARE ASBESTOS-CONTAINING.

STORED VINYL SHEET FLOORING IS PRESUMED ASBESTOS-CONTAINING.
