**Re: Site Inspection Report for July 11, 2023  
Avon Crest Building Demolition Project  
Avon Crest Facility – Stratford General Hospital  
86 John Street South, Stratford, Ontario (Site)**

## Figure PR04: Progress Inspection #4 – July 11, 2023

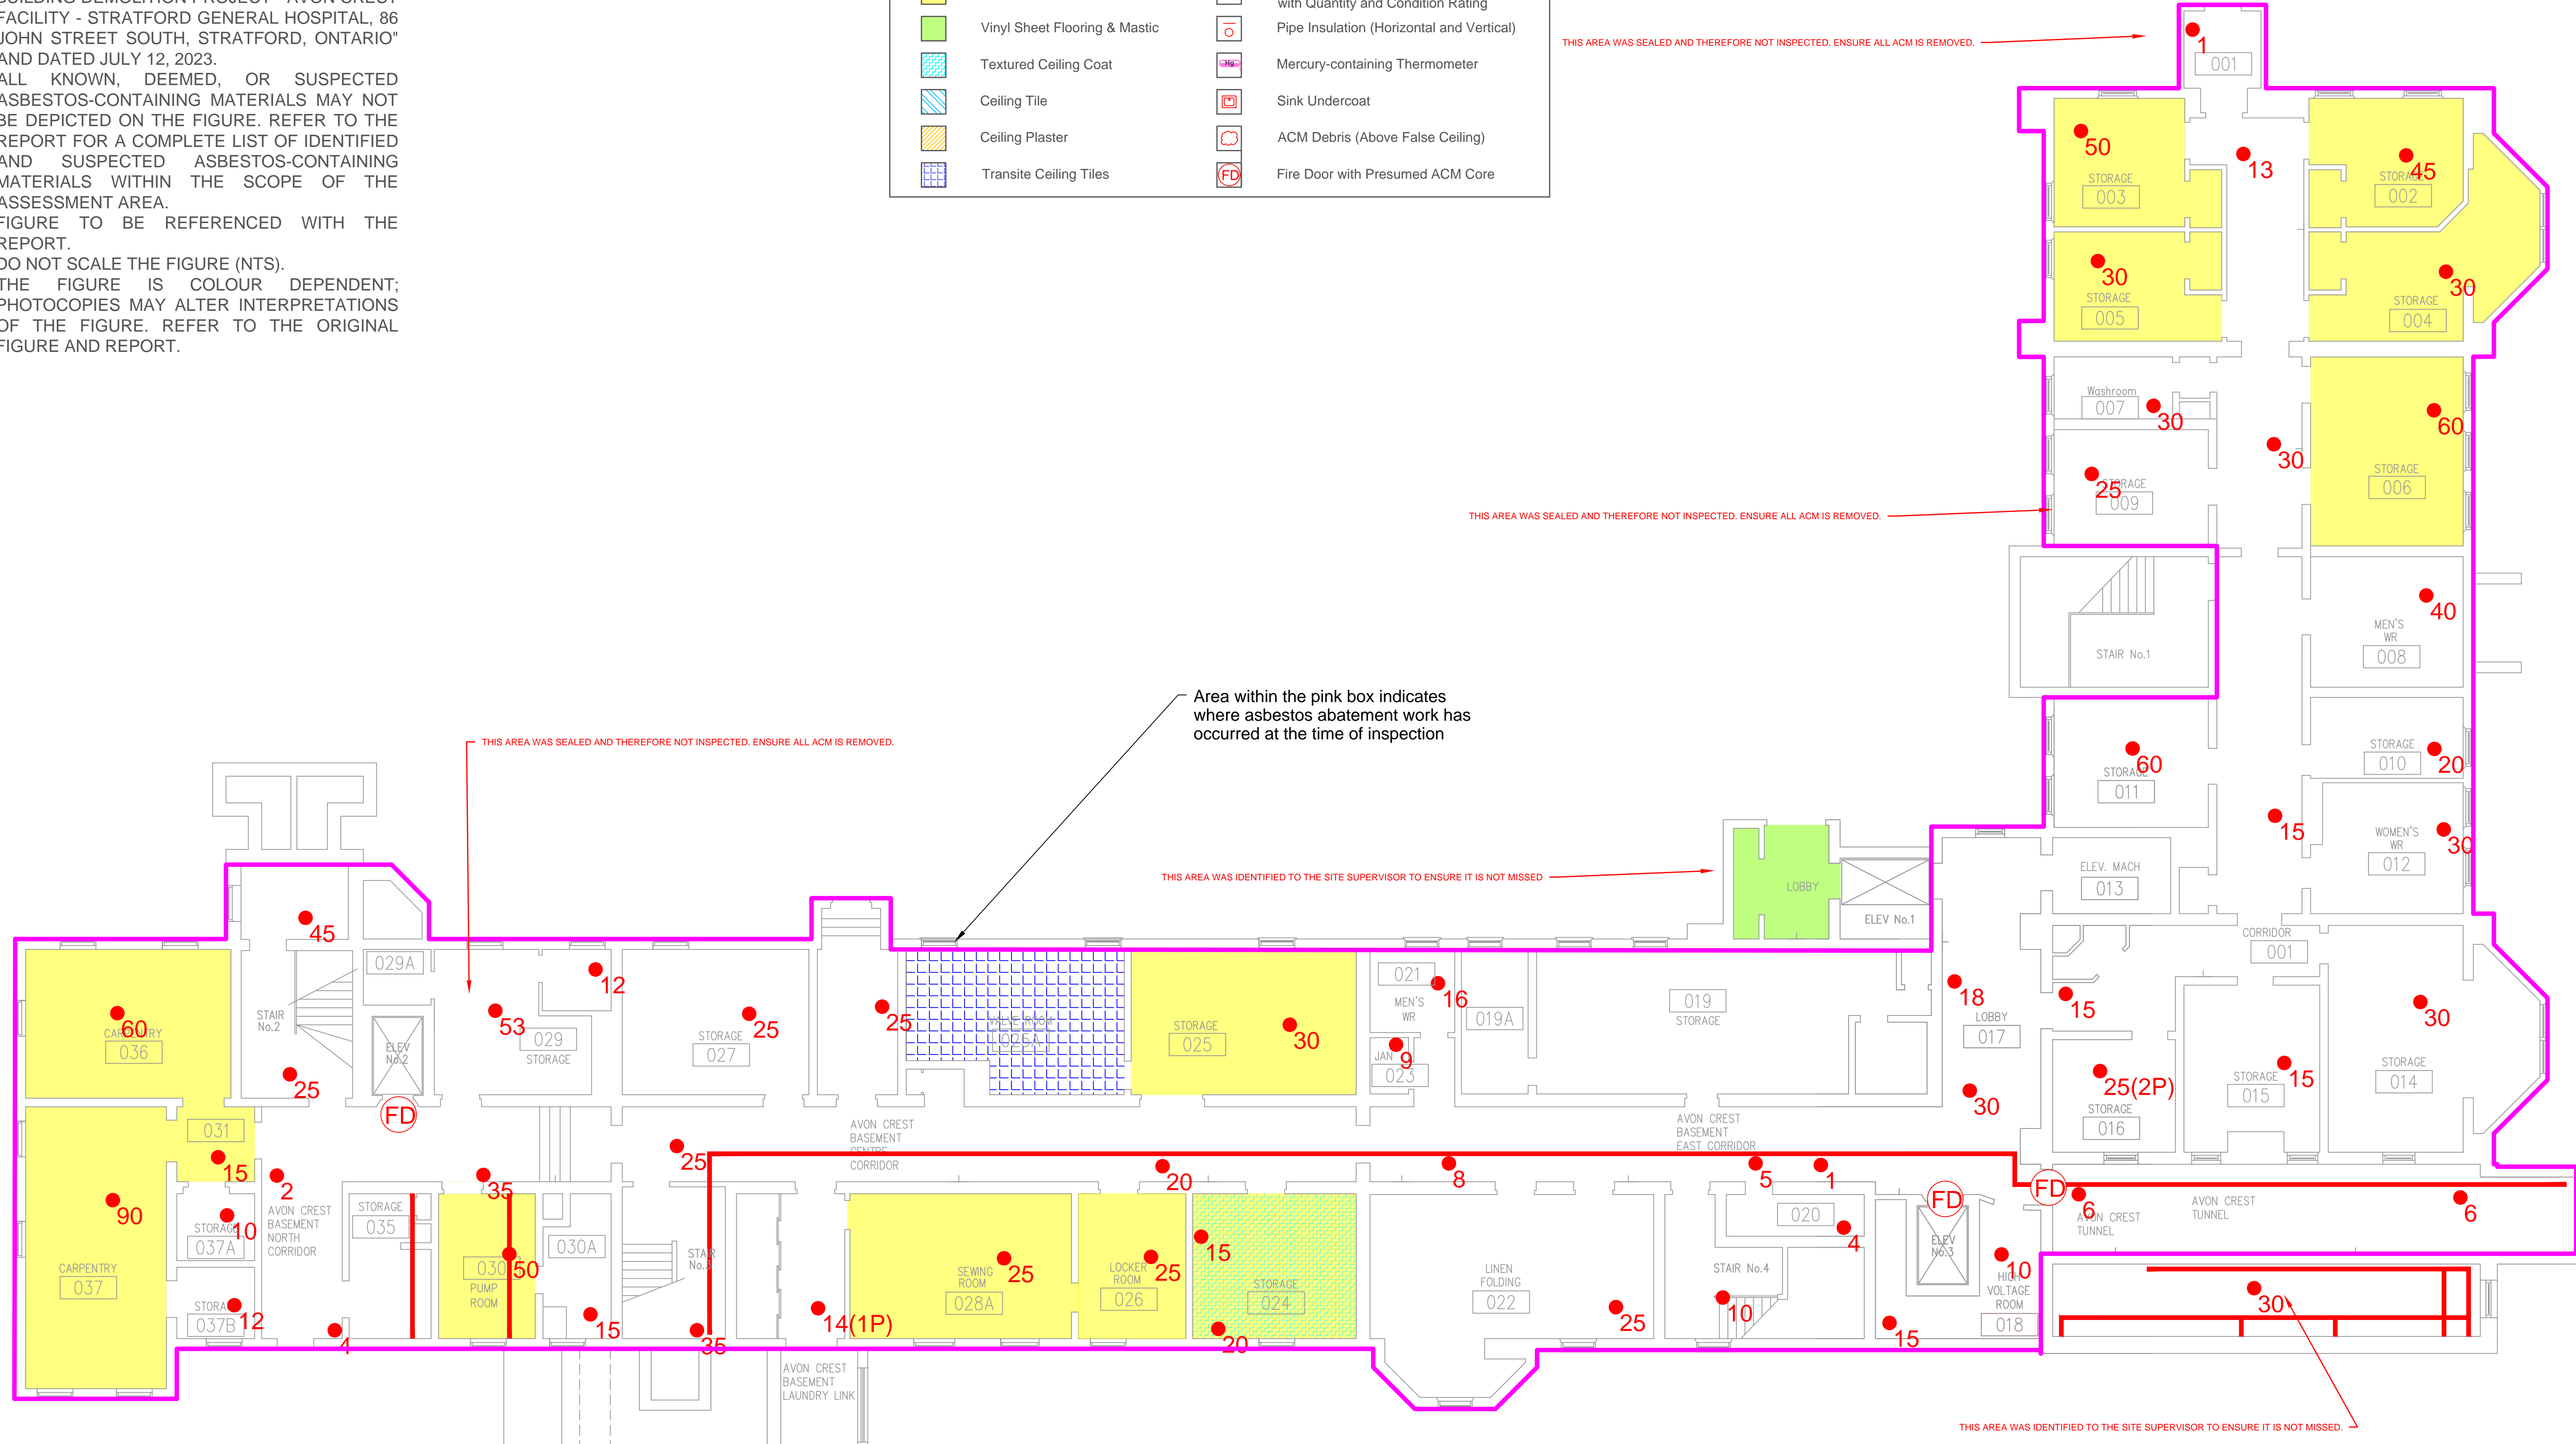
AVONCREST, WEST WING – BASEMENT

- The majority of asbestos-containing materials have been removed from the basement between Room 001 and Room 037B, including:
  - Vinyl floor tiles (**P1**);
  - Parged cement pipe fitting insulation (**P2**);
  - Pipe insulation straights (**P3**); and.
  - Parging cement on pipe hangars;
- Pipes were inspected for parging cement insulation remnants and were observed to be visually clean (**P4**);
- The work site appeared to be clean and tidy during the inspection.

During the inspection, Safetech identified the entrance to a lobby area north of Storage Room 019 and west of Elevator No. 1 to the site supervisor. This lobby area was noted to have asbestos-containing vinyl sheet flooring and was identified in order to ensure that asbestos abatement work within the area is completed.
